# VINTAGE OAKS CONDOMINIUMS

## VISUAL PROPERTY CONDITION REPORT

**PREPARED FOR:**  
VINTAGE OAKS HOA

**REPORT DATE:**  
12.1.25

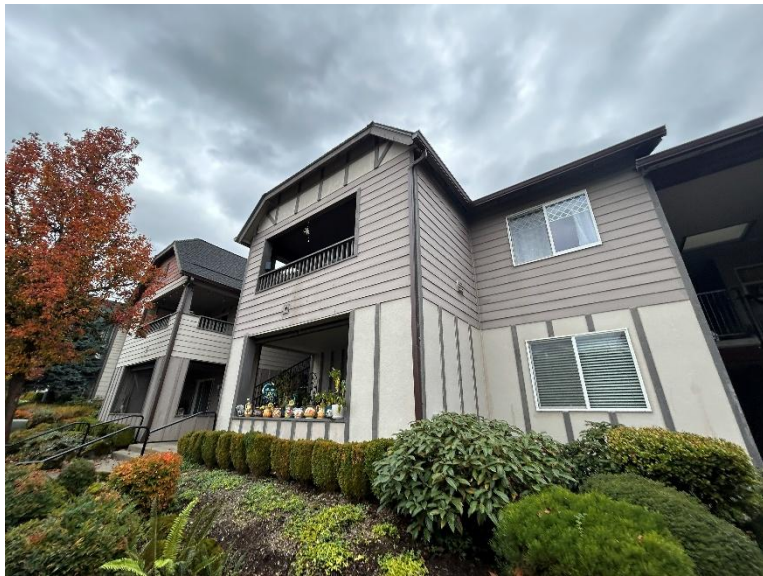
1.1 General building design. The buildings are stick built on slab and are two story. Built around 2005.

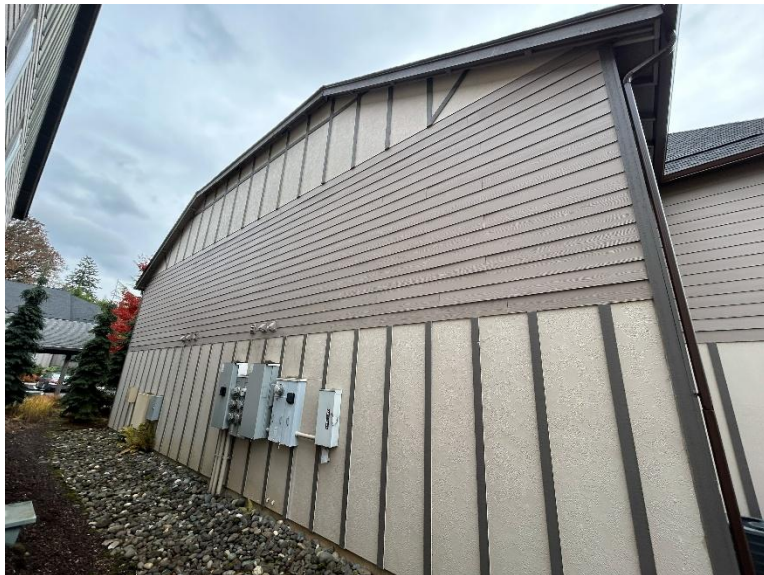
1.2 Cladding is a mix of fiber cement panel with bat and board finish and fiber cement horizontal lap siding of varying widths. Installation of cladding was done to 2005 manufacturer's standards.

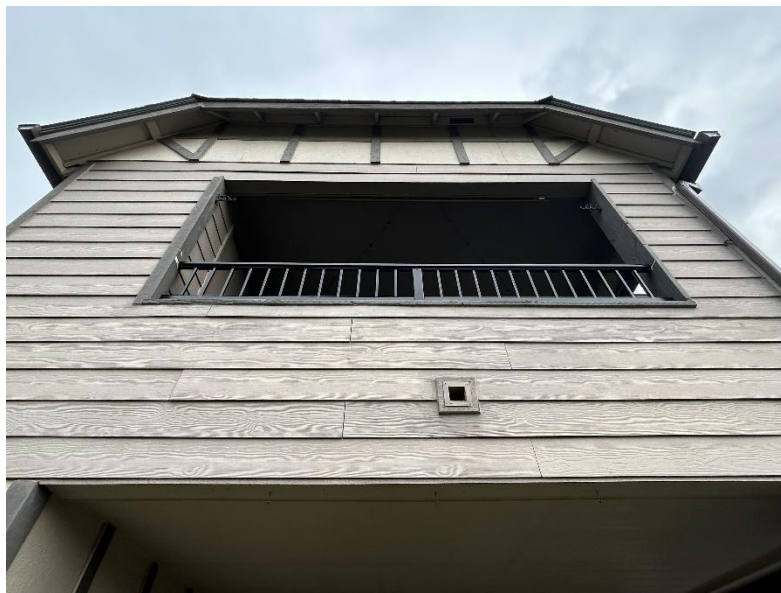
1.3 Most units have a patio or deck structure with various dimensions. This version with two side walls around the opening and the version below with only one side wall and an open post design at the corner.

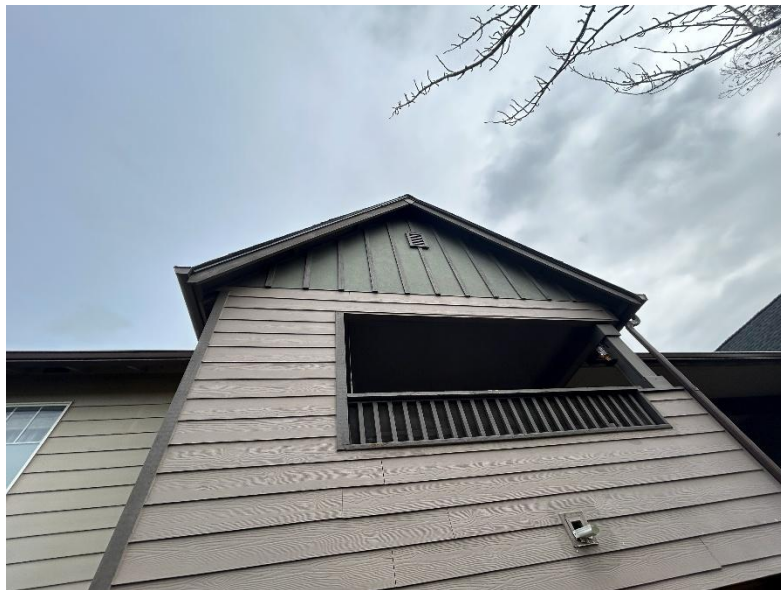
1.4 This is a typical open post design at the corner patio.

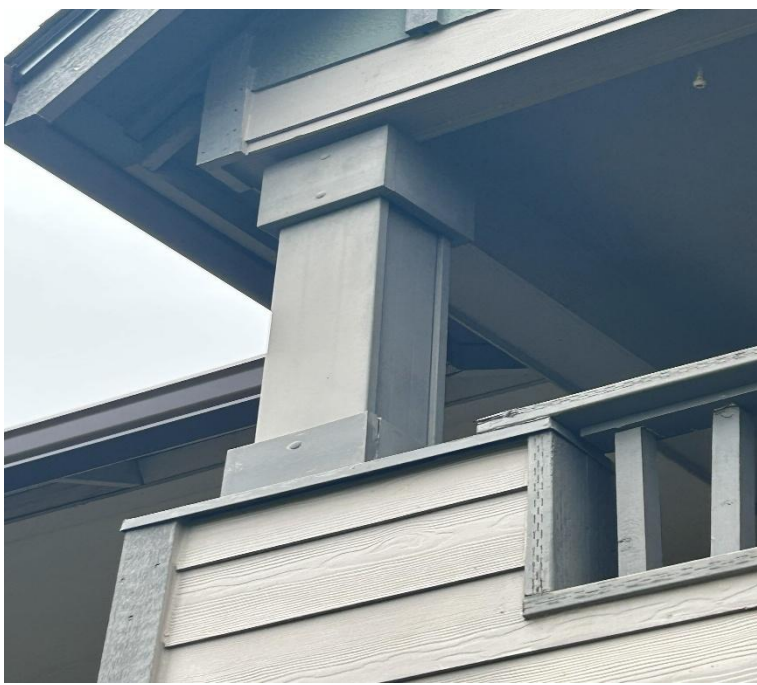
1.5 Each of the open post designs has either this vertical post with head and bottom trim.

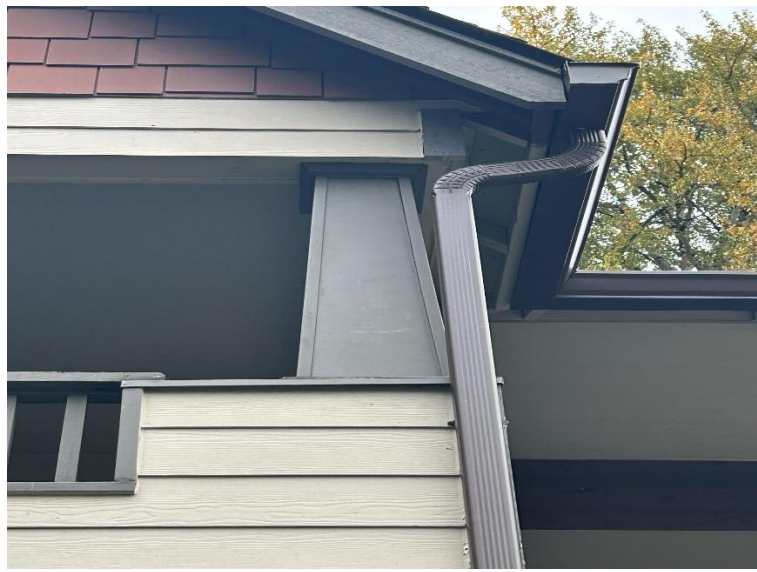
1.6 The other open post design is this pedestal with a larger base and trim on the vertical edges. Each of these appear to be original to the 2005 design.

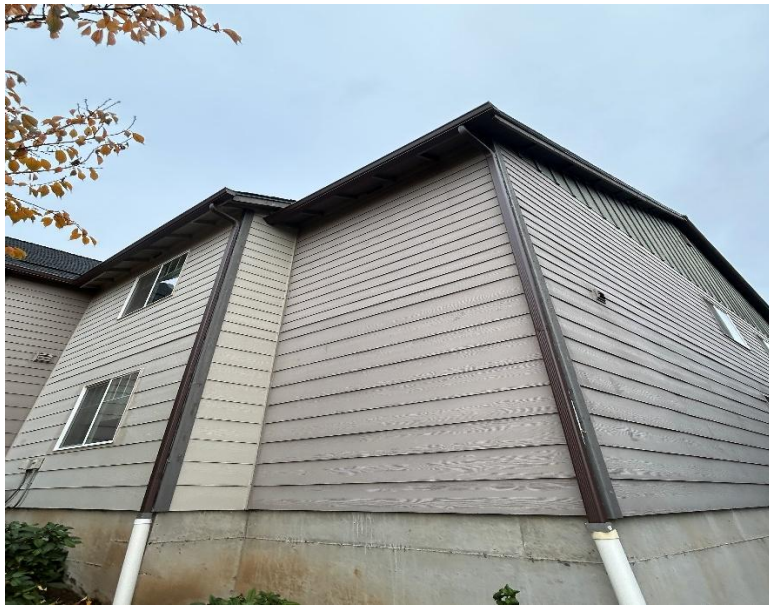
2.1 Each building has a little bit different design. Some have the larger area of lap siding with a thicker reveal, while others have the panelized and lap siding mix with a smaller lap siding reveal.

This building has thicker reveal at the bottom and thinner reveal at the top. Again Assuming this is original design.

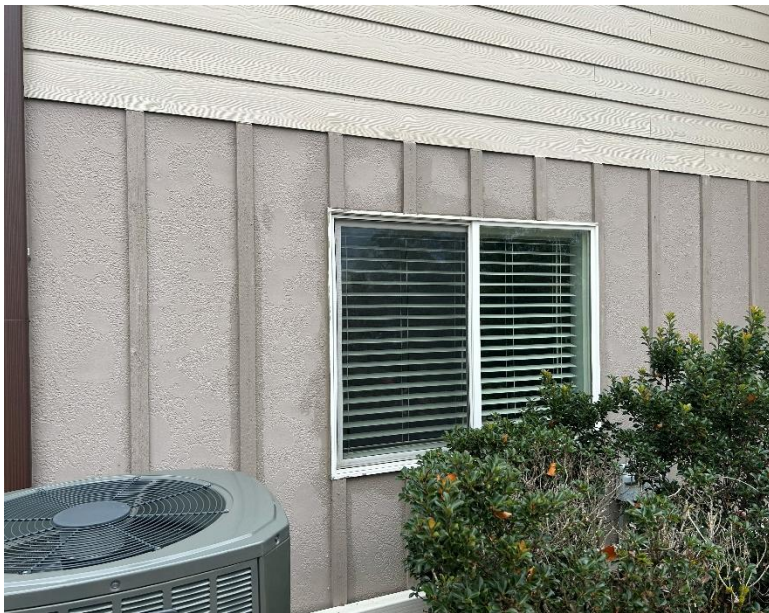
2.2 The Panelized cladding is an early fiber cement product that is made to look like stucco wall. And is trimmed on the face with Battens (wood vertical strips).

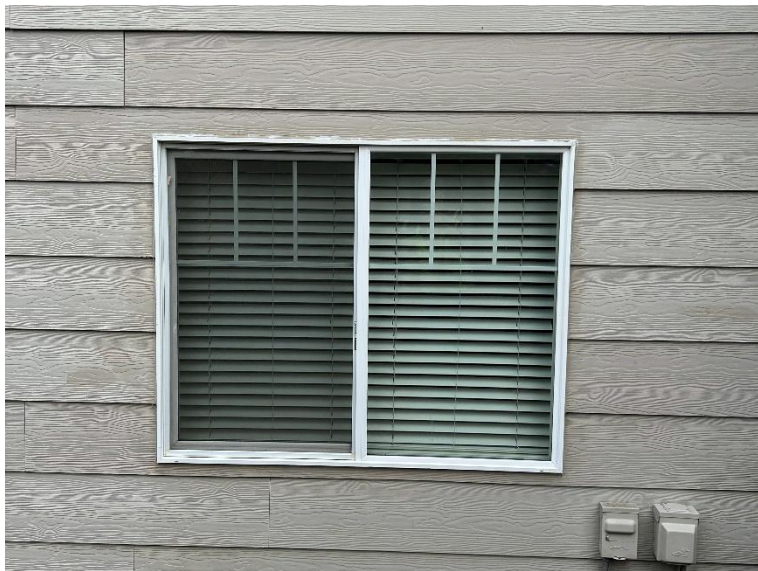
2.3 All windows appear to be the responsibility of each owner. Because there is such a variation in building designs there are many different grid patterns present at the property. Windows overall appear to be low E vinyl style, side sliders. Windows have no metal flashing, no trim, and no dynamic joints, but appear to be finned and most appear to be original.

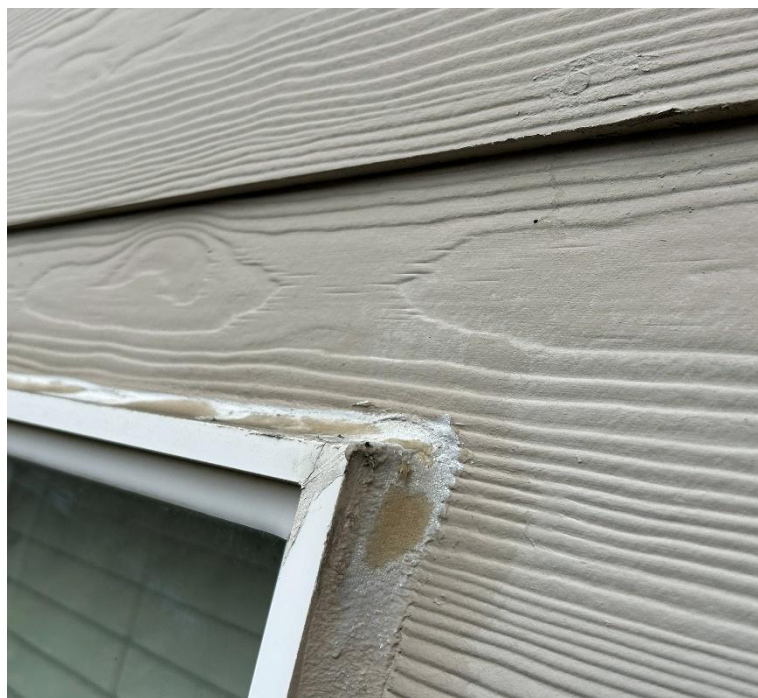
2.4 Some windows were noted as having been recently caulked and resealed and had touch up paint applied.

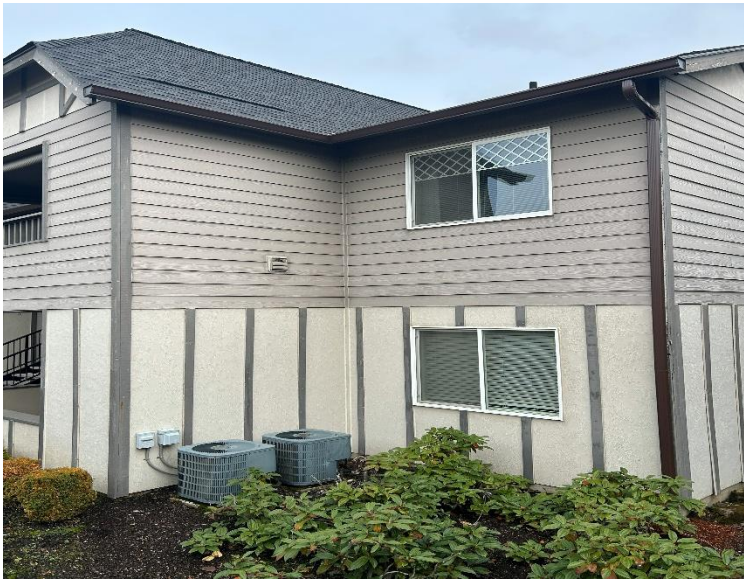
2.5 Roofs appear to be newer and replaced since construction. The material is a high quality architectural composition shingle. There are also intake vents installed at the overhangs and the system has a ridge vent for exhaust.

No access to attics was available during the inspection.

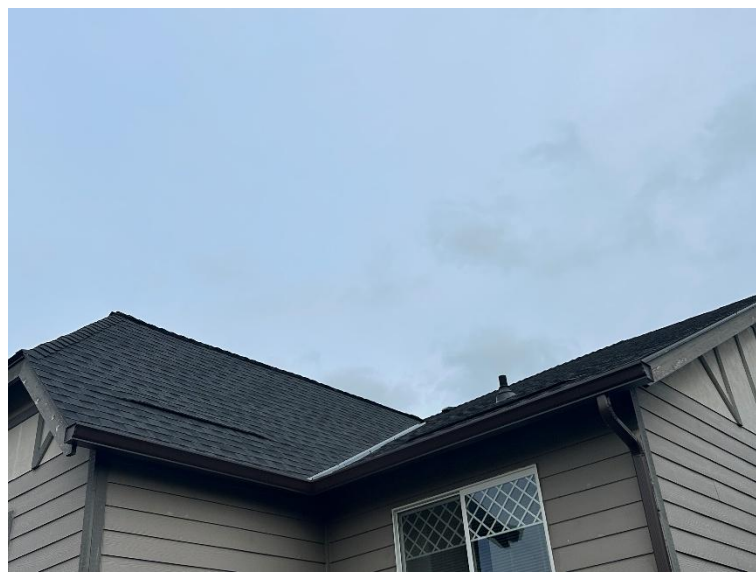
2.6 The installation of the roofs looks very well done with metal valleys and what appear to be new gutters and downspouts as well.

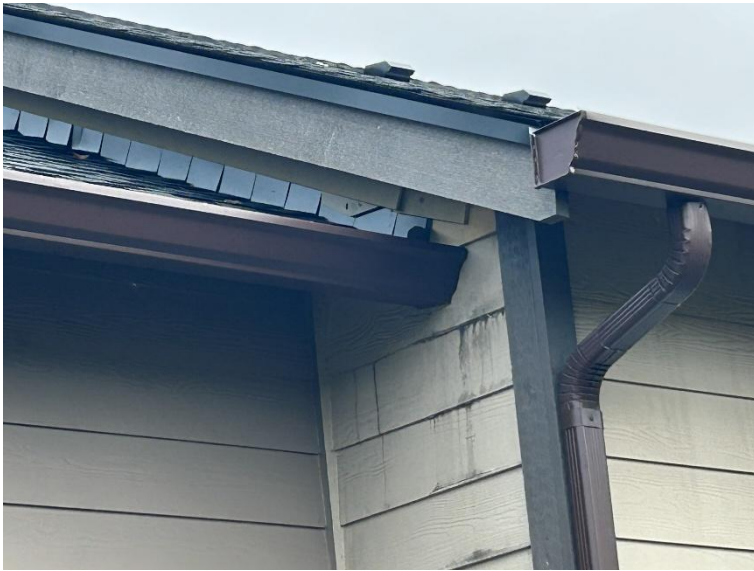
2.7 When the roof was installed it appears that new step flashing as well as kick out diverters were installed as well.

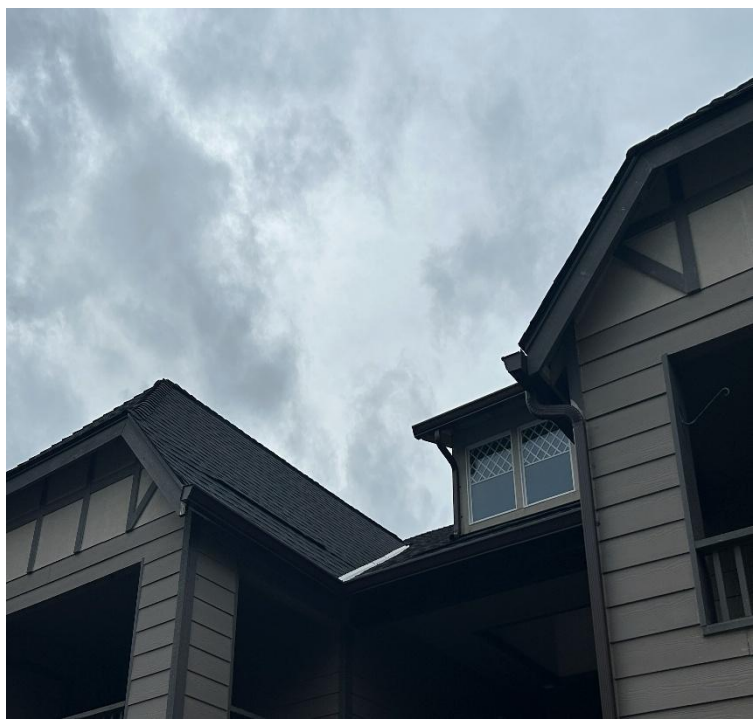
2.8 The existing roof should meet its full useful life of at least 40 years with regular maintenance.

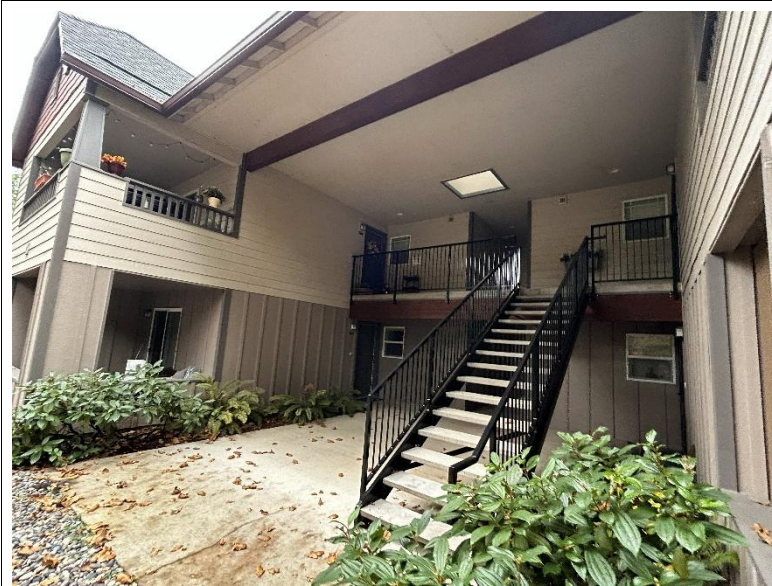
3.1 There are large entryway areas at each building allowing individual unit access both upstairs and downstairs.

Moisture readings were taken in these protected areas and no elevated moisture was found.

Staircases are robust well built and performing as designed. All railings meet current ADA requirements and will meet their expected useful life with regular maintenance.

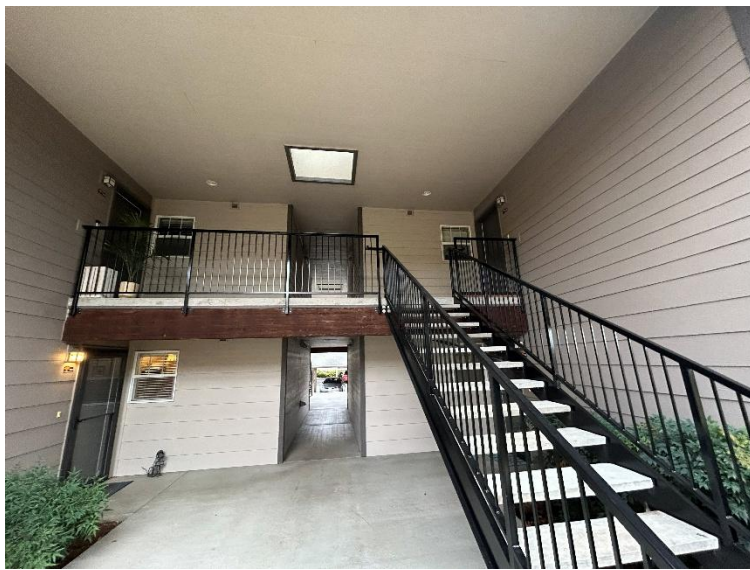
3.2 Cladding in the entryways and ceiling soffits were found to be dry and performing well.

Concrete flatwork in these entry's and hallways was also found to be performing well.

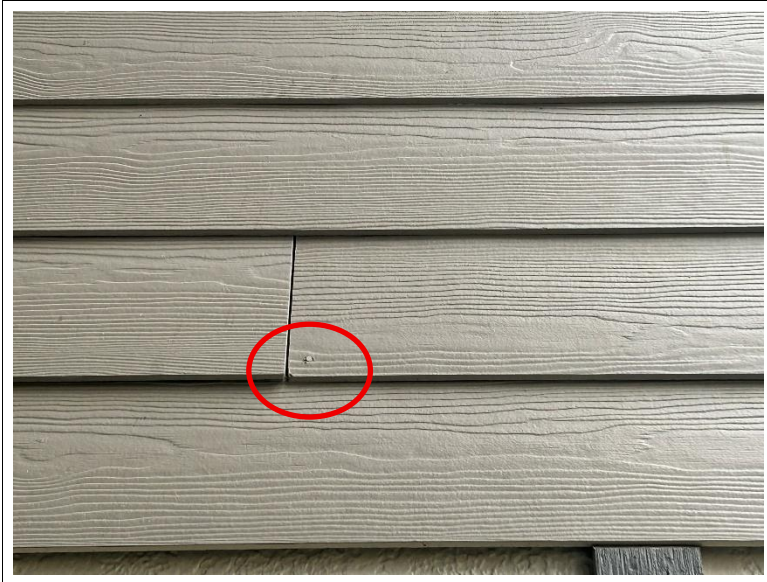
<p>3.3 The siding within the covered areas as mentioned is performing well.</p> <p>It does not meet current siding installation requirements, which were implemented in 2010, but given the 2005 installation the cladding in the covered areas is still performing very well, and does not need to be addressed and will continue to meet its useful life with regular maintenance.</p>

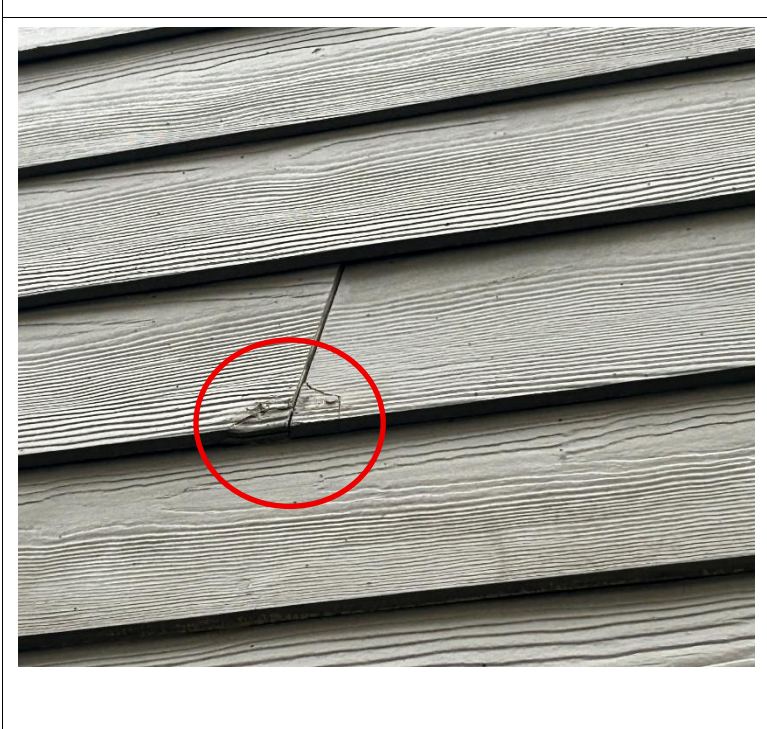
<p>3.4 The siding that is not covered is showing many signs of degrading and failure.</p> <p>The detail above shows a face nail and how it wears when dry. This picture shows the same face nailing when it is exposed to the wind and rain directly. It caused the siding to chip and break and created locations for water penetration.</p>

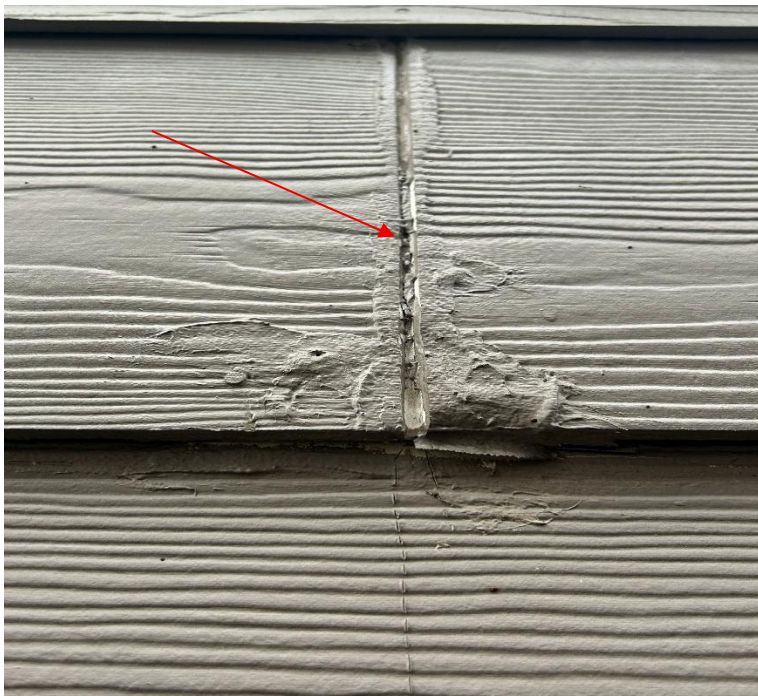
4.1 This condition is systemic around the entire property at the exposed areas. Some areas are worse than others, but given time these areas will continue to fail and allow water penetration within the wall assembly.

This location was approached by someone before painting in order to make the area perform better, but as you can see it becomes more of an eye sore, and the sealant has already failed at the seam.

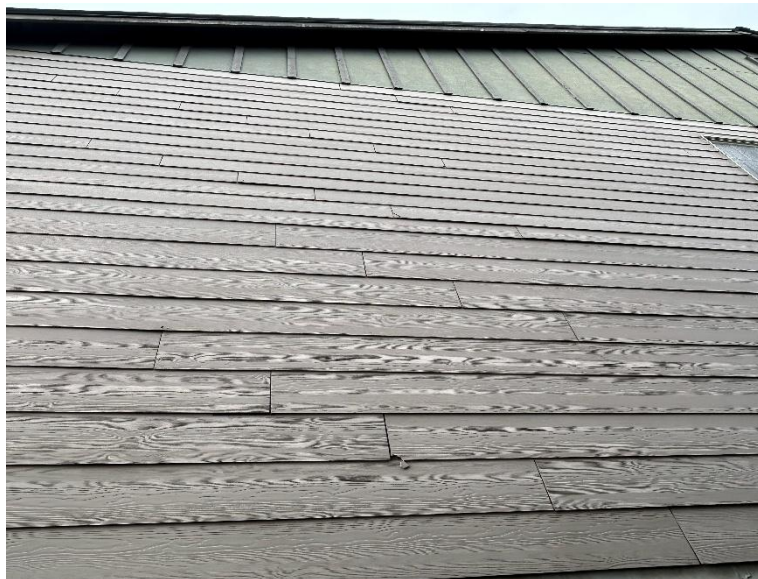
4.2 This large wall has multiple areas of broken, and failed siding. The only approach to repair would be to remove all the siding at this wall and install new siding.

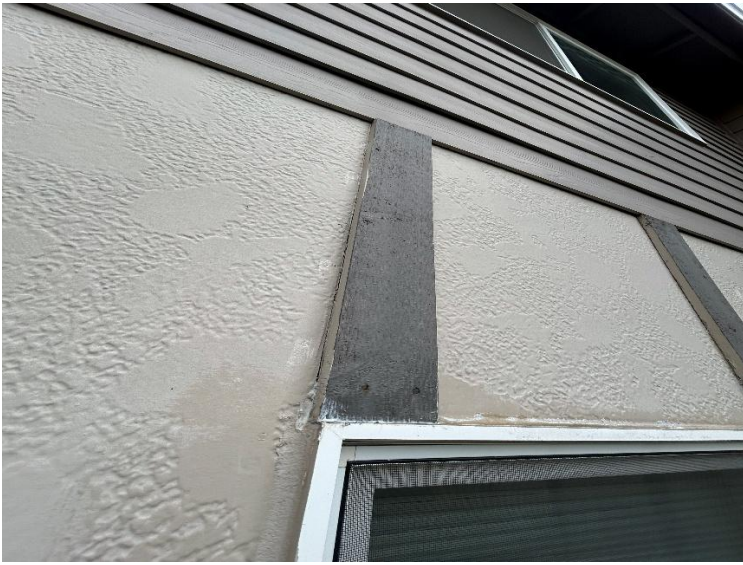
4.3 Given the 2005 vintage of the property all the trim material is SPF white wood. This material has since been discovered to be defective. It is made from Spruce, Pine, and Fir all soft wood remnants that are glue together and made into trim. It was used profusely throughout the country, but in the NW it has proven to be a failed product and most has been replaced in the region with fiber cement trim.

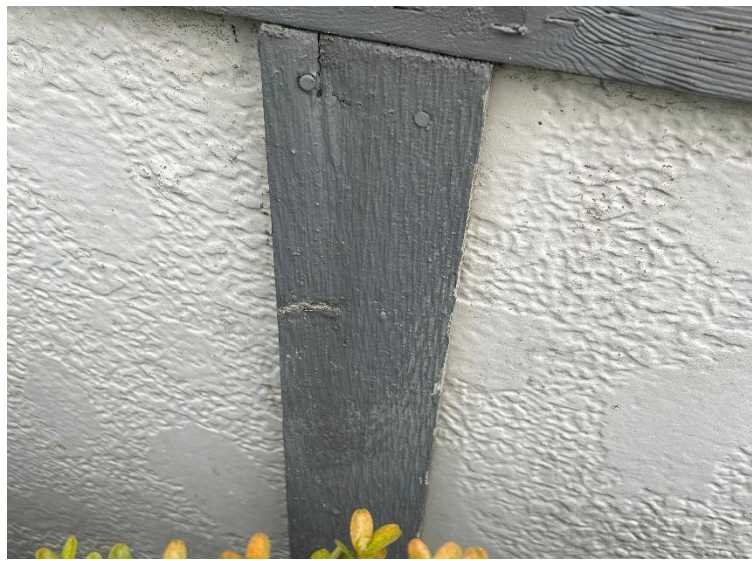
4.4 This SPF trim simply holds water like a sponge and never really dries out. As these trim battens are usually placed over seams in the Panel siding they become a place for water penetration within the wall assembly. Moisture readings were taken all around the property and elevated moisture was found at nearly all locations of trim that were not under cover in the entryways and hallways.

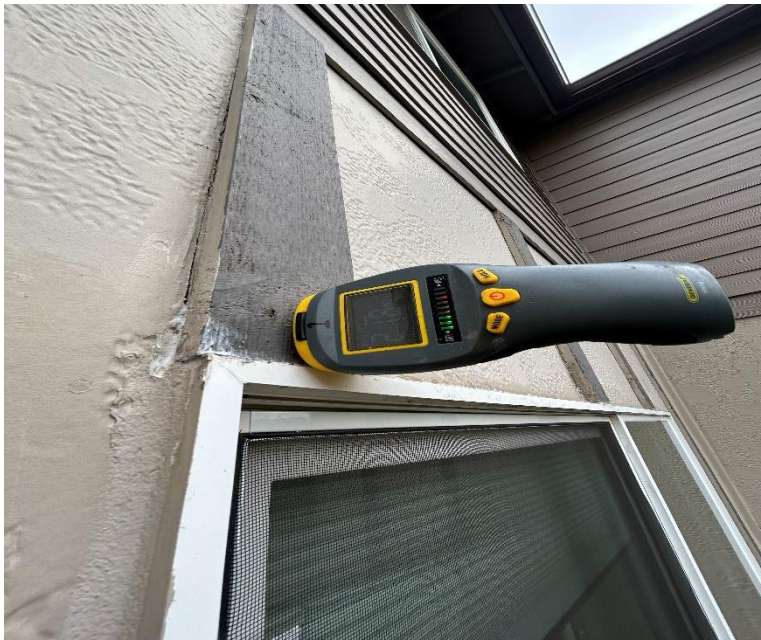
4.5 When performing moisture testing there are acceptable ranges of moisture in wood products. Different manufactures have different acceptable ranges. 16-19% is considered elevated. Anything over 19% is considered no longer structurally viable.

The average moisture reading on the trim at the property was 21% which means the majority is already failed, holding water and can not be re-used as a material product.

This location at the window head is 21.8%

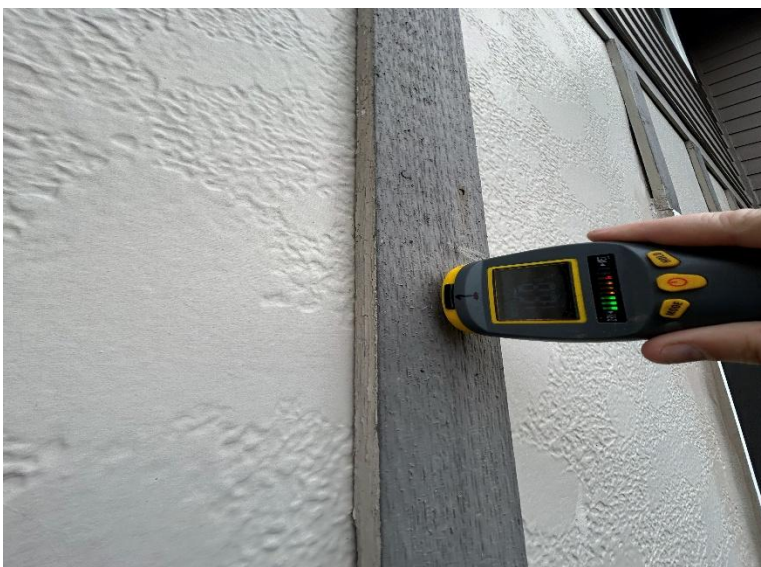
4.6 This location at the middle of the wall is 16.8%.

This was the lowest reading for the trim that was recorded at the property in areas that were not covered.

The readings in the covered areas were between 7-14% which is considered normal and performing well.

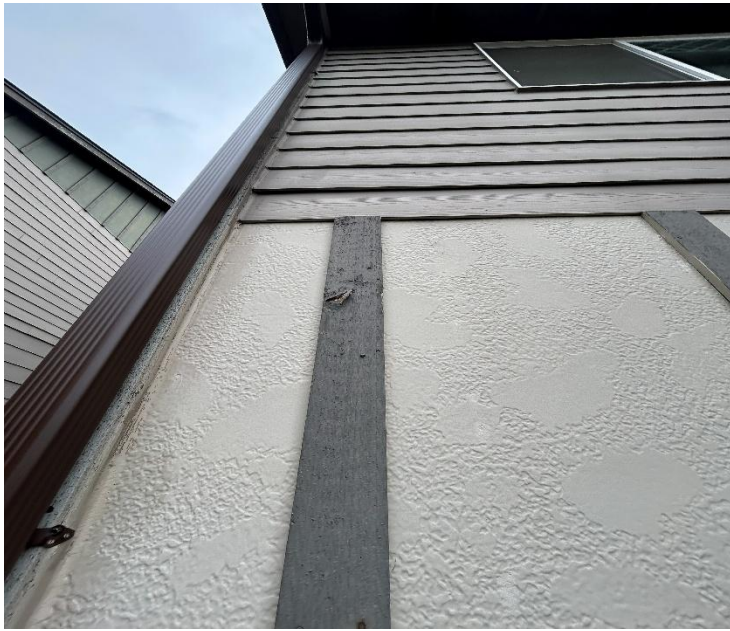
5.1 Detail of the batten board trim over the panel and the integration of the lap siding found throughout the property.

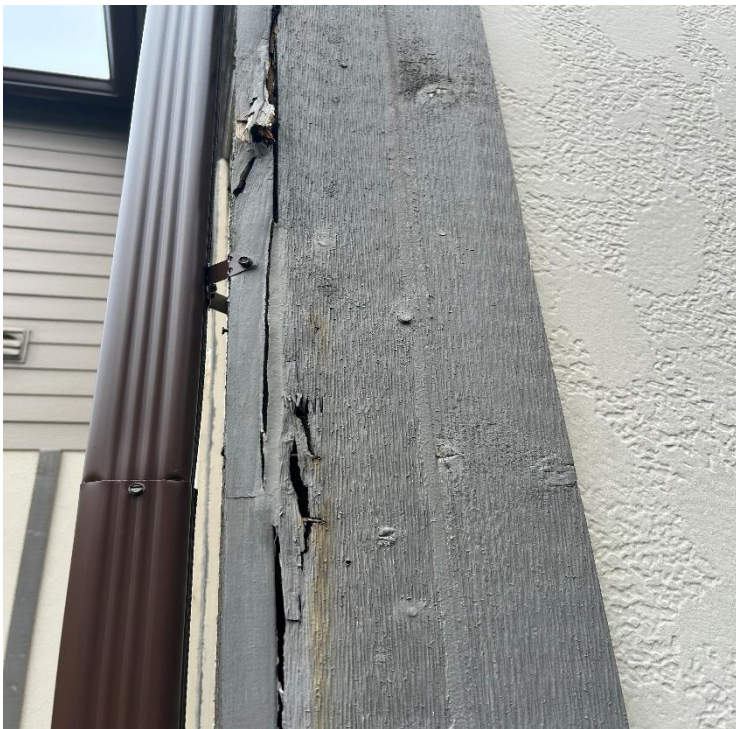
5.2 The outside corner trim is especially susceptible to water penetration especially those that hold the downspout.

This location was completely rotted likely due to the previous downspout. It is still allowing water to penetrate as wind drives rain into these voids from the material failure.

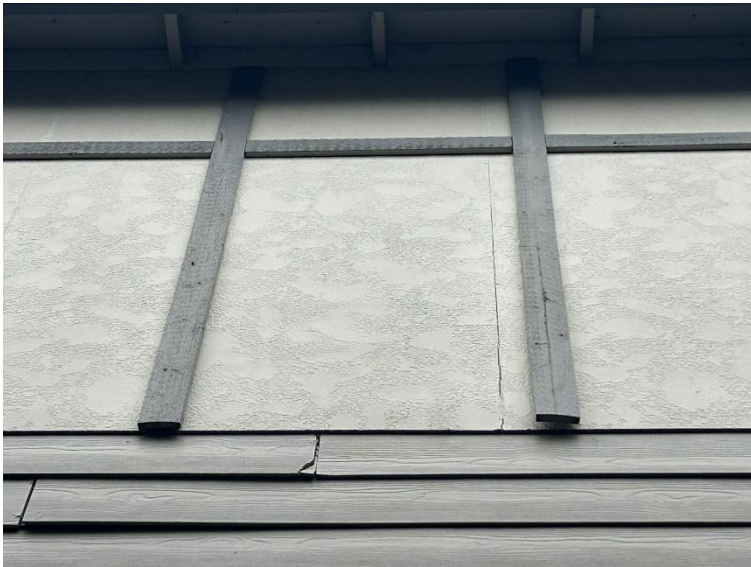
5.3

The interchange between the panel and the lap siding cause the materials to fail if not installed well with proper terminations.

This vertical trim has become so wet and dried out quickly so that it twisted and is pulling away from the panel.

This location appears to have a bulge due to the underlying wall assembly likely being wet, and both the panel and lap siding are being pushed out.

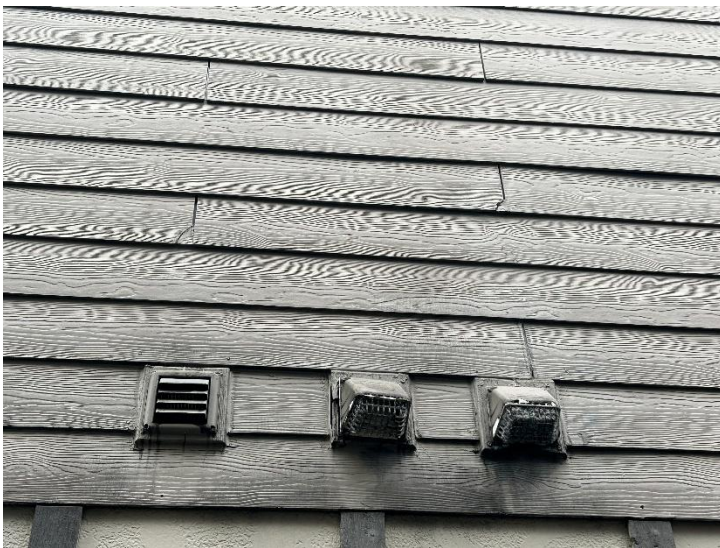
5.4

There are through wall vents at multiple areas around the property. These locations are blocked, but most of this vintage are not properly connected and allow warm moist air to accumulate within the wall structure especially if they are not cleaned regularly.

This visible discoloration and cracking of the siding above are likely from moisture within the wall assembly.

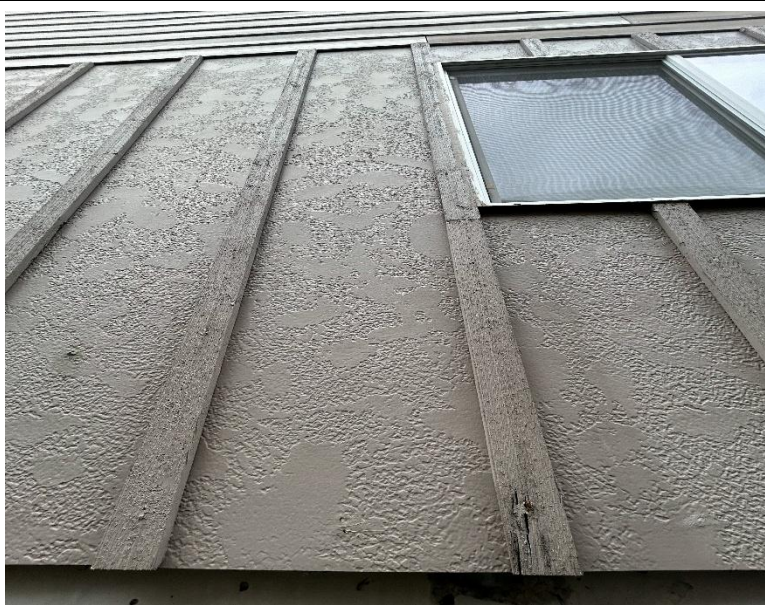
5.5

Another commonly found item is the vertical trim bases are damaged from water accumulation at the drip edge. If these drip edges are not properly sealed and painted then water can begin to work its way back into the trim member.

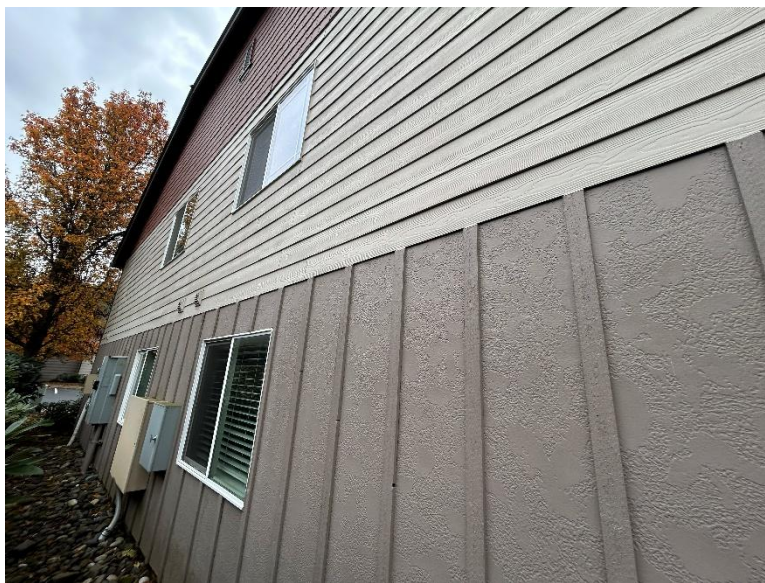
5.6

Some areas between buildings do not see such high volumes of water and wind and are performing better. They still have the same outdated materials and will eventually wear down.

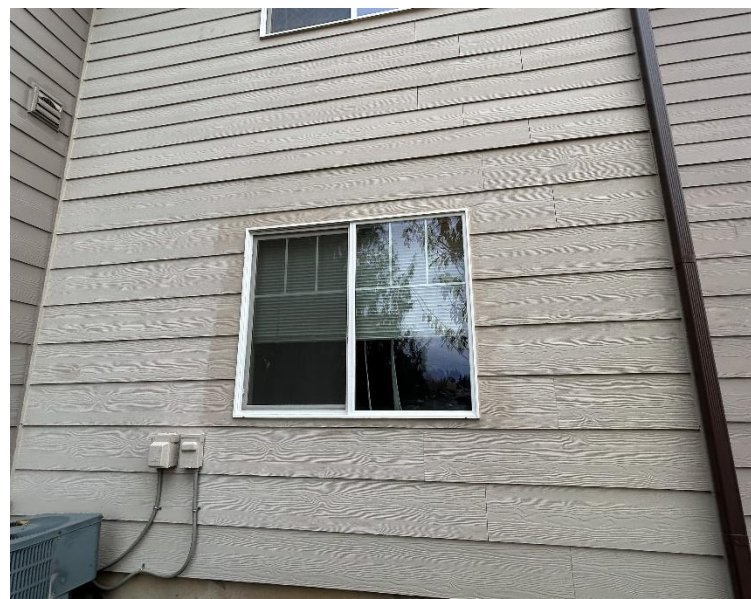
5.7 This is a example of a window location that was caulked and touch up painted. The touch up paint does not match the faded version of the same color.

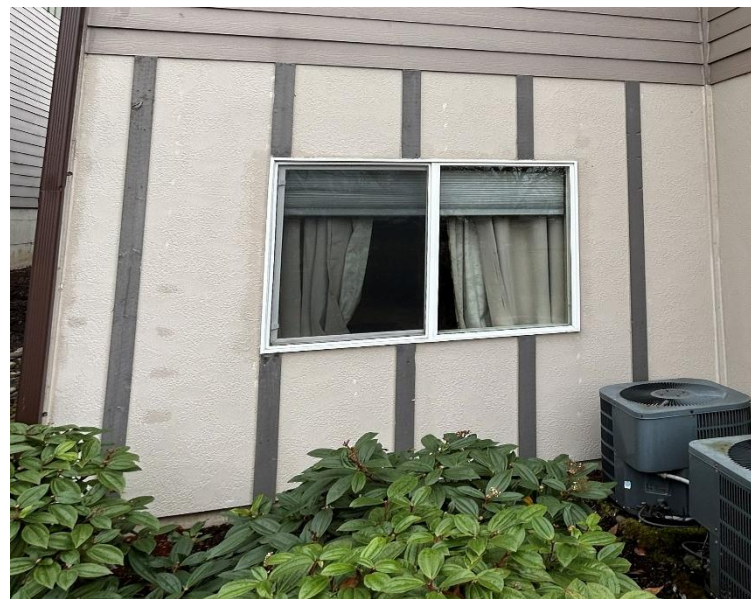
5.8 Another area of sealant installed perhaps due to water intrusion into the unit? That was touched up but didn't match.

These areas are randomly present around the property.

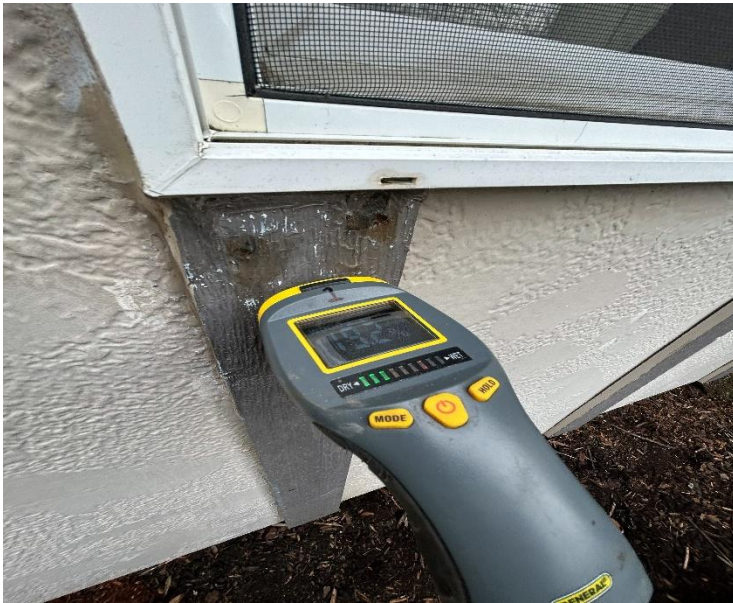
6.1 19.2% at the SPF trim under the window after sealant installed.

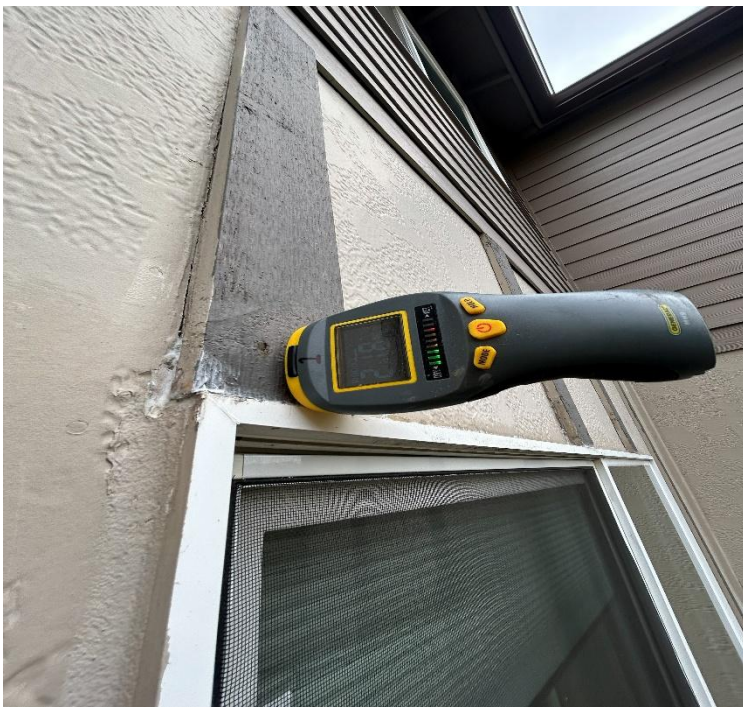
6.2 21.8 % trim above the window after the sealant was installed.

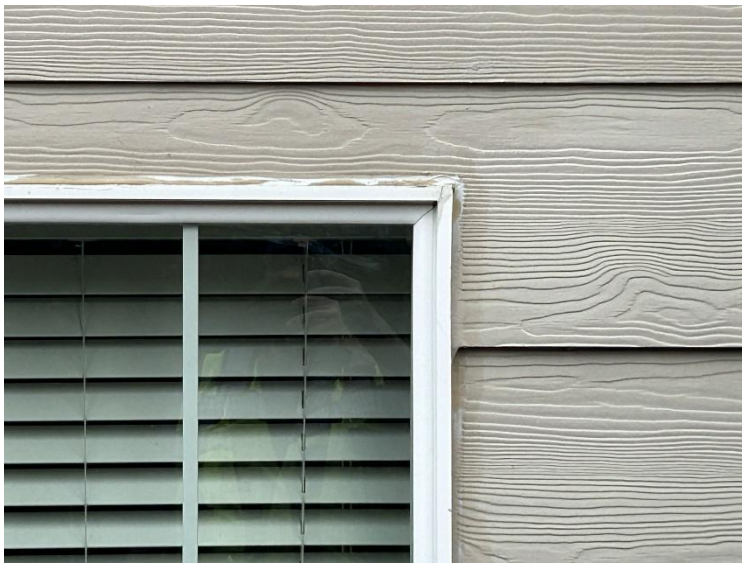
6.3 The only thing protecting these windows is sealant (caulk), there is no metal head flashing to divert water away from the window or to egress moisture out of the wall assembly at this horizontal plane. This is not acceptable on a modern window installation. And sealant is not considered a waterproofing seal as it is only temporary. When siding is replaced all the windows need to be brought up to current waterproofing code.

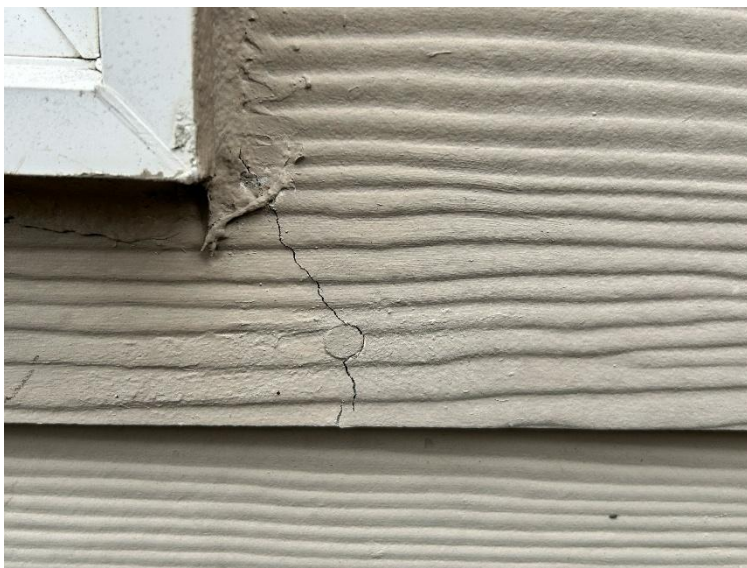
6.4 Detail of failed siding at the base of the window. This could be due to water penetration and siding installed too tight. Either way this crack is a location for water penetration within the wall assembly.

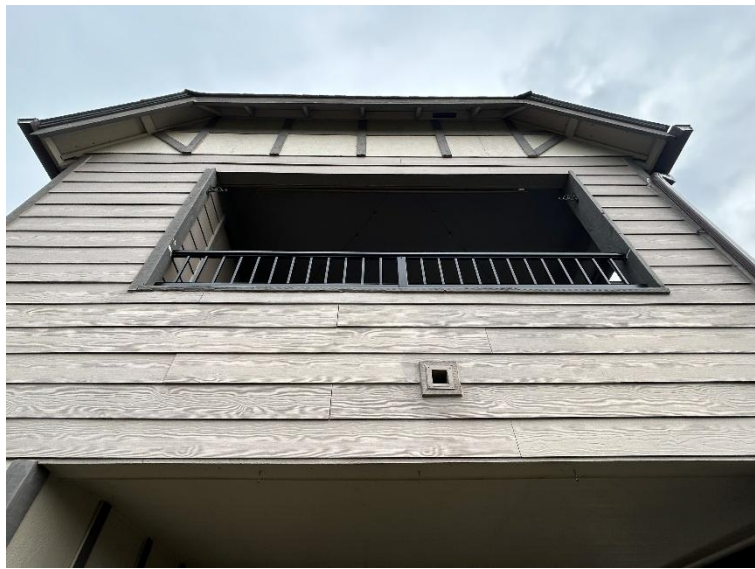
6.5

The upper patio/deck areas are causing damage at nearly all lower patio deck areas.

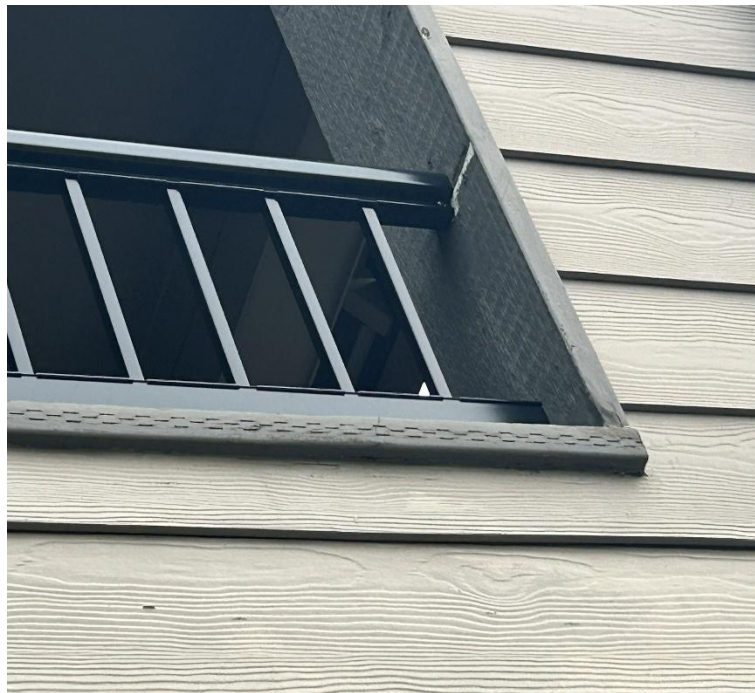
6.6

Railings are robust and installed well.

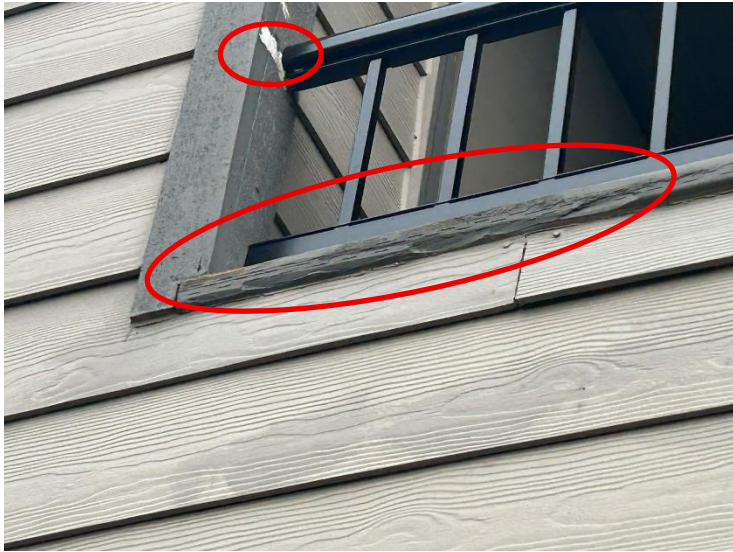
6.7 But there are existing damages that are still present from whatever old railing performance was.

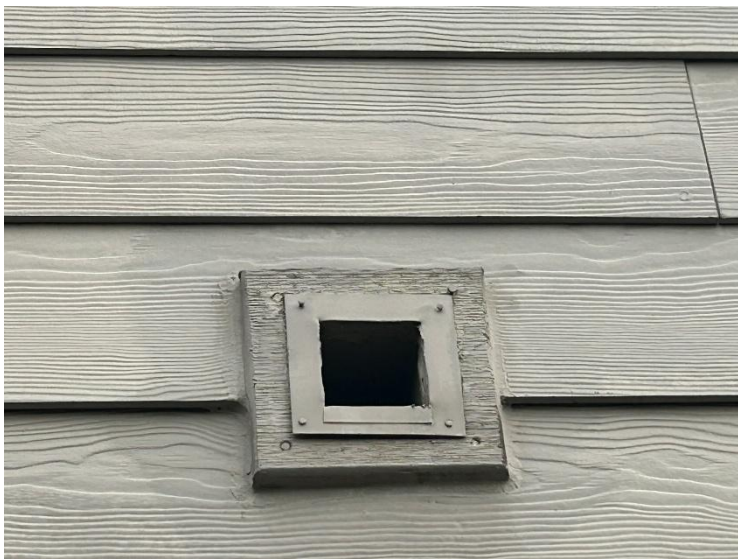
6.8 Upper Decks are drained through a single scupper that drains through the wall and down to the lower deck on the exterior of the building.

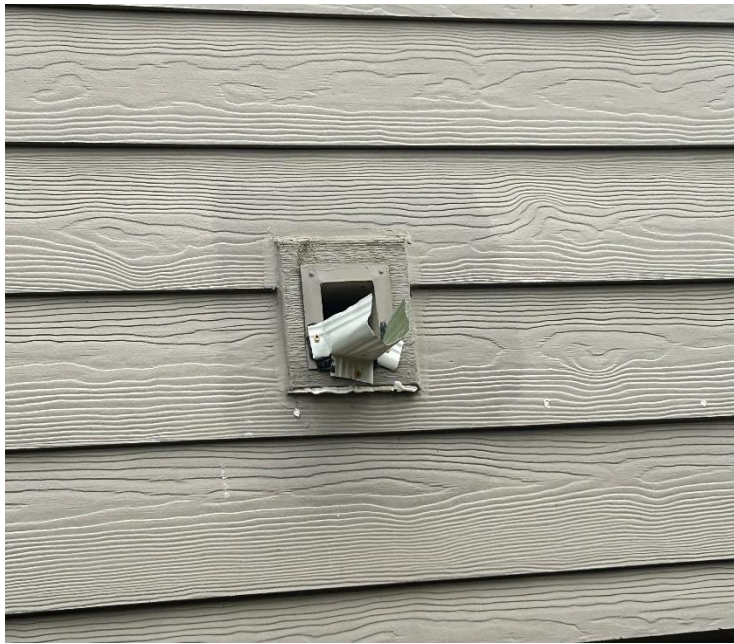
6.9 Some of these scupper have been modified to assist the drainage.

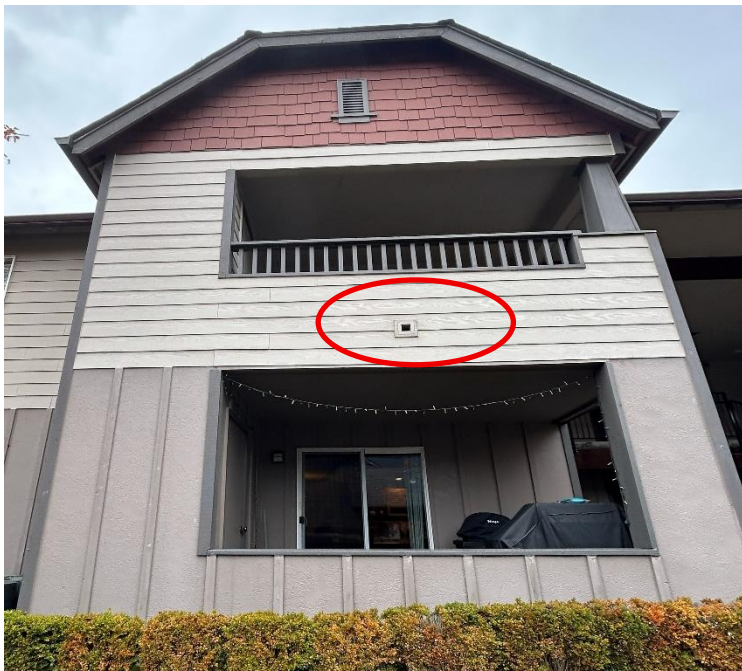
6.10 The typical upper deck drainage for the property deck designs.

This design is far too small for the upper deck to properly expel all potential water that will accumulate at the upper deck especially in a heavy rain.

That also assumes all decks are properly sloped to the one point of exit. Then once water is expelled if it all goes through the scupper it is dropped directly on the deck below, specifically on the horizontal ledge.

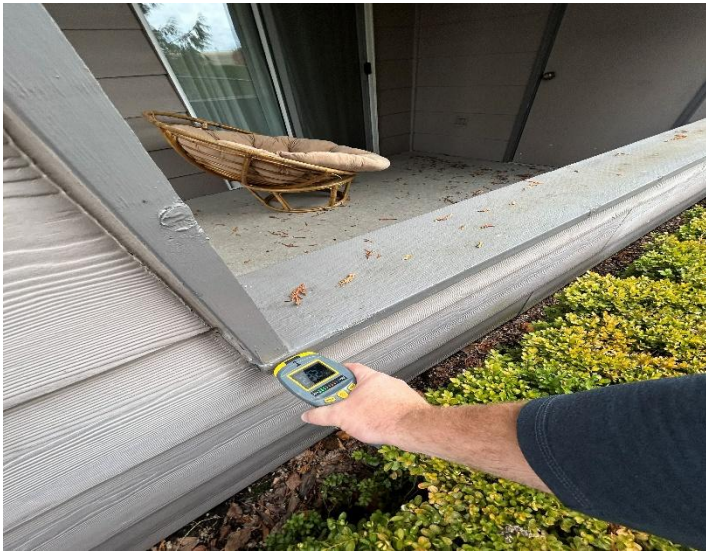
7.1

This location is reading at 23.3% moisture at the horizontal ledge. That is directly from the deck above and water is finding its way down the vertical trim and accumulating at this lower edge. This is happening in most cases from within the wall structure we believe. And occurring at both sides of the lower deck ledge in nearly all deck locations. We believe this is directly related to the existing scupper system and its inability to expel all water at its given location.

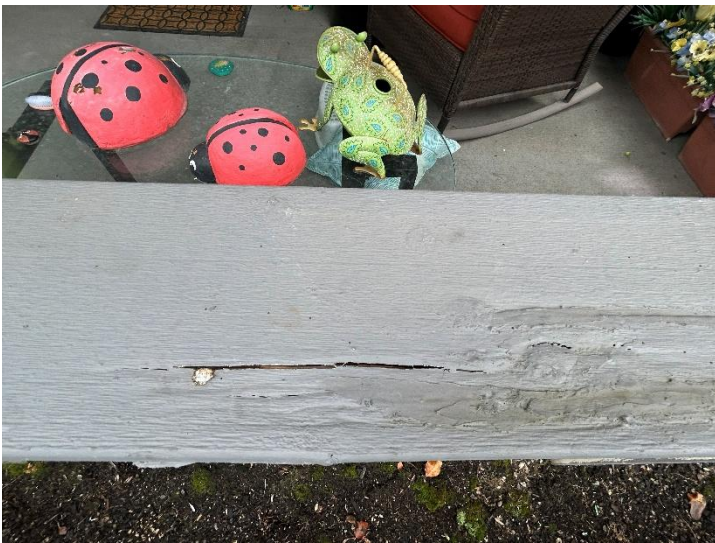
7.2

Detail of another horizontal ledge that is getting dripped on continuously from the scupper from the upper deck.
