# VINTAGE OAKS CONDOMINIUMS

## VISUAL PROPERTY CONDITION REPORT

**PREPARED FOR:**  
VINTAGE OAKS HOA

**REPORT DATE:**  
12.1.25

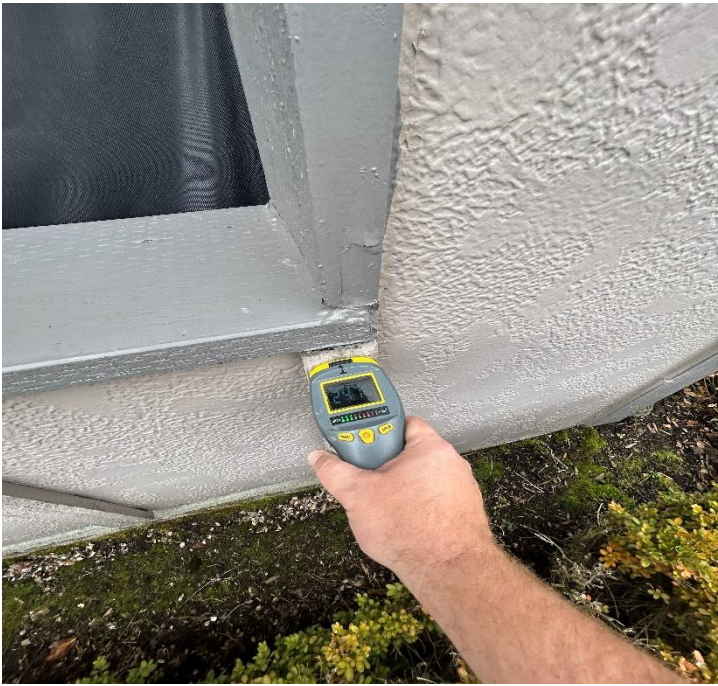
7.3 Another area at the right side of the horizontal ledge with a 24.7% reading showing large amounts of water within this particular location.

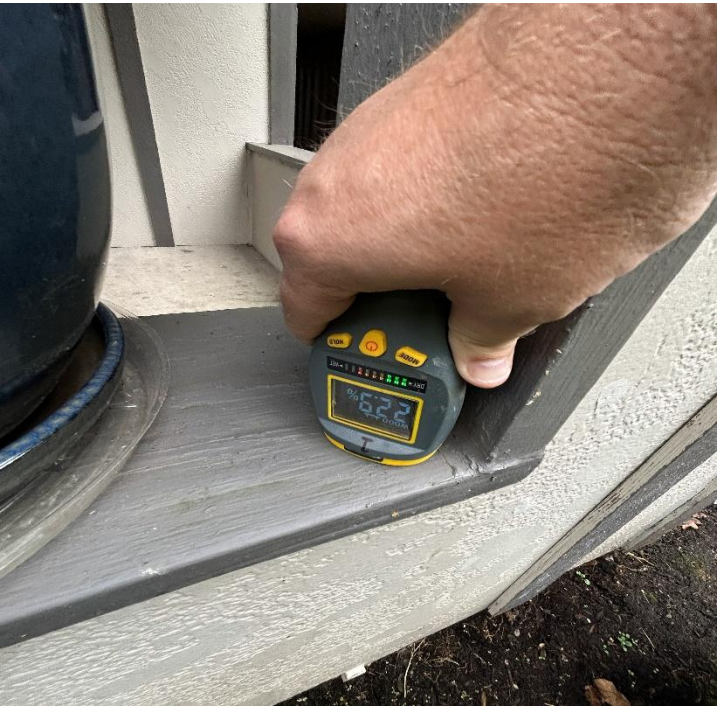
7.4 Typical reading at the horizontal ledge face 22.9% means this piece of material is no longer performing as designed and must be replaced. There is likely rot damage beneath it at the framing as well due to sustained moisture accumulation.

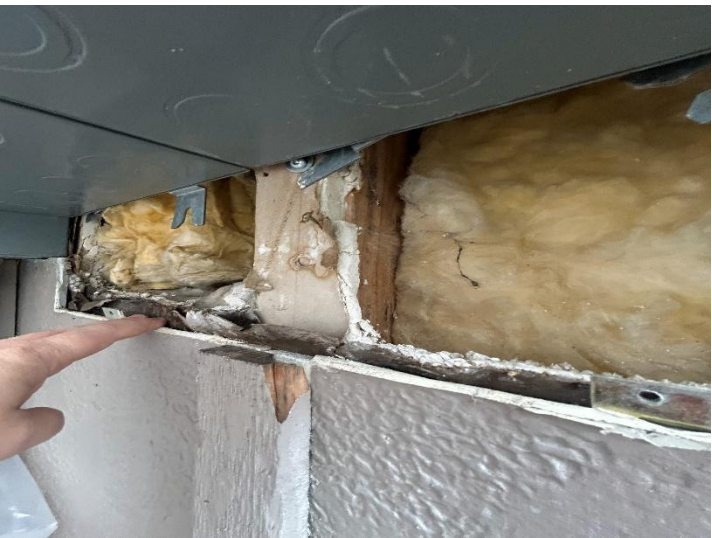
<p>8.1 Detail of an area that was opened recently for some repairs showing the internal wall assembly.</p> <p>This area is dry and sits beneath the electrical boxes.</p> <p>But it shows us that this is a single wall wood framed system with 2X6 framing. And the Panelized cladding is acting as the building shear wall.</p>

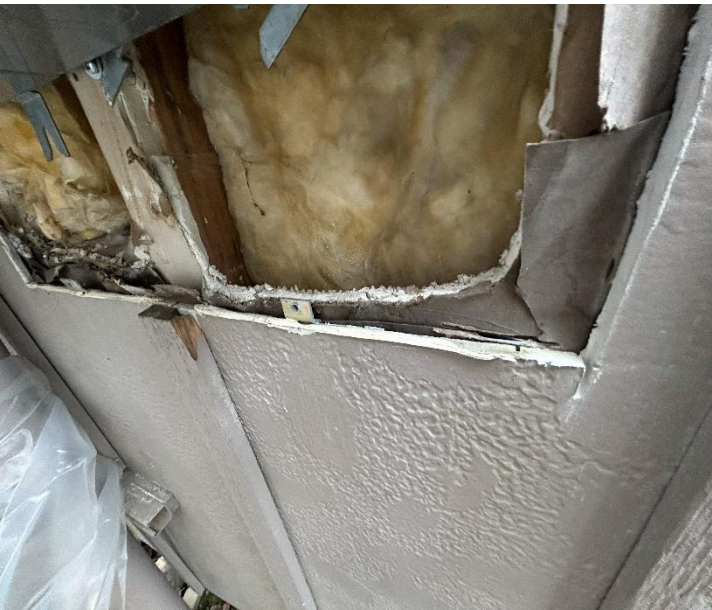
<p>8.2 Other details noted is that the WRB is a 30lb tar paper that has about a 90 minute water permeability rating. Meaning if water is standing on the surface of this material for more than 90 minutes then water can penetrate it and push beyond into the wall cavity and framing assembly.</p> <p>This could mean in other locations with high moisture readings that there is likely penetration within the wall assembly.</p>

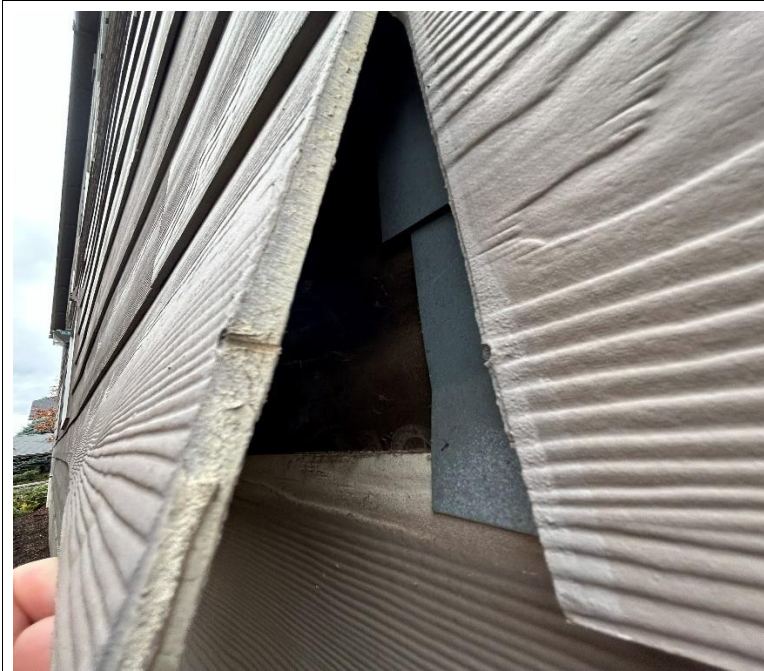
8.3 Detail of proper backflashing present.

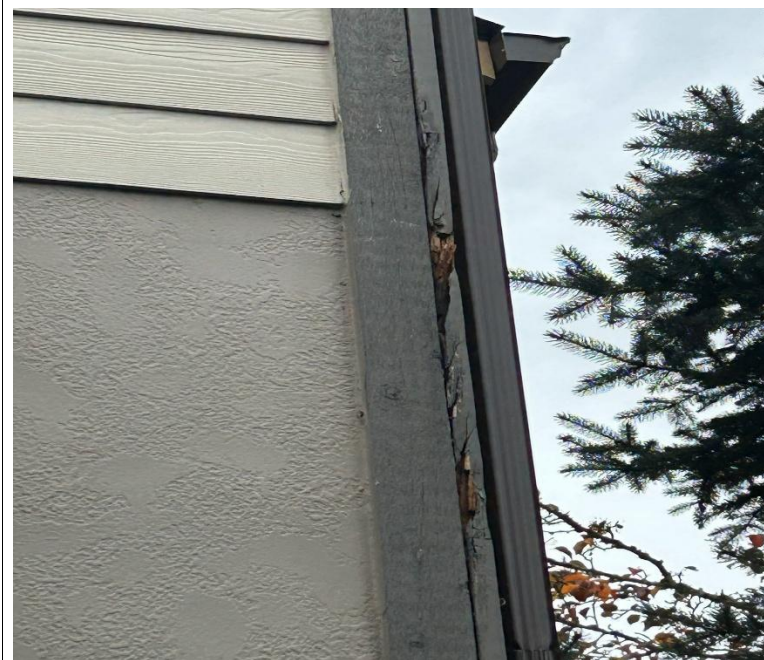
8.4 Detail of corner trim damaged by previous downspout still present.

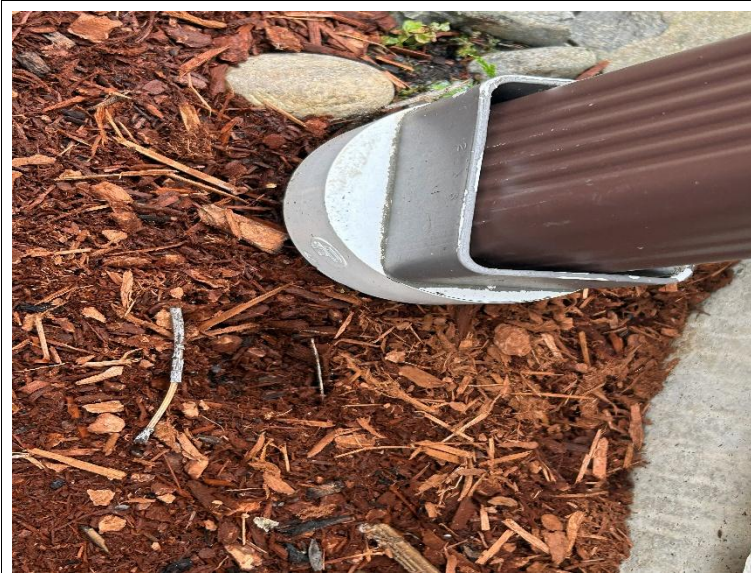
8.5 Detail of downspout and ground drain interchange. It would be beneficial to get some clean outs at these locations.

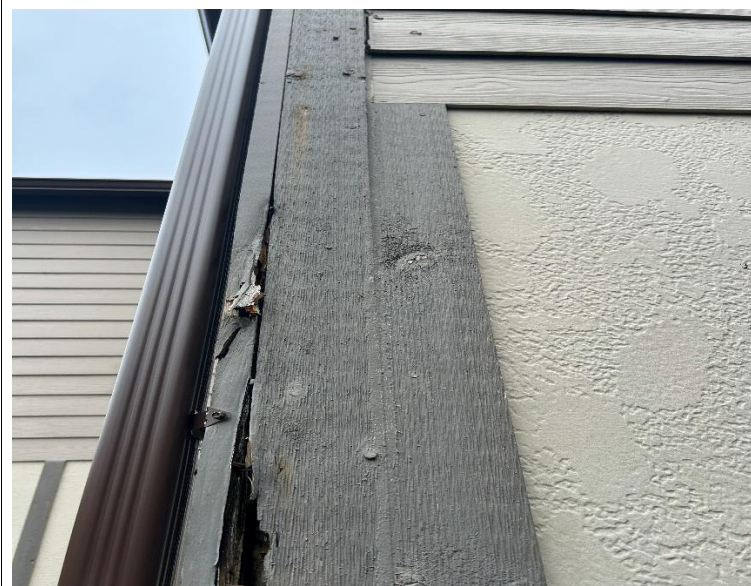
8.6 Detail of damaged corner trim behind new gutters.

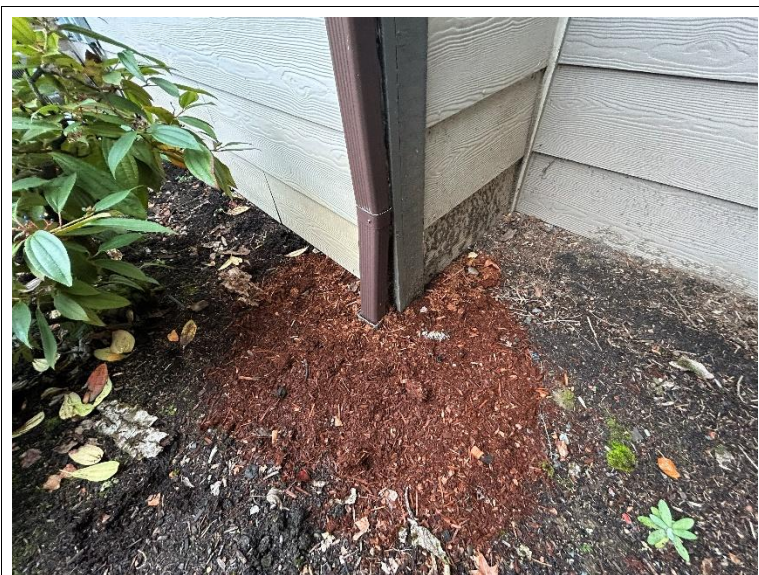
8.7 Detail downspout and ground drain areas that should have clean outs.

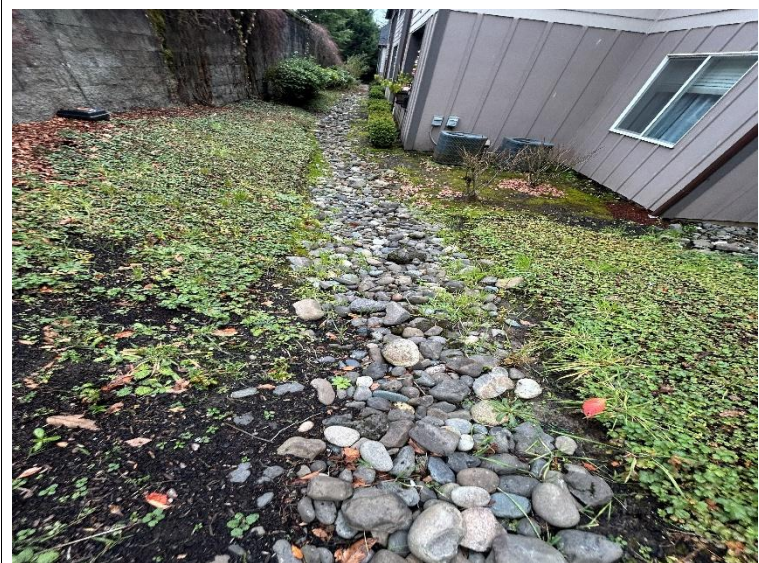
8.8 Detail of the French Drain system at the back of the East elevation of the property.

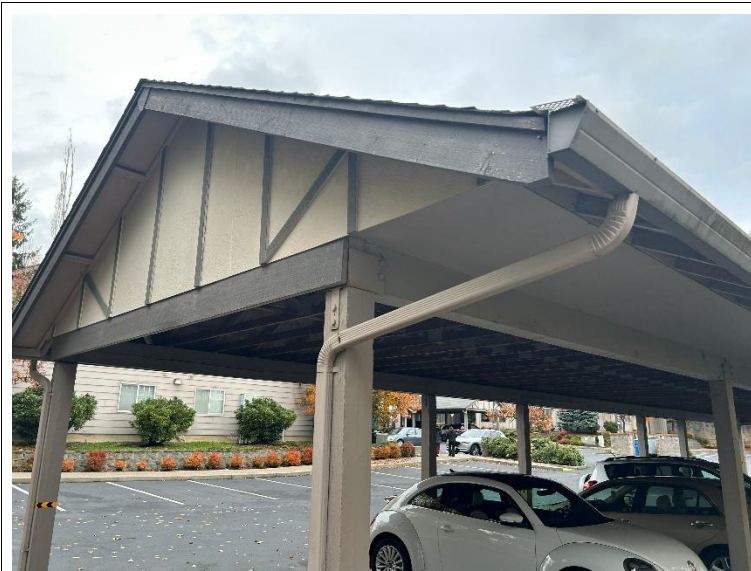
8.9 Carports appear to be in good condition and performing as designed.

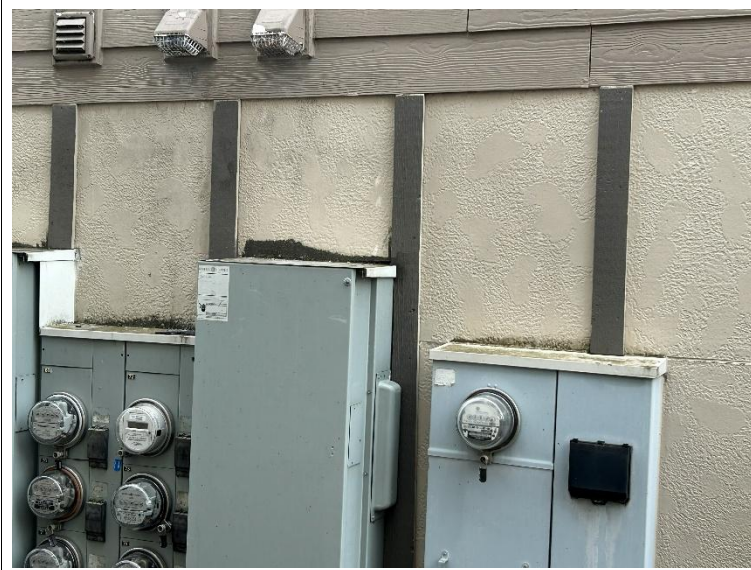
8.10 There are metal hoods over the electrical panels, but they do not have any slope for water run off and hence they are accumulating moss and organic growth and are a place for water to be trapped.

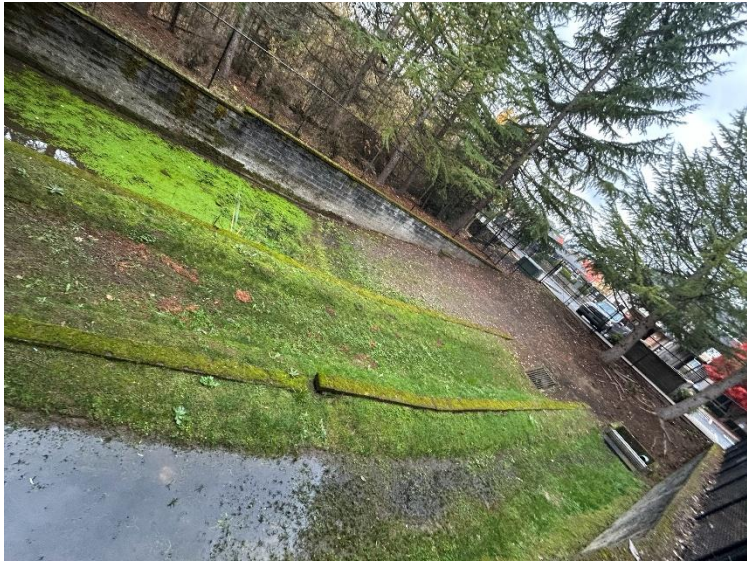
8.11 Detail of water containment (bioswale) area that appears to be performing as designed.

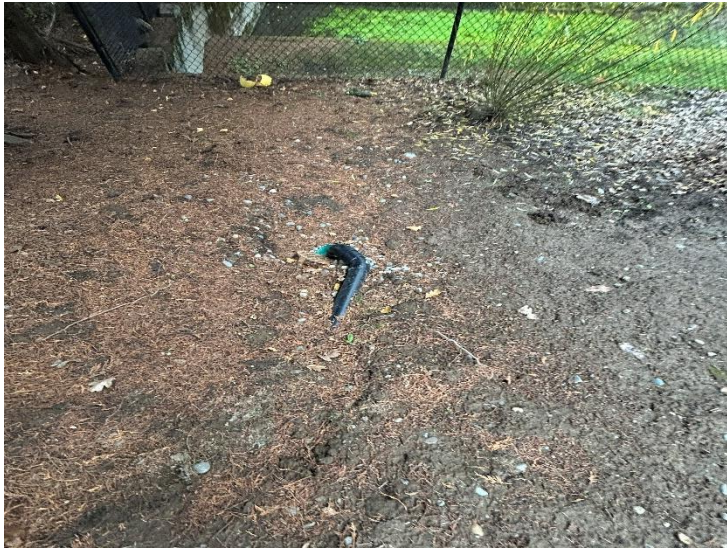
8.12 Drain pipe leading to water containment area is operational.

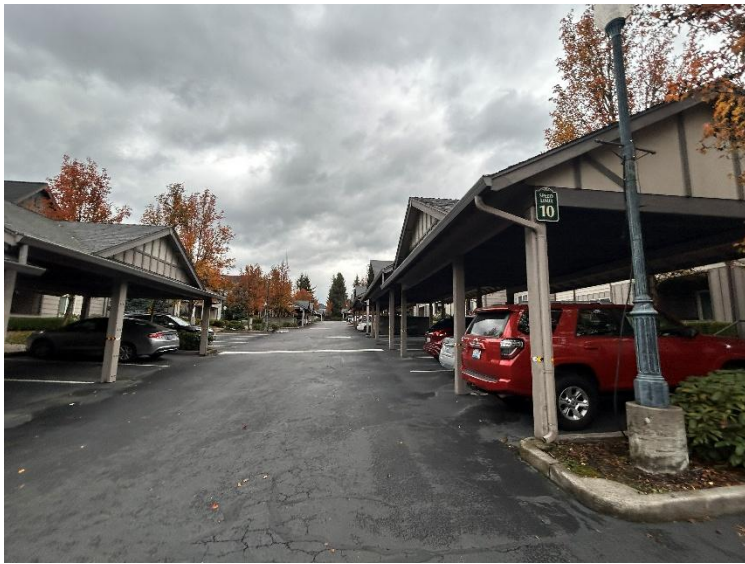
8.13 The roadway asphalt is in fair condition, but performing as designed.

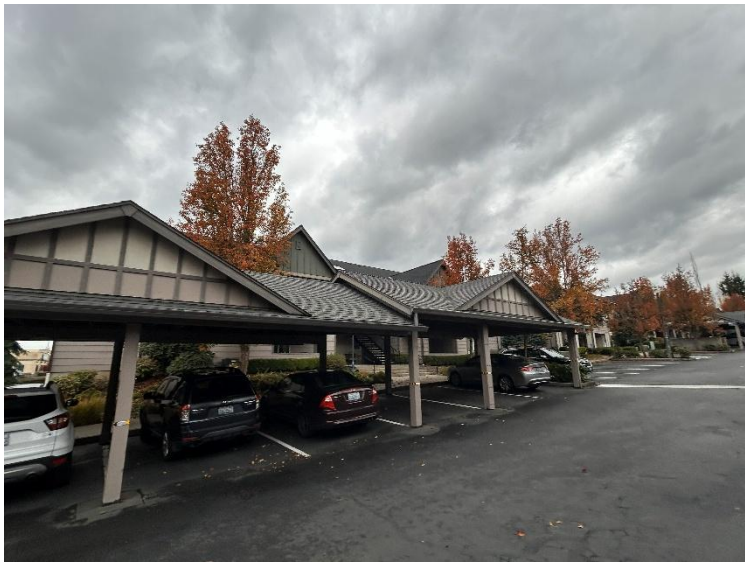
8.14 The parking stalls are striped clearly and should be re-striped during the next seal coat work.
