# VINTAGE OAKS HOA

## BUILDING ENVELOPE INVESTIGATION

PREPARED FOR:  
VINTAGE OAKS HOA BOARD

REPORT DATE:  
5.25.2017

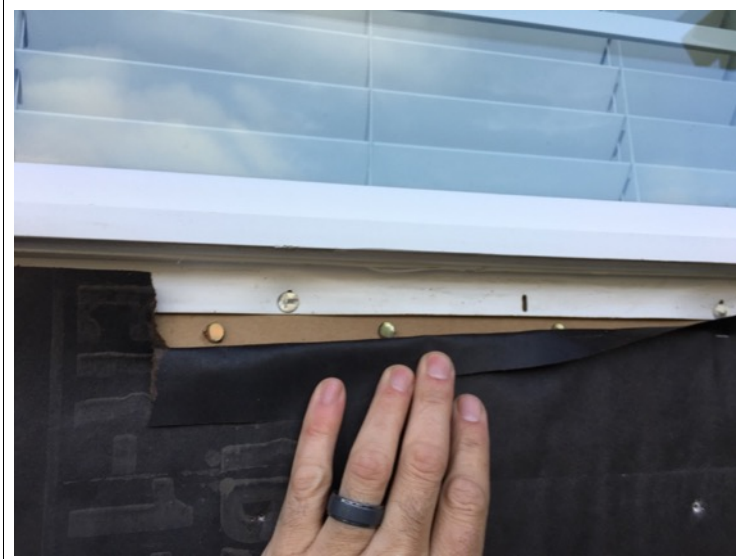
1.1.11

WRB reverse lapped at sill mounting flange.

*Condition negates incidental water egress and facilitates moisture accumulation within the exterior wall assembly.*

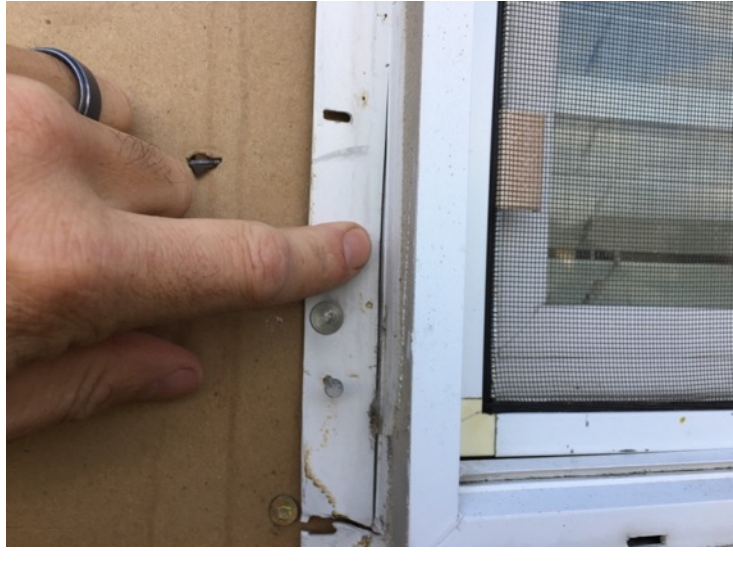
<p>1.1.17 Cracked mounting flange.</p> <p><i>Damage results from improper fastener placement which does not accommodate thermal movement of vinyl window assembly.</i></p>

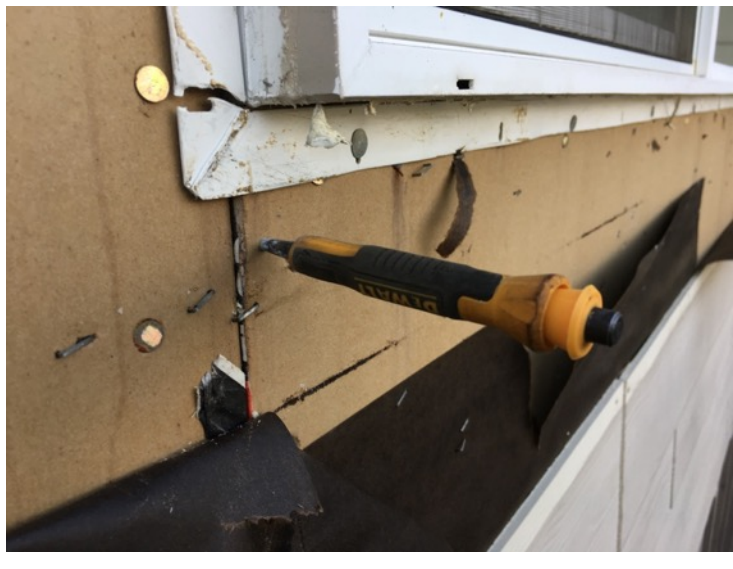
<p>1.1.18 Demonstration of deteriorated gypsum sheathing.</p> <p><i>Damage results from sustained moisture absorption by exterior wall assembly components and/or moisture accumulation within exterior wall assembly.</i></p>

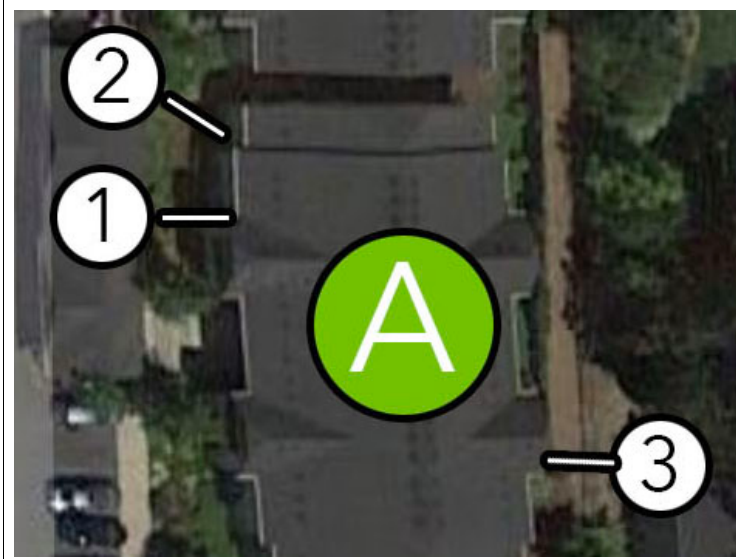
1.2.1

Exploratory Opening 2.  
Building A, West Elevation,  
Gutter to Wall Termination.

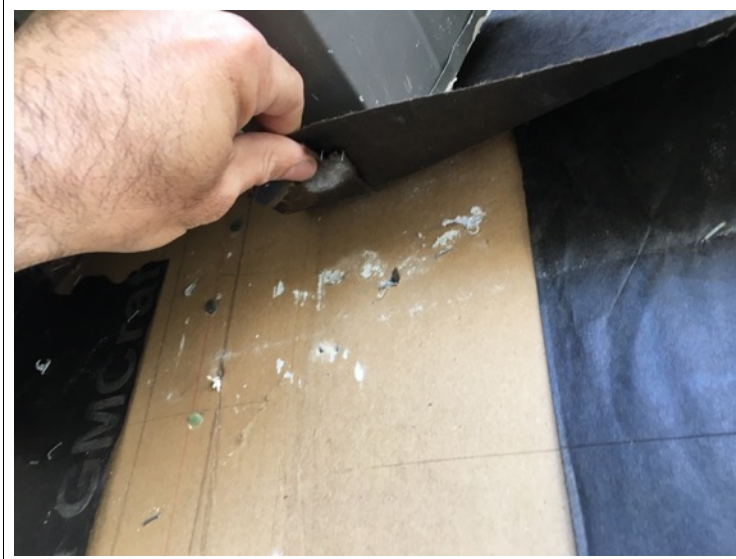
1.2.7

Gypsum sheathing appears dry at this location. Slight signs of staining from water infiltration.

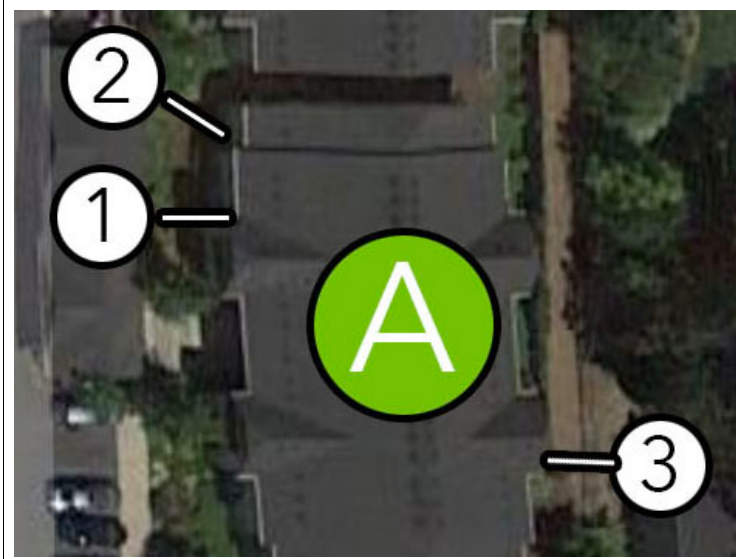
1.3.1

Exploratory Opening 3.  
Building A, East Elevation,  
Deck Assembly.

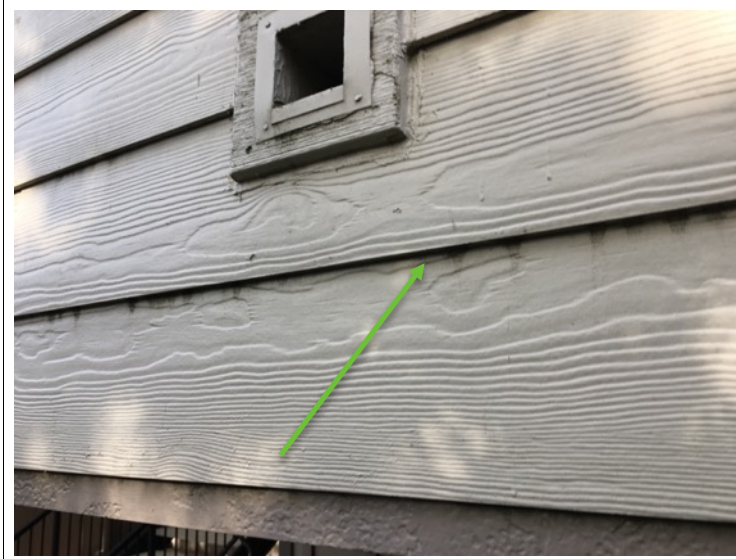
1.3.3

Staining observed emanating from within exterior cladding components.

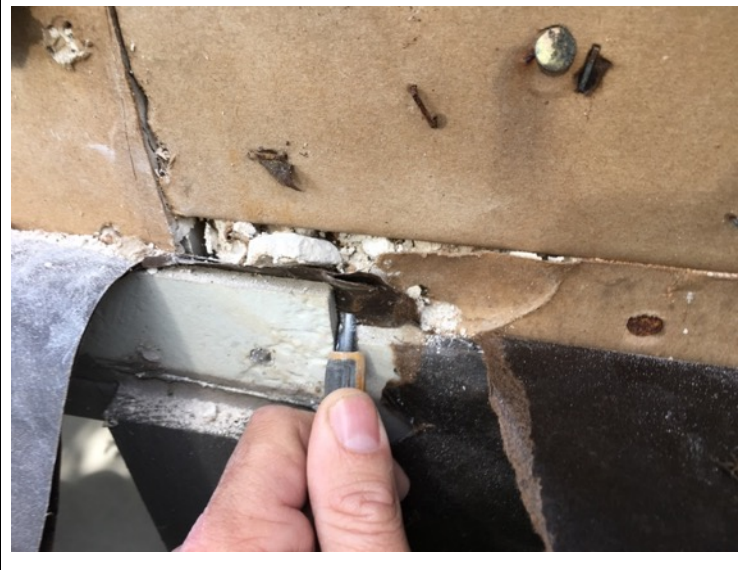
<p>1.3.11 Deteriorated gypsum sheathing.</p> <p><i>Damage due to water infiltration and/or moisture accumulation within exterior wall assembly.</i></p>

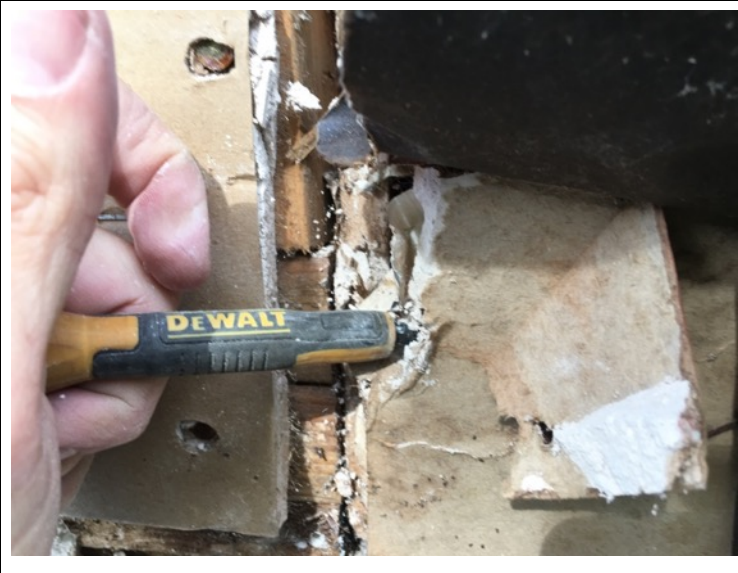
<p>1.3.12 Deteriorated gypsum sheathing.</p> <p><i>Damage due to water infiltration and/or moisture accumulation within exterior wall assembly.</i></p>

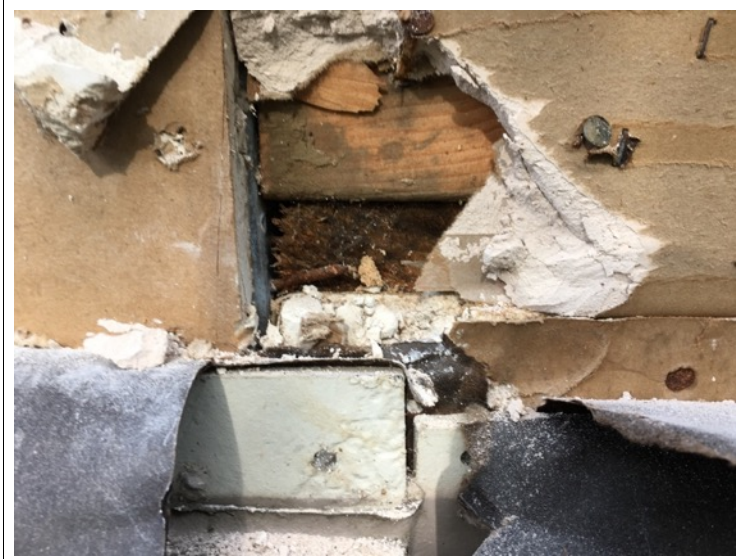
1.3.13

Deteriorated gypsum sheathing. Moisture stained framing members.

*Damage results from sustained moisture absorption by exterior wall assembly components and/or moisture accumulation within exterior wall assembly.*

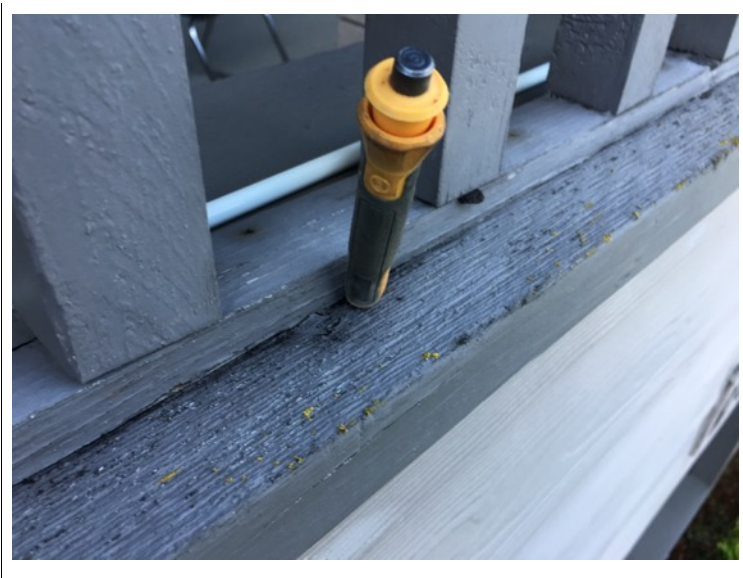
<p>1.4.9 Demonstration of deteriorated wall assembly components.</p> <p><i>Damage due to water infiltration and/or moisture accumulation within exterior wall assembly.</i></p>

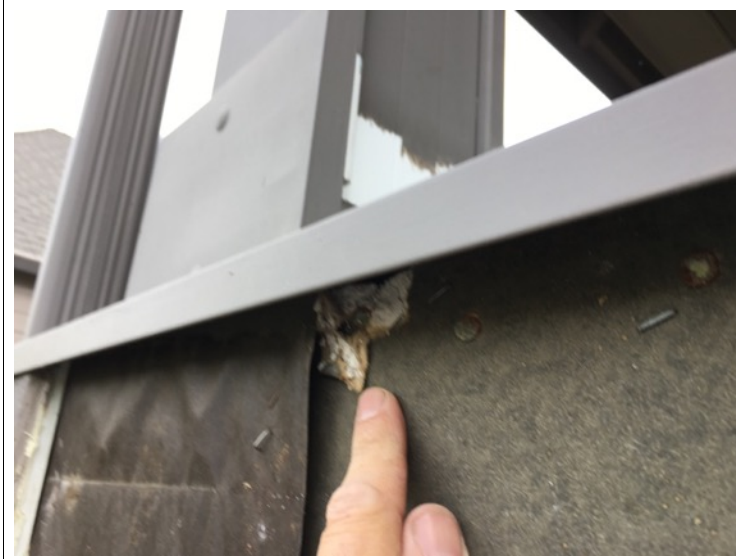
1.4.13

Demonstration of deteriorated wall assembly components.

*Damage due to water infiltration and/or moisture accumulation within exterior wall assembly.*

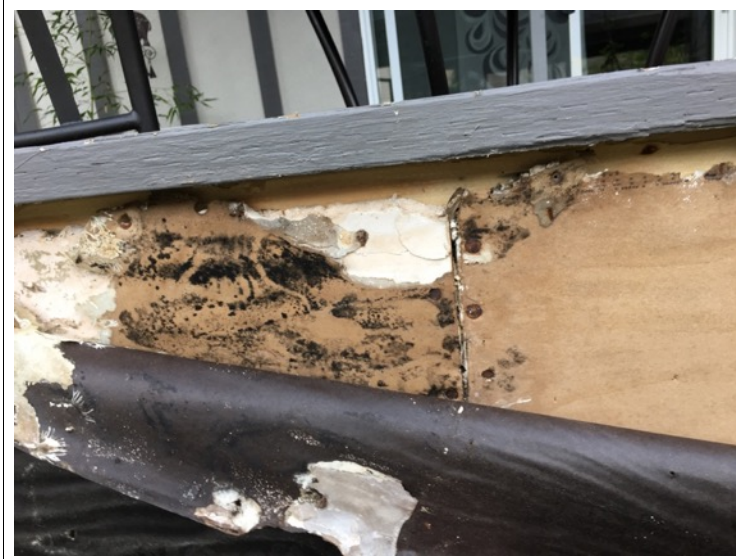
1.5.5

Omitted metal flashing and/or flexible flashing atop underlying wall assembly below wood trim.

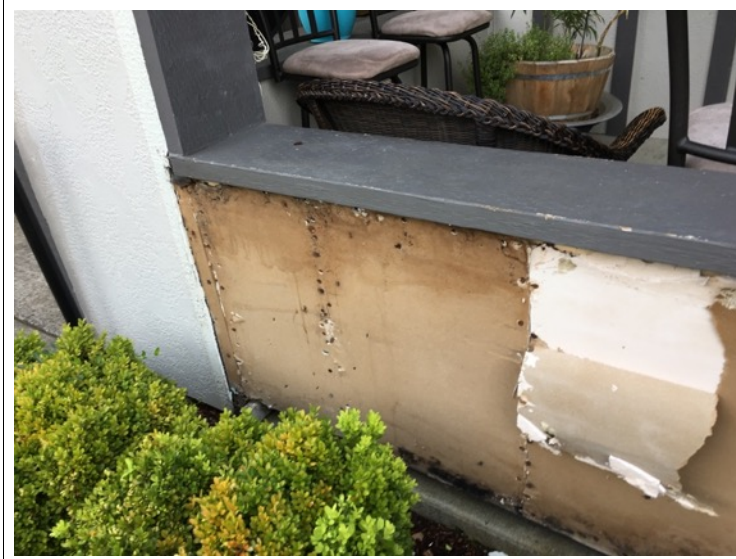
1.5.9

Deteriorated gypsum sheathing.

*Damage due to water infiltration and/or moisture accumulation within exterior wall assembly.*

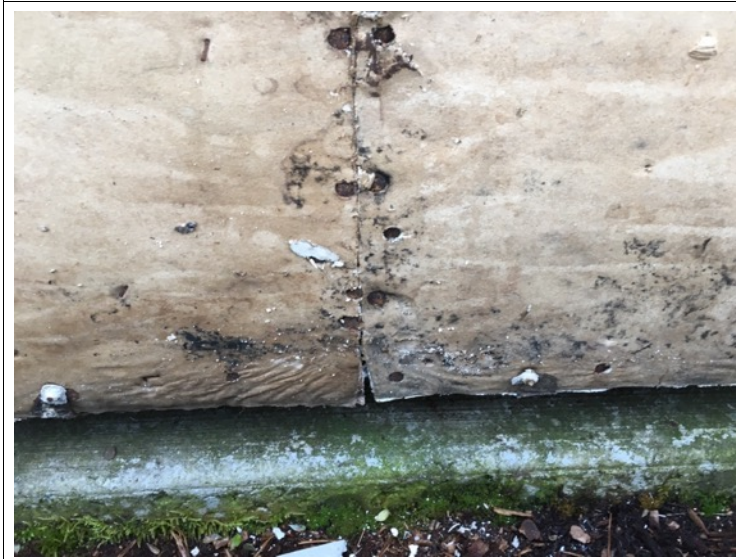
1.5.10

Microbial growth, fungal growth, deteriorated gypsum sheathing observed.

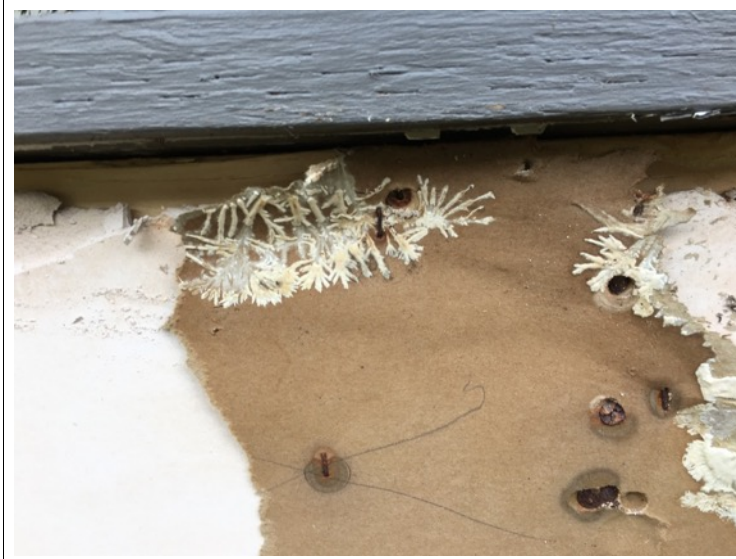
1.5.11

Microbial growth, fungal growth, deteriorated gypsum sheathing observed.

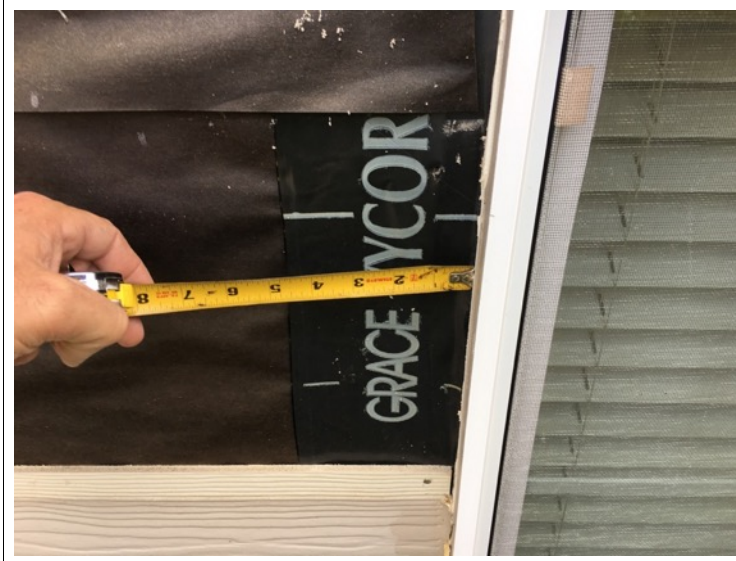
1.6.7

Improper installation of flexible flashing. Flexible flashing should have minimum 9" width.

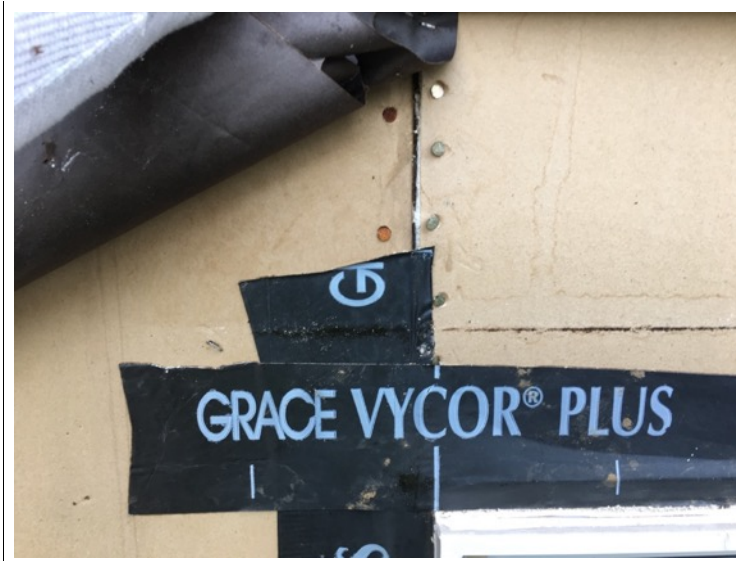
1.6.9

Improper installation of flexible flashing. Head flashing should cover vertical extension of jamb flashing.

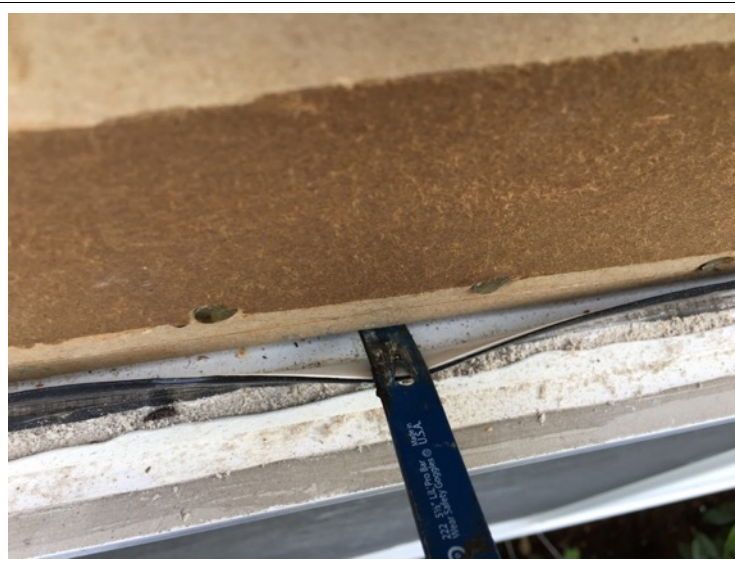
<p>1.6.12 Omitted or discontinuous sealant bedding beneath fenestration mounting flange.</p> <p><i>Condition fails to provide adequate air leakage control and facilitates moisture transport through exterior wall assembly at fenestration rough opening.</i></p>

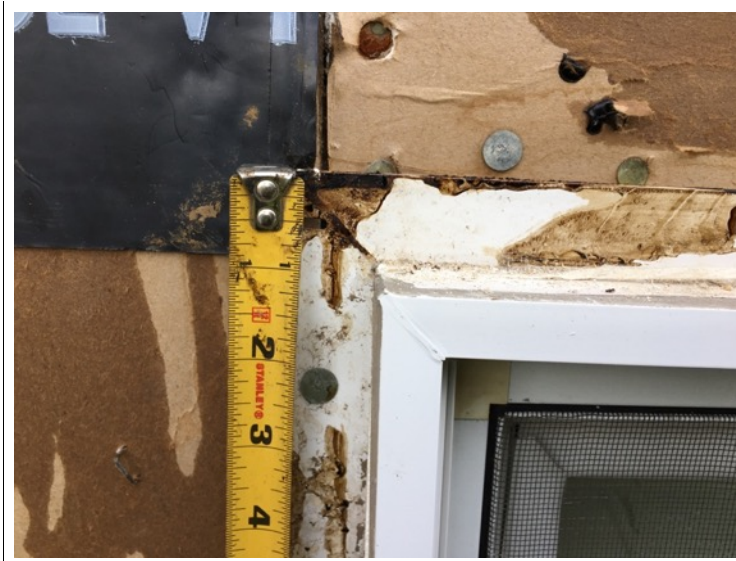
1.6.13

Improper fastener installation. Fastener installed within 3" of window corner.

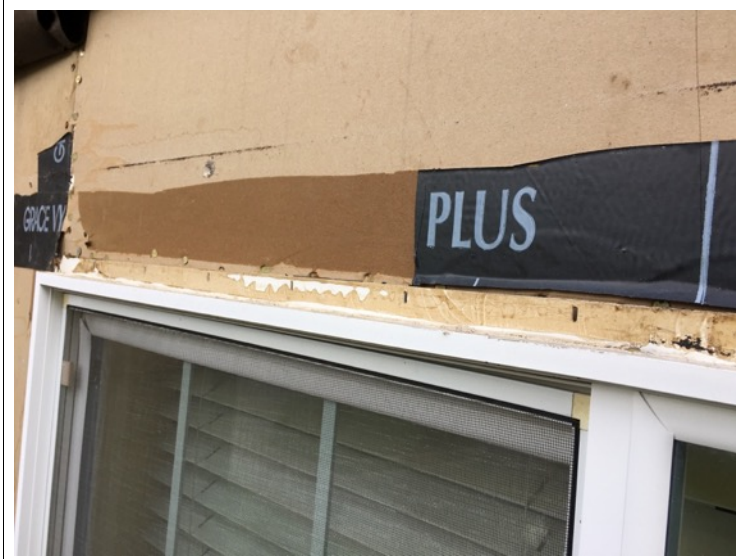
1.6.15

Omitted fasteners along entire span at window head.

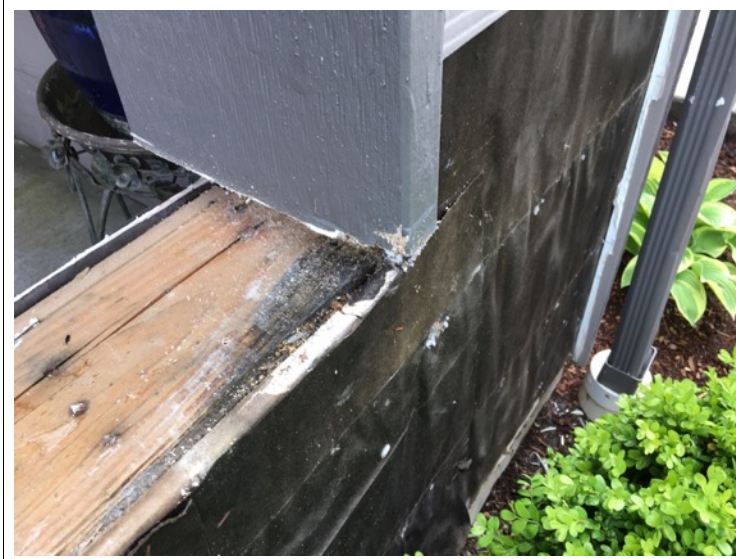
1.7.7

Deteriorated framing member.

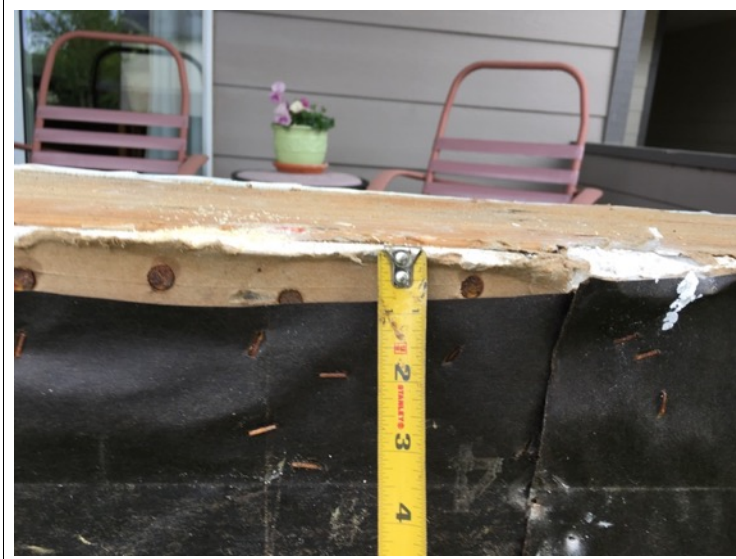
1.7.9

Discontinuous WRB.

*Condition fails to provide adequate protection of underlying wall assembly components from water infiltration.*

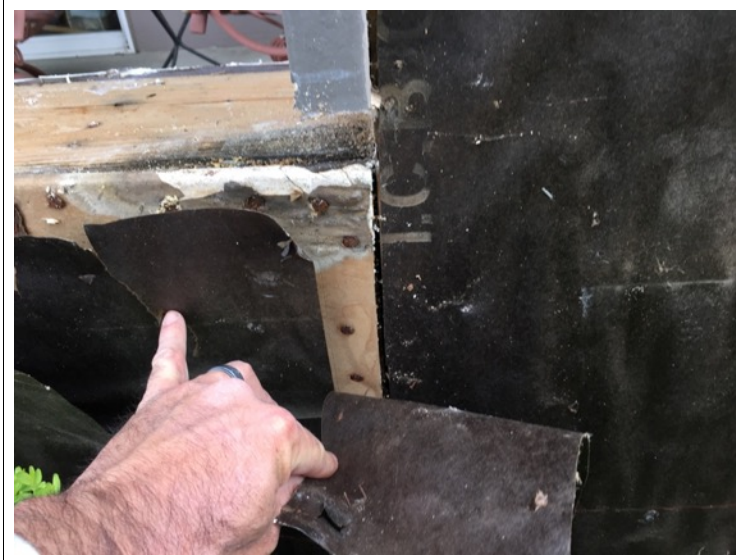
1.7.10

Deteriorated gypsum sheathing, corroded fasteners.

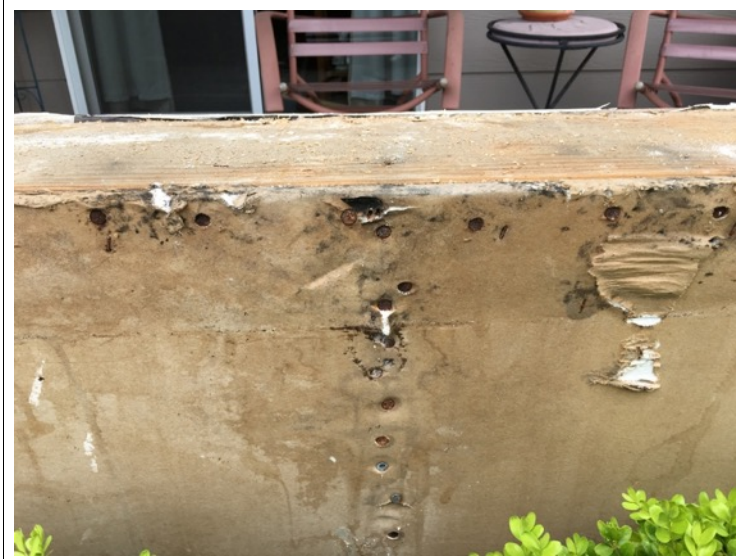
1.7.17

Deteriorated gypsum sheathing, corroded fasteners.

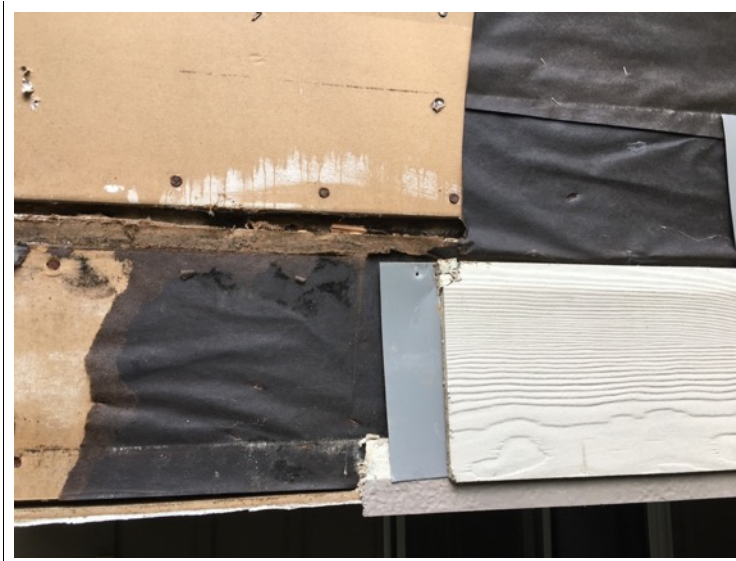
1.9.7

Moisture staining, microbial growth observed on gypsum sheathing. Corroded fasteners observed.

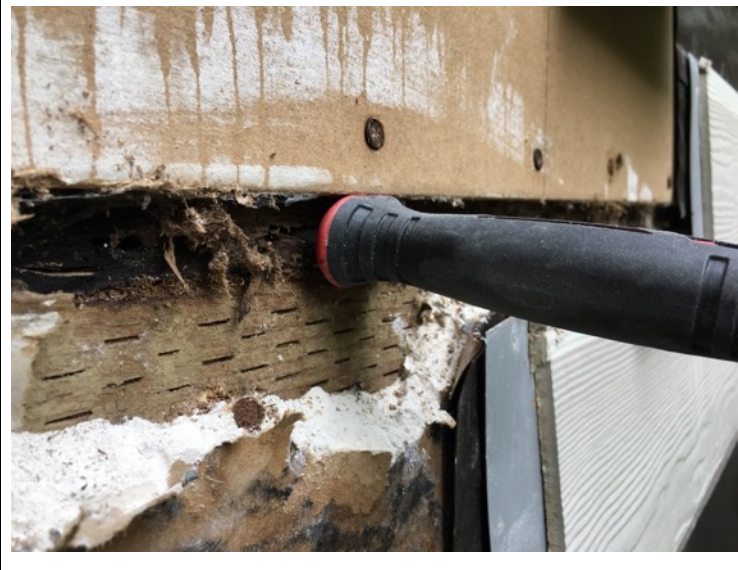
<p>1.9.15 Demonstration of deteriorated plywood sheathing which comprises deck floor substrate. This damage observed along the entire span of the deck floor substrate.</p> <p><i>Damage results from sustained moisture absorption by exterior wall assembly components and/or moisture accumulation within exterior wall assembly.</i></p>
 	<p>1.9.16 Demonstration of deteriorated gypsum sheathing.</p> <p><i>Damage results from sustained moisture absorption by exterior wall assembly components and/or moisture accumulation within exterior wall assembly.</i></p>

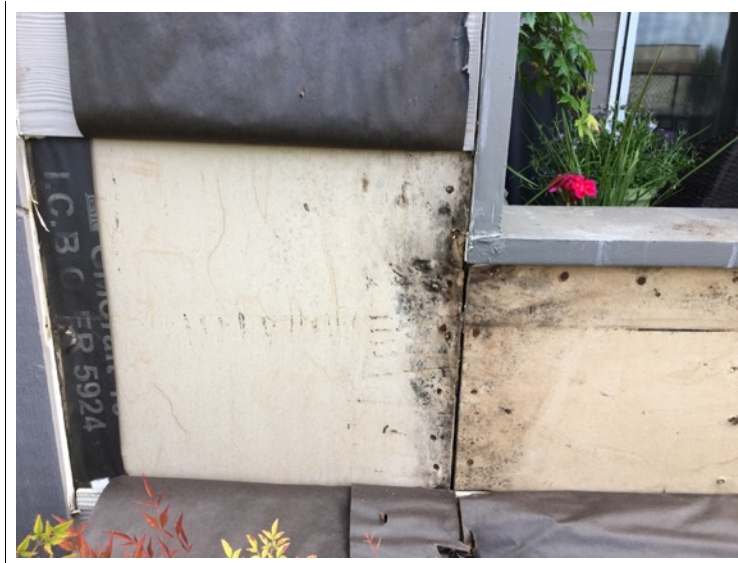
1.10.7

Deteriorated gypsum sheathing.

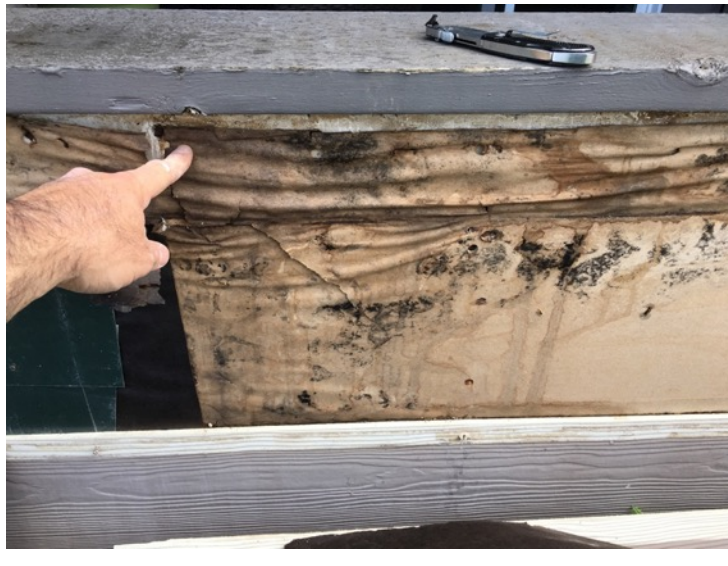
1.10.12 Deteriorated gypsum sheathing.

*Damage results from sustained moisture absorption water leakage and/or moisture accumulation within the exterior wall assembly.*

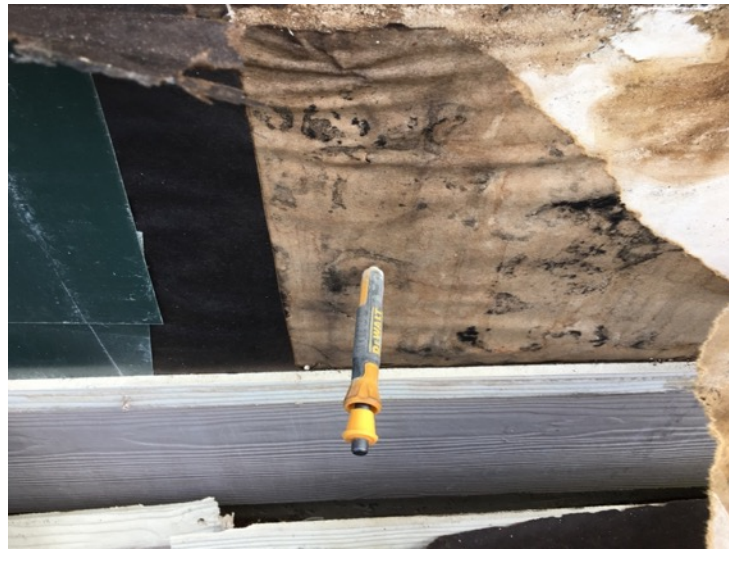
1.10.14 Demonstration of deteriorated gypsum sheathing.

*Damage results from sustained moisture absorption water leakage and/or moisture accumulation within the exterior wall assembly.*

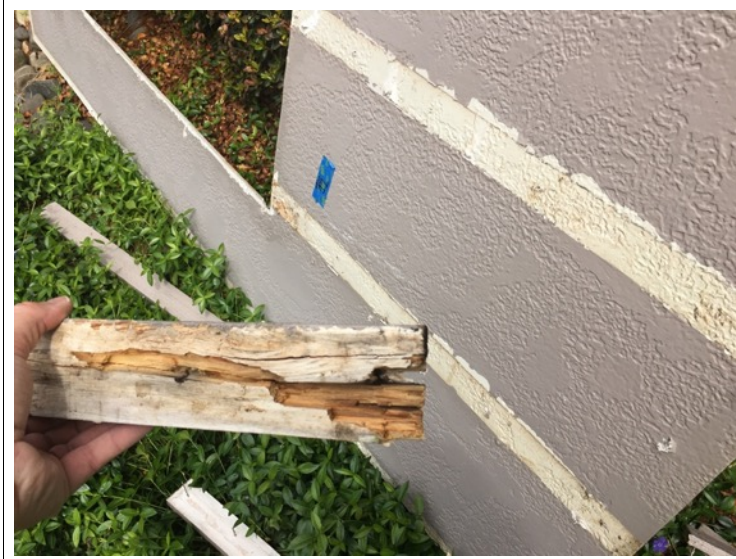
1.11.7

Deteriorated wood trim member.

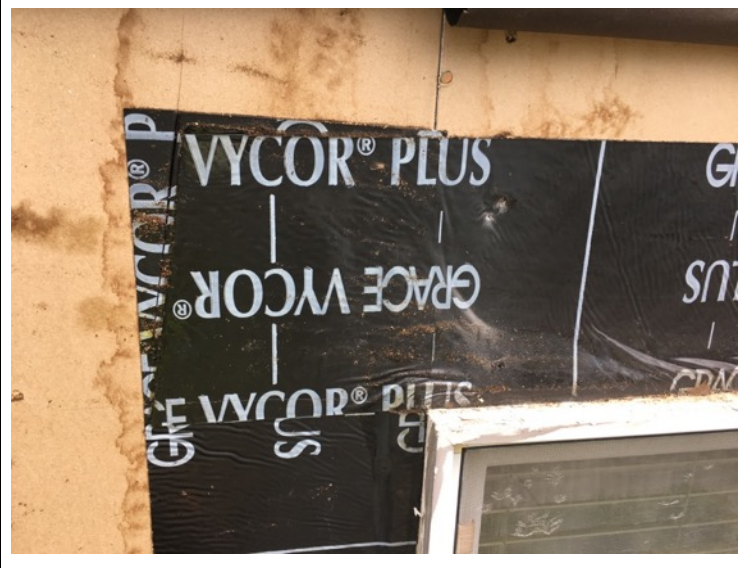
<p>1.11.9 Moisture staining observed on gypsum sheathing.</p> <p><i>Damage results from sustained moisture absorption by exterior wall assembly components and/or moisture accumulation within exterior wall assembly.</i></p>

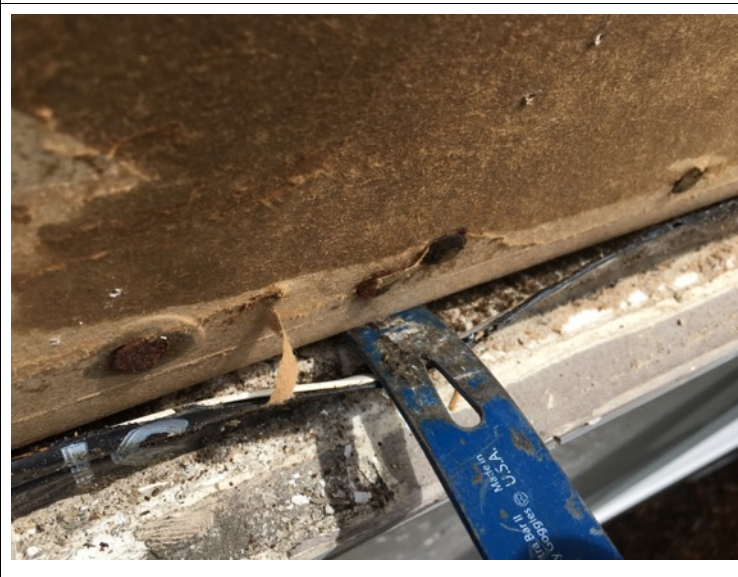
<p>1.11.10 Omitted or discontinuous sealant bedding beneath fenestration mounting flange.</p> <p><i>Condition fails to provide adequate air leakage control and facilitates moisture transport through exterior wall assembly at fenestration rough opening.</i></p>

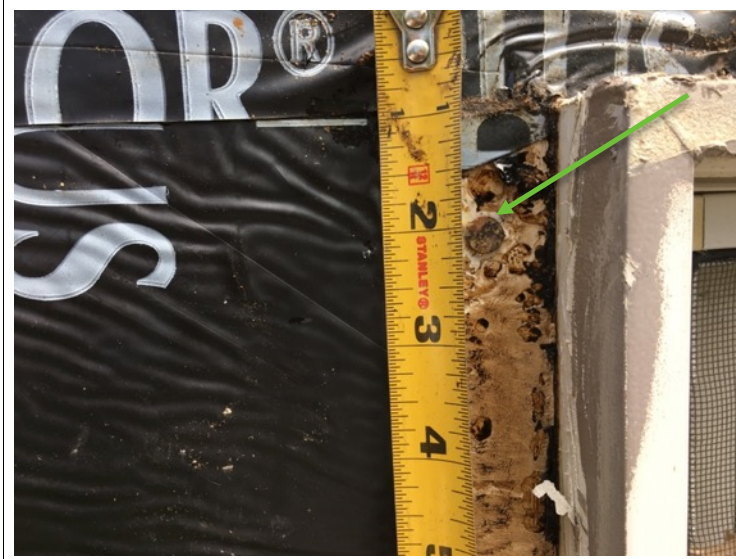
1.11.11 Improper installation of window assembly: fasteners not installed through pre-punched slots in mounting flange. Fastener installed within 3" of window corner.

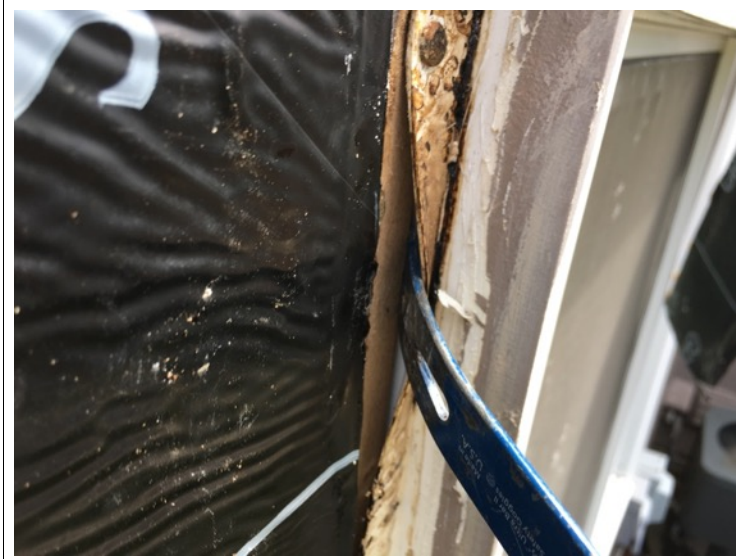
1.11.13 Omitted or discontinuous sealant bedding beneath fenestration mounting flange.

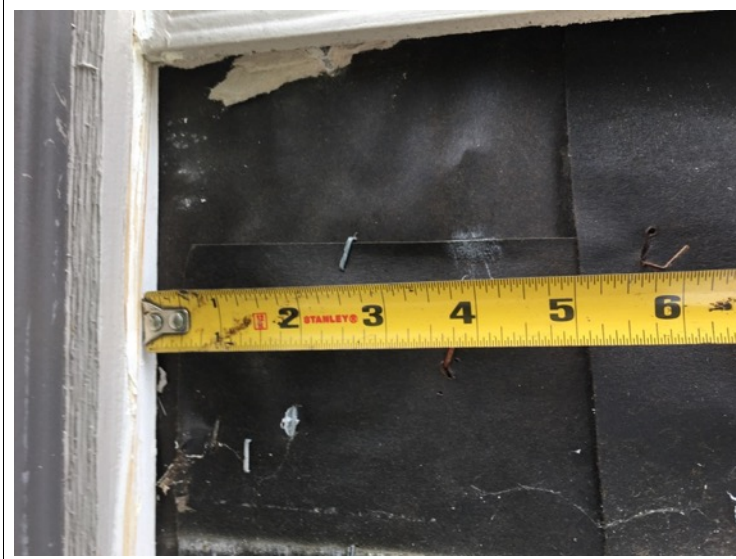
1.12.11 Improper installation of WRB: WRB should wrap corner of wall assembly.

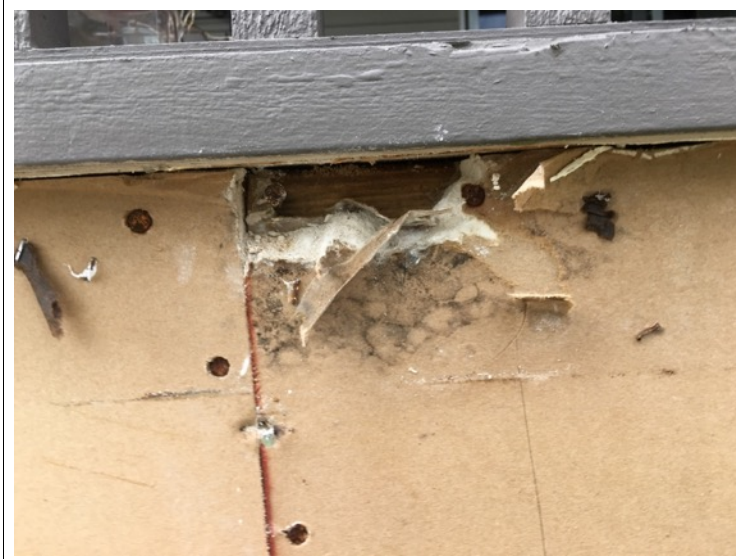
1.12.15 Demonstration of deteriorated wall assembly components.

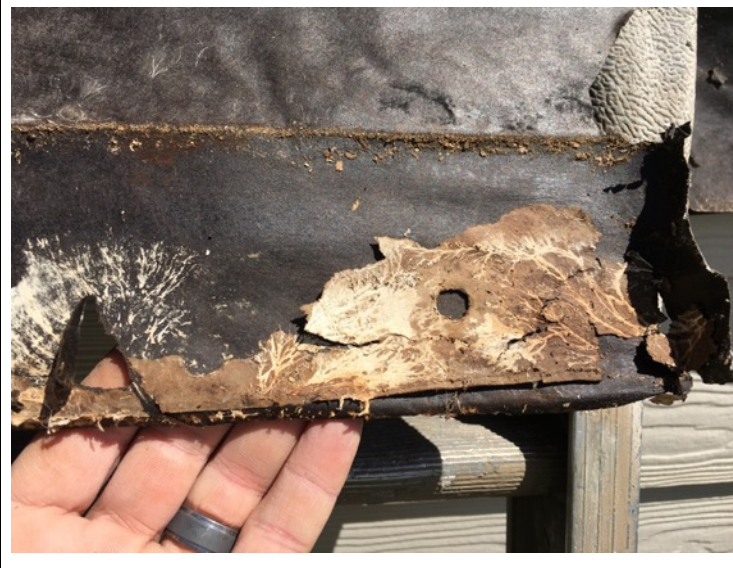
1.13.12 Fungal growth observed emanating from exterior wall assembly components.

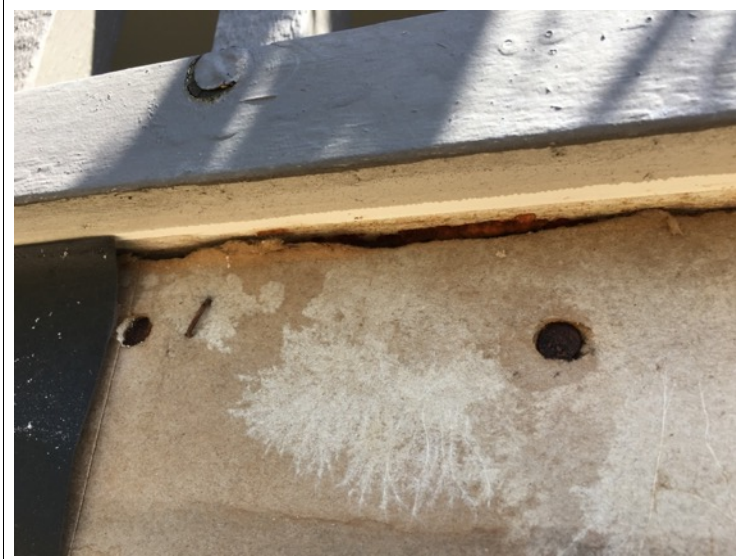
1.13.13 Fungal growth observed emanating from exterior wall assembly components.

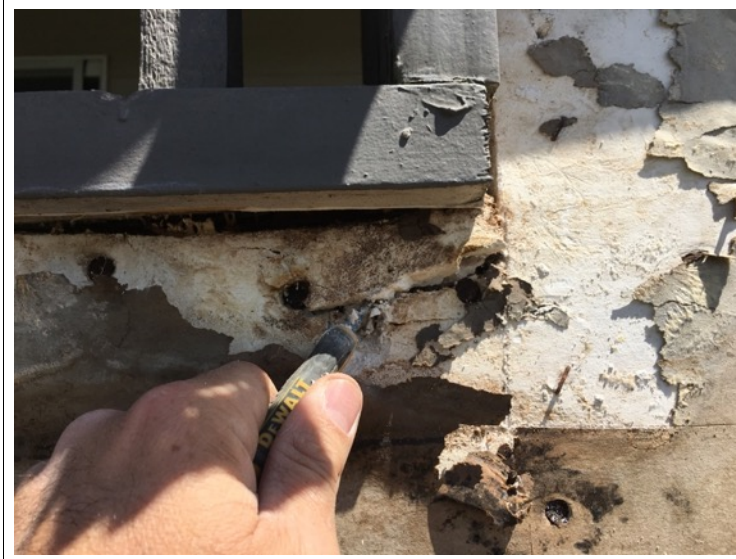
1.13.14 Demonstration of deteriorated gypsum sheathing.  
*Damage results from sustained moisture absorption water leakage and/or moisture accumulation within the exterior wall assembly.*

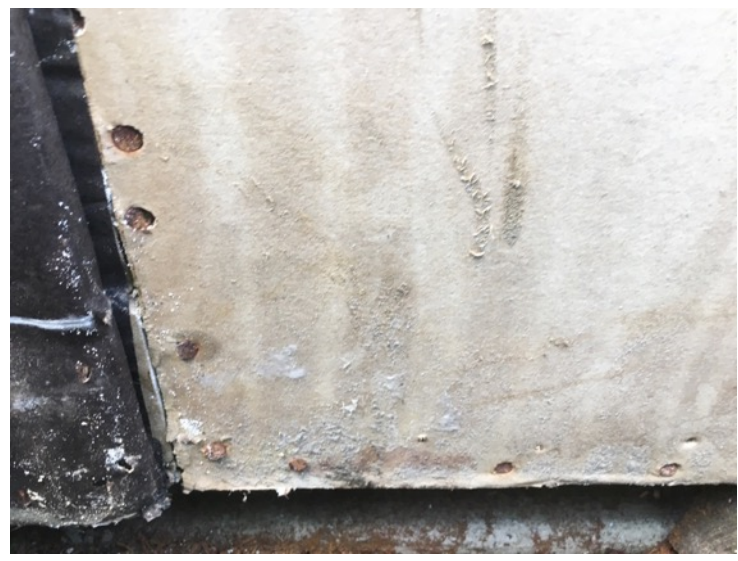
<p>1.14.5 Corroded fasteners observed.</p> <p><i>Damage results from sustained moisture to water leakage and/or moisture accumulation within the exterior wall assembly.</i></p>

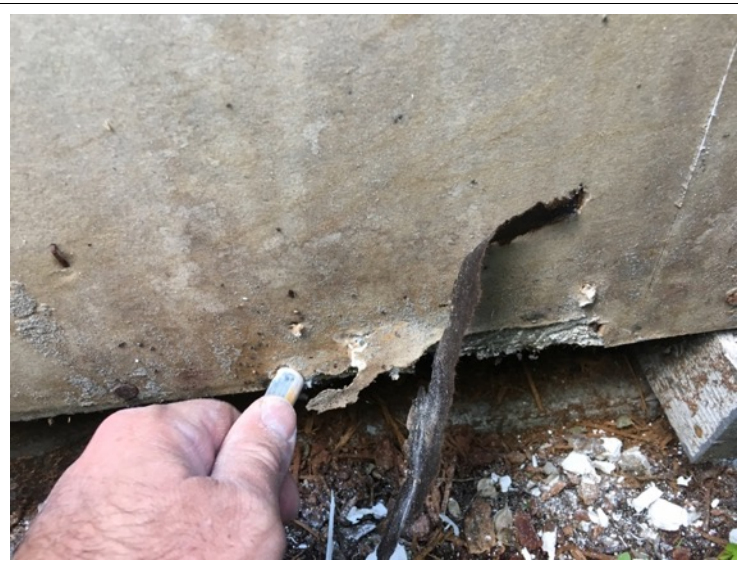
<p>1.14.6 Demonstration of deteriorated gypsum sheathing.</p> <p><i>Damage results from sustained moisture absorption water leakage and/or moisture accumulation within the exterior wall assembly.</i></p>

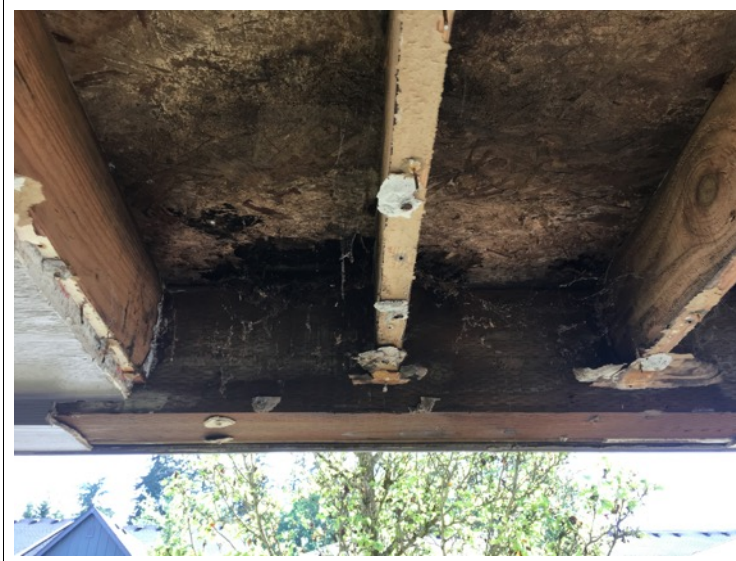
1.16.11 Plywood sheathing which comprises the deck floor substrate is completely deteriorated at the face of the deck.

*Damage results from sustained moisture to water leakage and/or moisture accumulation within the exterior wall assembly.*

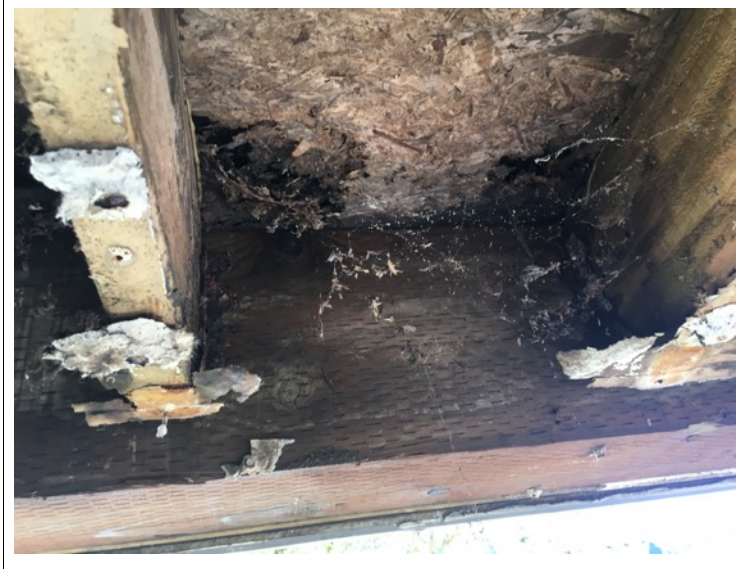
1.16.12 Plywood sheathing which comprises the deck floor substrate is completely deteriorated at the face of the deck.

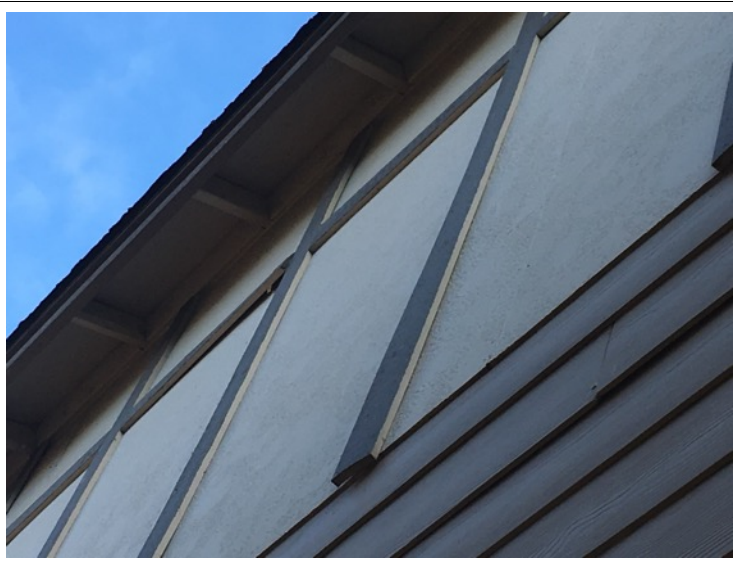
<p>1.17.8</p> <p>Improper installation of fiber cement panel siding and wood trim. Trim member should be installed to cover the seam between panels.</p>

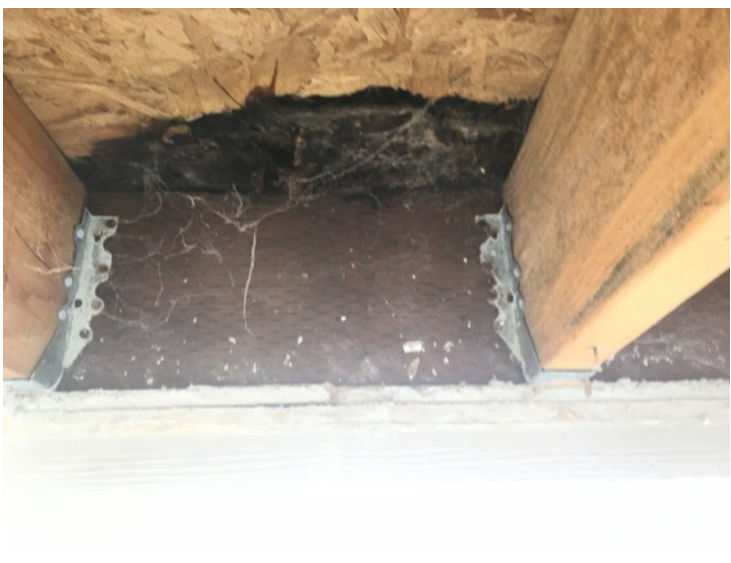
<p>1.18.8</p> <p>Moisture staining, microbial growth observed, and deterioration of plywood sheathing which comprised deck floor substrate.</p> <p><i>Damage results from sustained moisture to water leakage and/or moisture accumulation within the exterior wall assembly.</i></p>

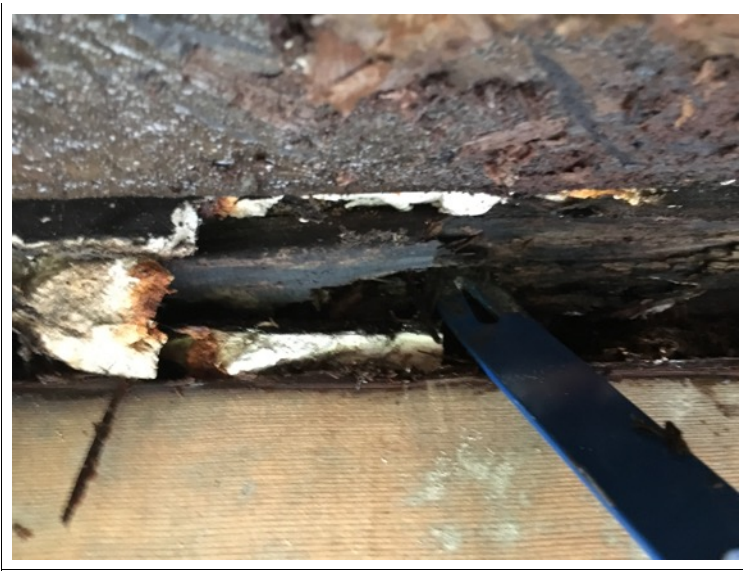
<p>1.20.9 Demonstration of deteriorated framing member in deck wall assembly.</p> <p><i>Damage results from sustained moisture to water leakage and/or moisture accumulation within the exterior wall assembly.</i></p>

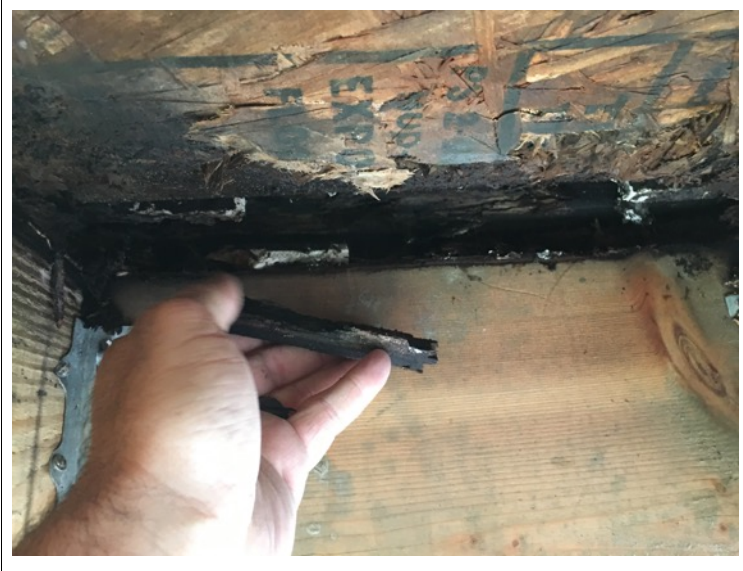
<p>1.20.10 Demonstration of deteriorated framing member in deck wall assembly.</p> <p><i>Damage results from sustained moisture to water leakage and/or moisture accumulation within the exterior wall assembly.</i></p>
