# VINTAGE OAKS HOA

## BUILDING ENVELOPE INVESTIGATION

PREPARED FOR:  
VINTAGE OAKS HOA BOARD

REPORT DATE:  
5.25.2017

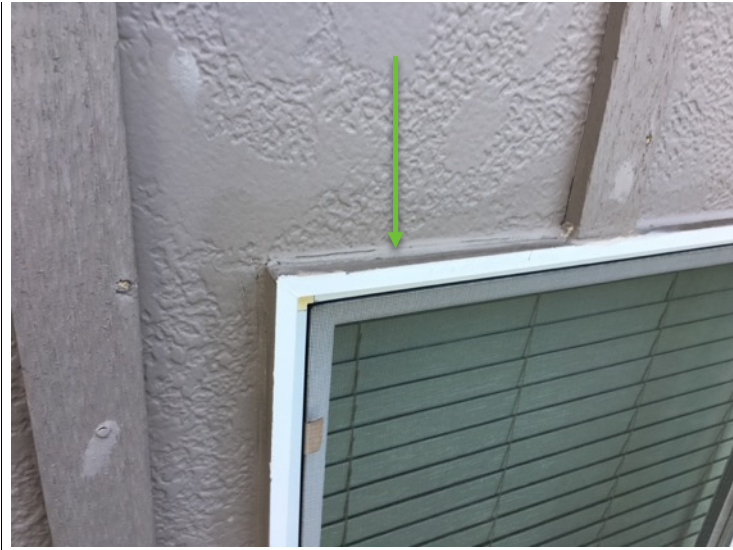
1.1.3 Omitted egress at horizontal siding termination.

*Condition negates incidental water egress and facilitates moisture accumulation within the exterior wall assembly.*

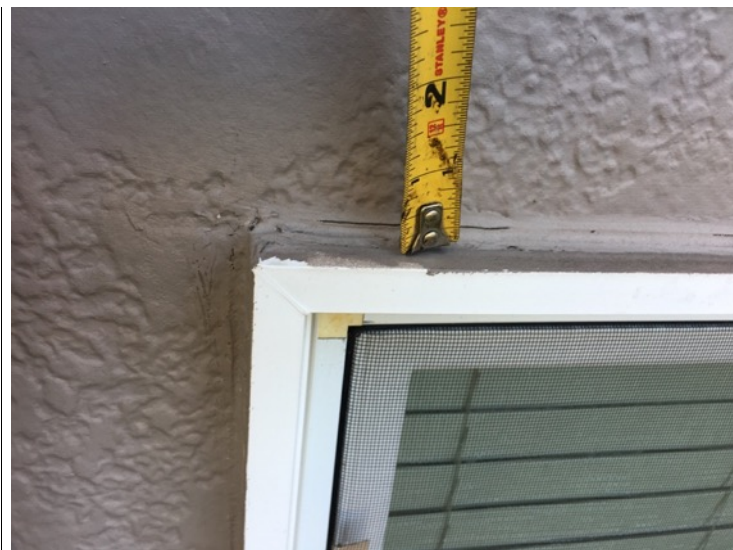
1.1.4 Minimum 1/4" egress required between horizontal siding termination and head of window frame.

*Condition does not allow for the installation of properly dimensioned dynamic sealant joint application.*

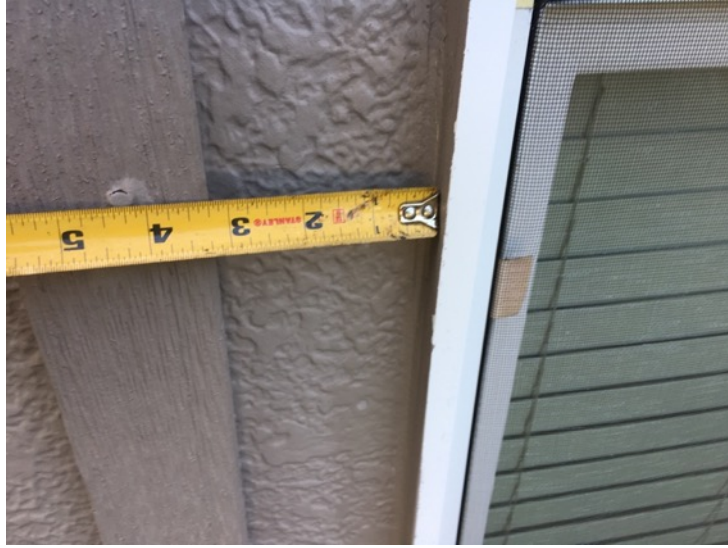
1.1.5 Improper clearance between siding and window frame: Less than 3/8".

*Condition does not allow for the installation of properly dimensioned dynamic sealant joint application.*

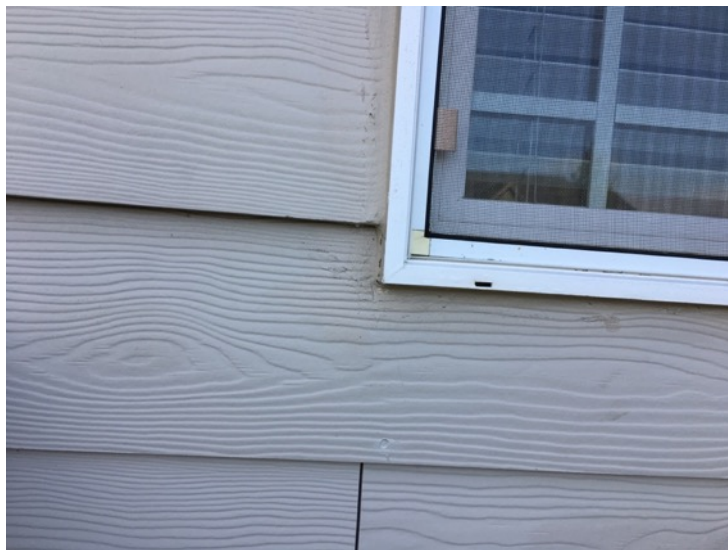
1.1.6 Improper clearance between siding and window frame: Less than 3/8".

*Condition does not allow for the installation of properly dimensioned dynamic sealant joint application.*

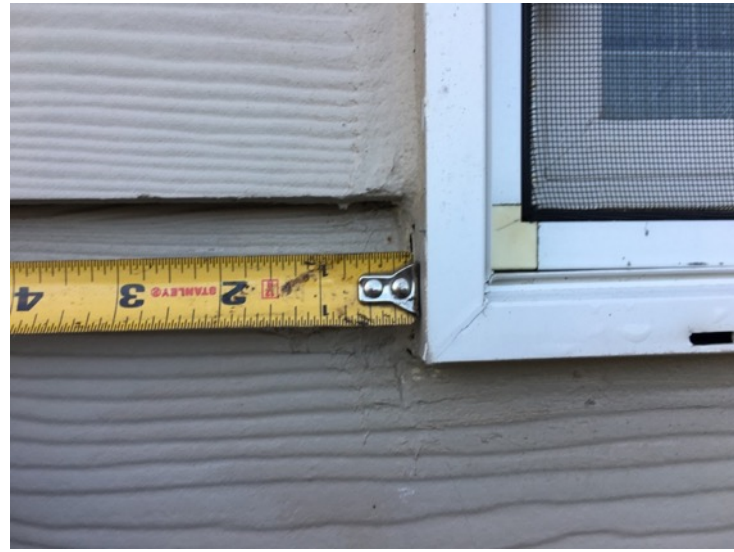
1.1.7

Improper clearance between siding and window frame: Less than 3/8".

*Condition does not allow for the installation of properly dimensioned dynamic sealant joint application.*

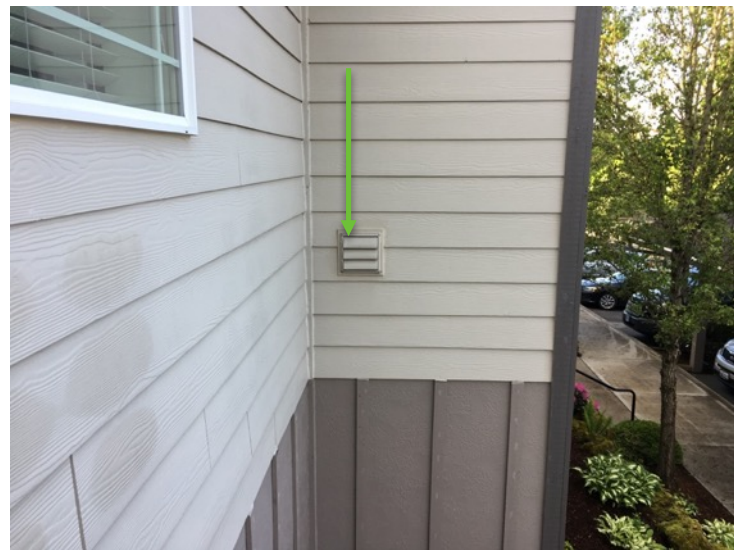
1.1.8

Omitted metal flashing atop projecting wood trim.

*Condition does not adequately shed water infiltration within exterior wall assembly.*

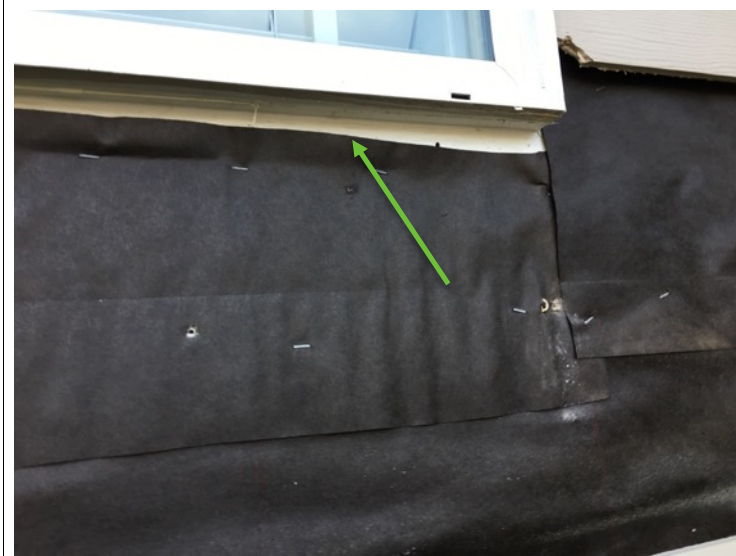
1.1.10

WRB reverse lapped at sill mounting flange.

*Condition negates incidental water egress and facilitates moisture accumulation within the exterior wall assembly.*

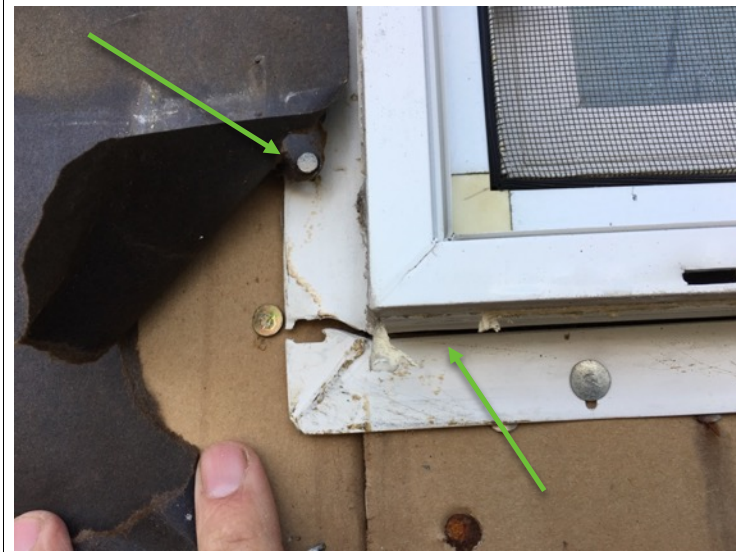
1.1.12

Cracked mounting flange.

*Damage results from improper fastener placement which does not accommodate thermal movement of vinyl window assembly.*

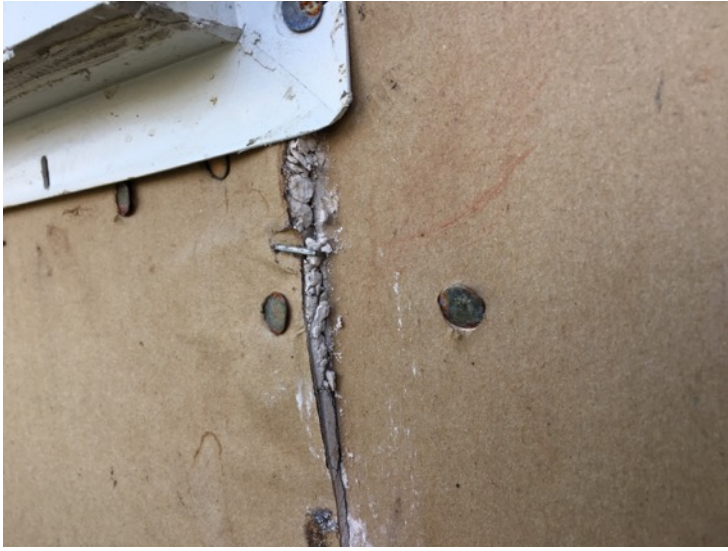
1.1.15	<p>Deteriorated gypsum sheathing.</p> <p><i>Damage results from sustained moisture absorption by exterior wall assembly components and/or moisture accumulation within exterior wall assembly.</i></p>

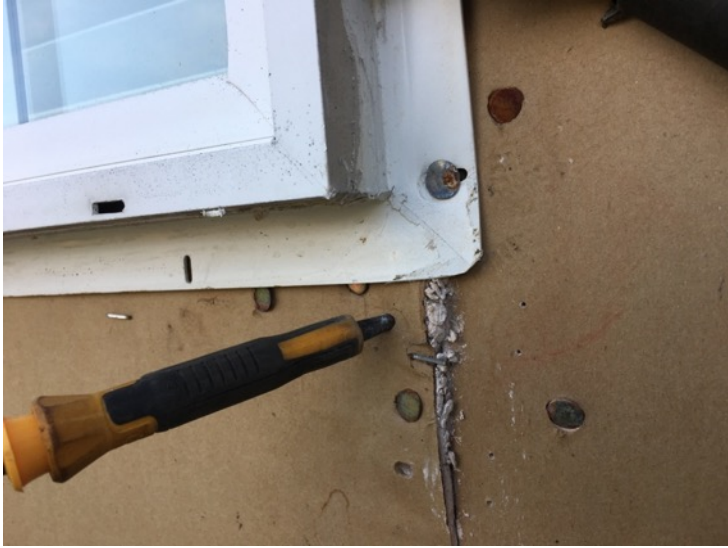
1.1.16	<p>Demonstration of deteriorated gypsum sheathing.</p> <p><i>Damage results from sustained moisture absorption by exterior wall assembly components and/or moisture accumulation within exterior wall assembly.</i></p>

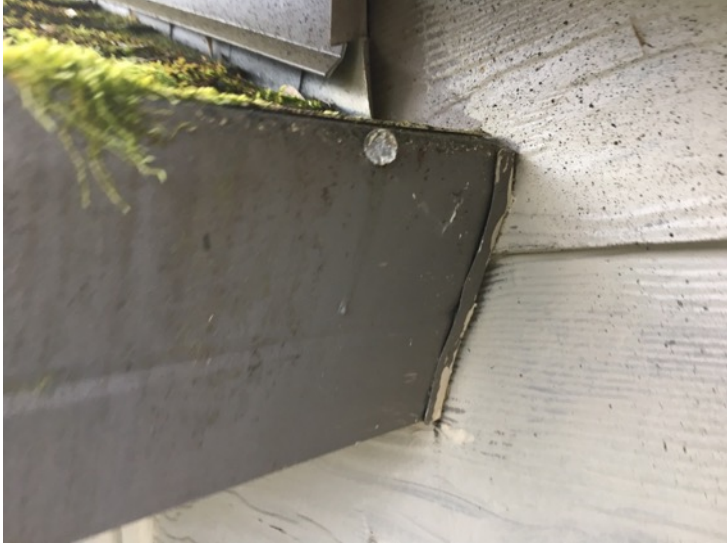
<p>1.2.3</p> <p>Improper clearance between termination and wall assembly. 1" clearance required by siding manufacturer.</p> <p><i>Condition facilitates water intrusion into exterior wall assembly.</i></p>

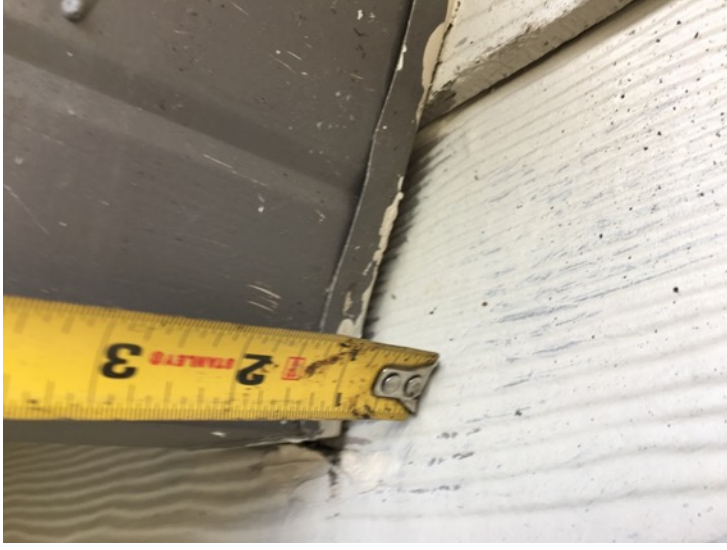
<p>1.2.4</p> <p>Improper clearance between termination and wall assembly. 1" clearance required by siding manufacturer.</p> <p><i>Condition facilitates water intrusion into exterior wall assembly.</i></p>

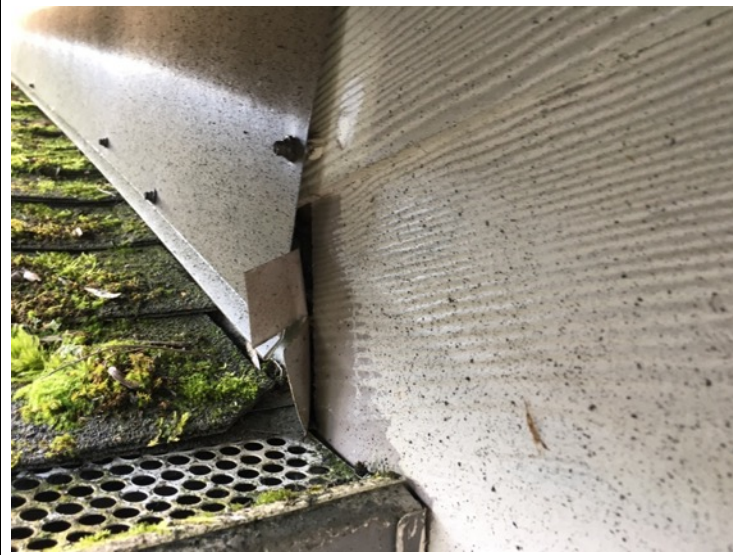
1.2.5

Omitted and/or improperly dimensioned diverter flashing at roof to wall transition.

*Condition fails to adequately convey water from the roof into gutter. Condition facilitates water intrusion into exterior wall assembly.*

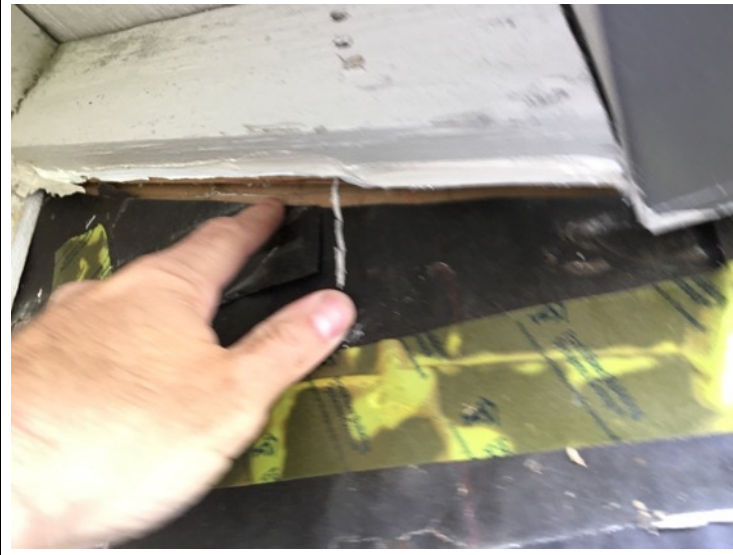
1.2.6

Discontinuous WRB.

*Condition fails to provide adequate incidental water protection for the underlying exterior wall assembly components.*

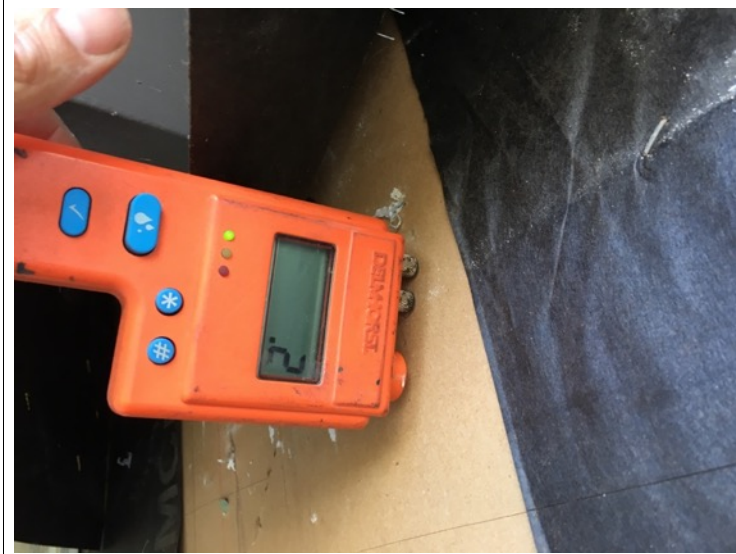
1.2.8

Moisture content of gypsum sheathing within acceptable limits.

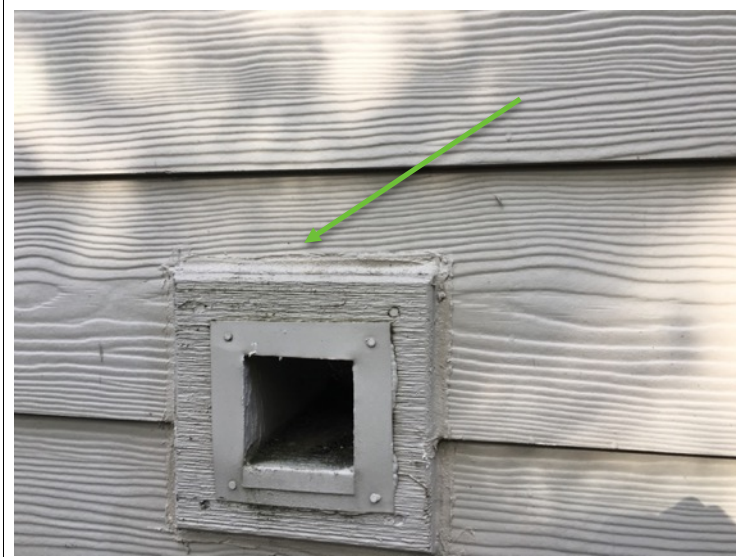
1.3.4

Omitted egress at horizontal siding termination.

*Condition negates incidental water egress and facilitates moisture accumulation within the exterior wall assembly.*

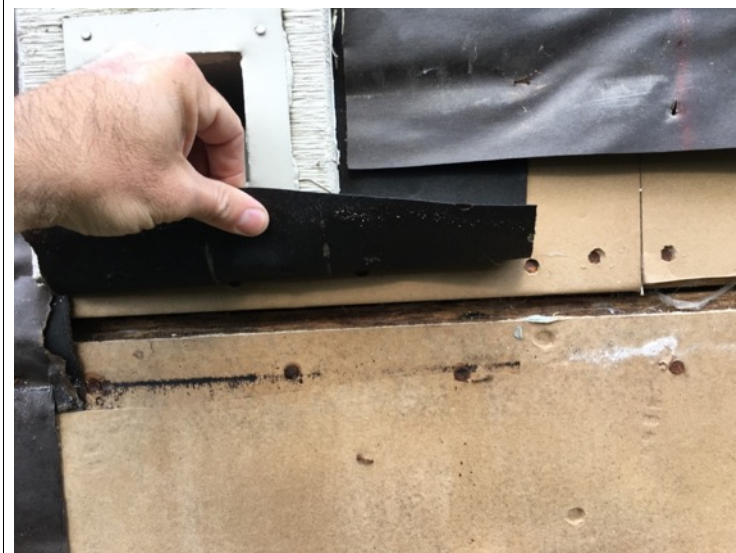
1.3.6

Microbial growth, moisture staining, corroded fasteners observed on underlying gypsum sheathing.

*Damage due to water infiltration and/or moisture accumulation within exterior wall assembly.*

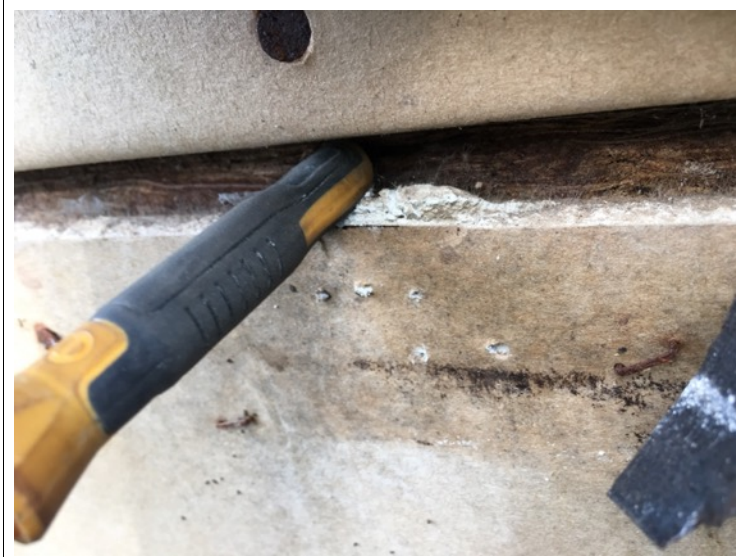
1.3.7

Demonstration of deteriorated plywood deck floor sheathing.

*Damage due to water infiltration and/or moisture accumulation within exterior wall assembly.*

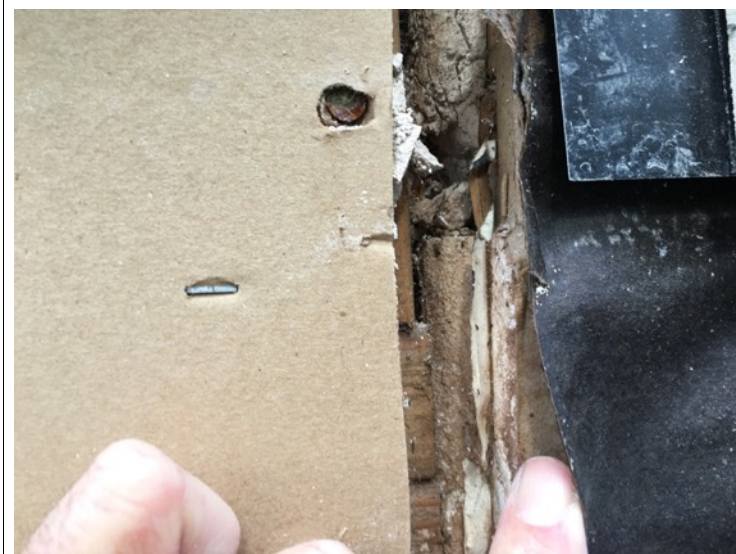
1.3.8

Deteriorated gypsum sheathing.

*Damage due to water infiltration and/or moisture accumulation within exterior wall assembly.*

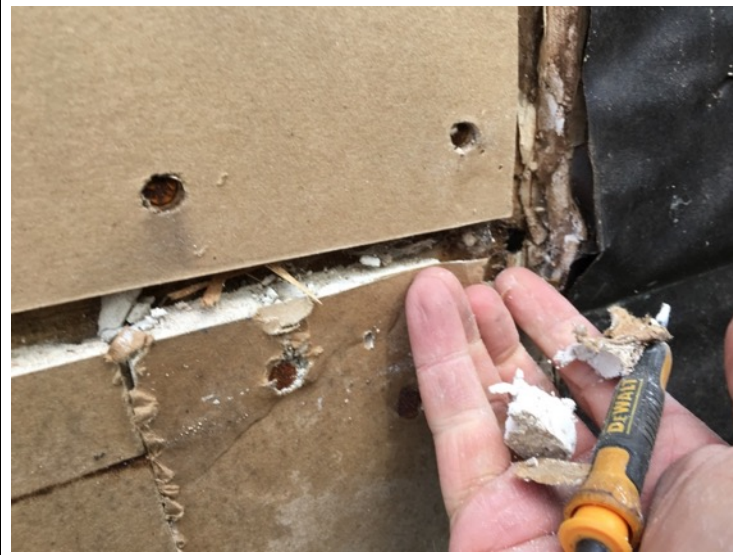
1.3.9

Deteriorated gypsum sheathing.

*Damage due to water infiltration and/or moisture accumulation within exterior wall assembly.*

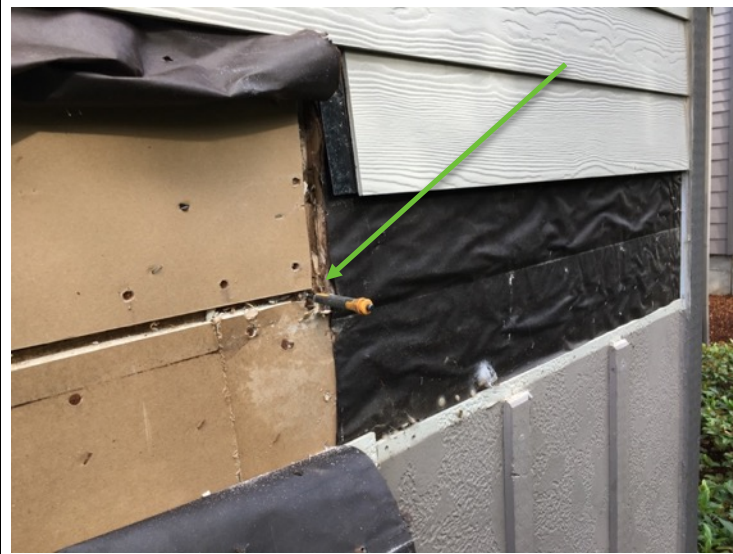
1.3.10

Demonstration of deteriorated gypsum sheathing.

*Damage due to water infiltration and/or moisture accumulation within exterior wall assembly.*

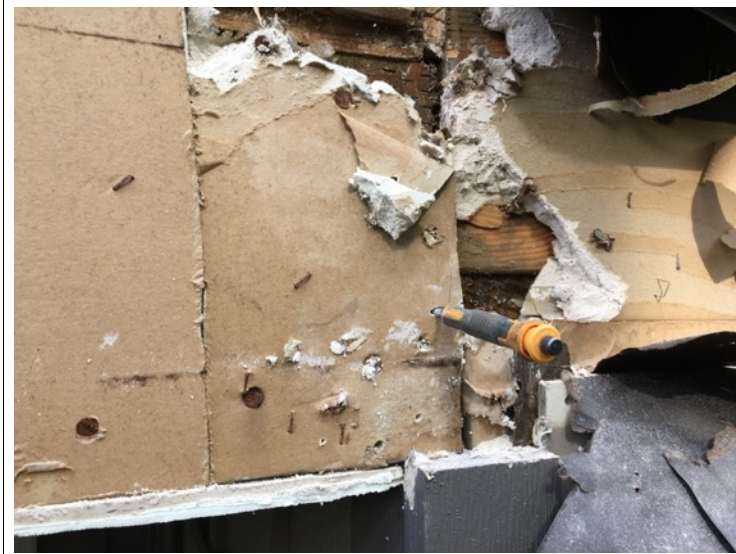
1.3.14

Deteriorated gypsum sheathing. Moisture stained framing members.

*Damage results from sustained moisture absorption by exterior wall assembly components and/or moisture accumulation within exterior wall assembly.*

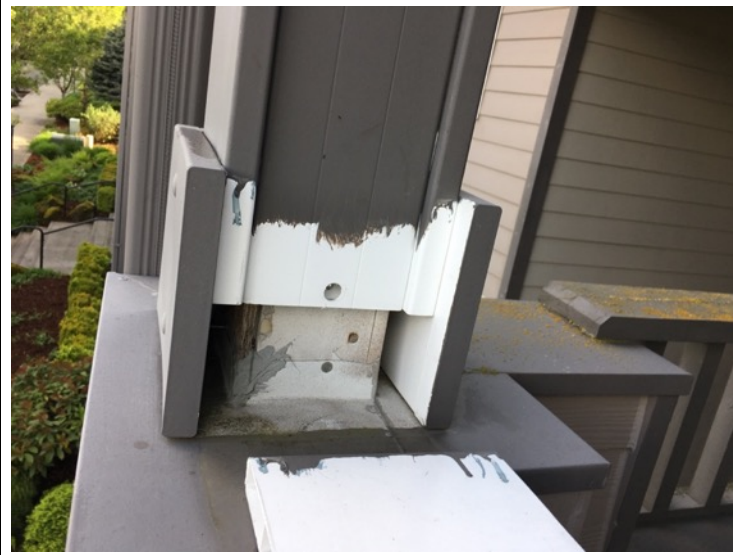
1.4.5

Omitted flashing and sealant at perimeter base of column assembly. Improper materials used for column construction.

*Conditions fail to provide adequate protection of underlying deck and wall assembly components from water infiltration.*

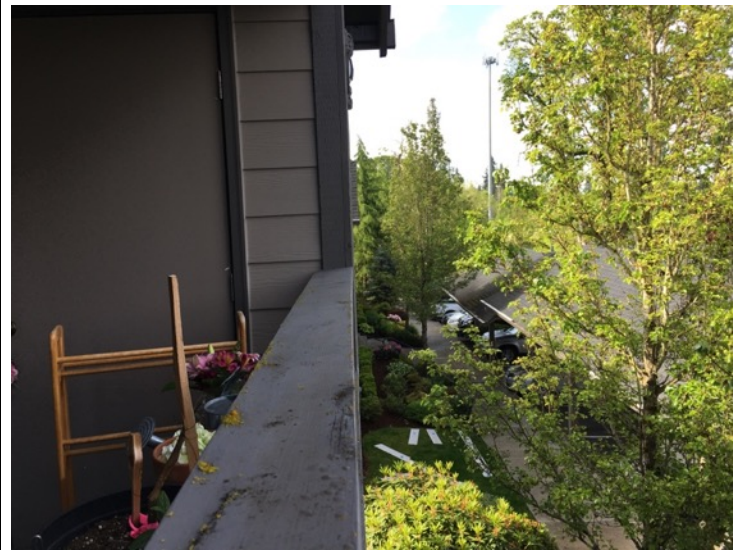
1.4.6

Omitted flashing provisions atop horizontal wood trim.

*Condition facilitates water intrusion into exterior wall assembly.*

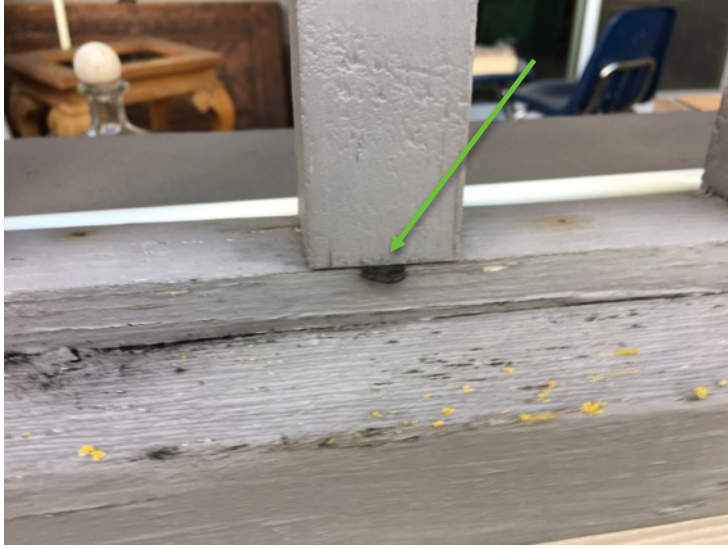
<p>1.4.7 Fungal growth observed emanating from wall assembly components.</p> <p><i>Damage due to water infiltration and/or moisture accumulation within exterior wall assembly.</i></p>

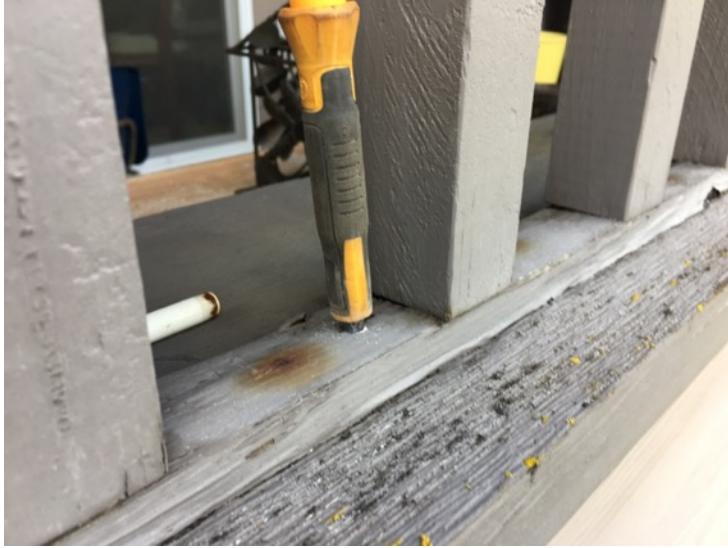
<p>1.4.8 Demonstration of deteriorated wall assembly components.</p> <p><i>Damage due to water infiltration and/or moisture accumulation within exterior wall assembly.</i></p>

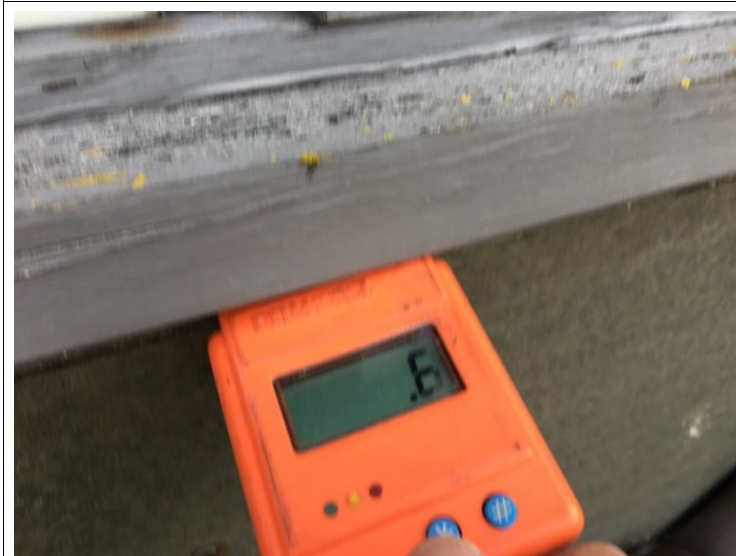
1.4.14

Elevated moisture content (.6%) of gypsum sheathing. 1% and above MC reading of gypsum sheathing is considered saturated.

*Damage results from sustained moisture absorption by exterior wall assembly components and/or moisture accumulation within exterior wall assembly.*

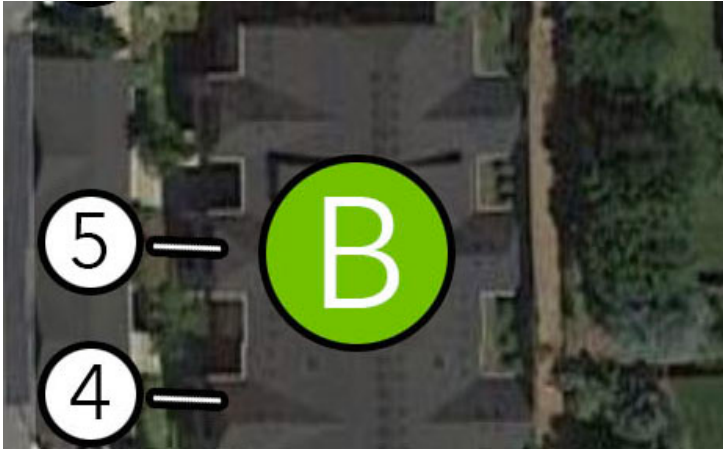
<p>1.5.1 Exploratory Opening 5. Building B, West Elevation, 1<sup>st</sup> Story Deck Wall.</p>

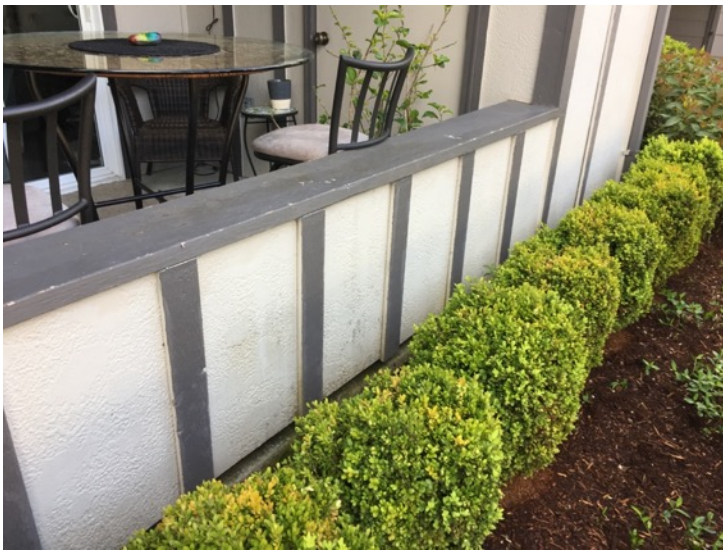
<p>1.5.2 Exploratory Opening 5. Building B, West Elevation, 1<sup>st</sup> Story Deck Wall.</p> <p>Omitted flashing provisions atop horizontal wood cap.</p> <p>Omitted isometric flashing at horizontal to vertical interface.</p> <p><i>Condition facilitates water intrusion into exterior wall assembly.</i></p>

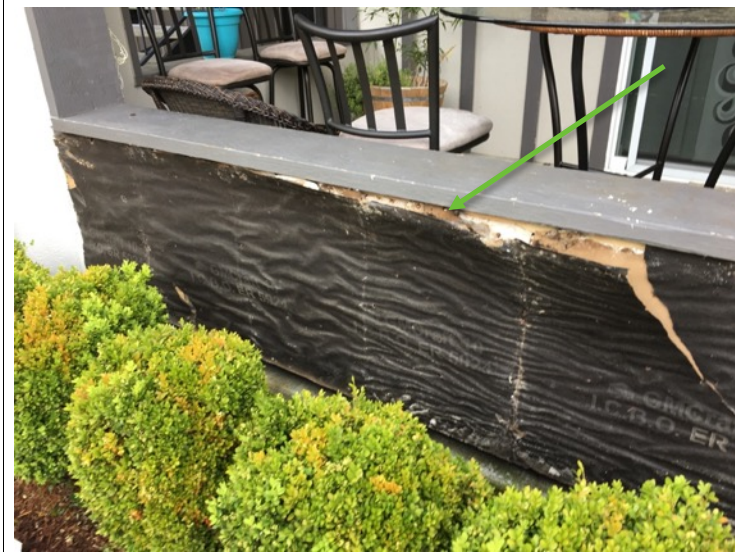
1.5.4

Discontinuous WRB.

*Condition fails to provide adequate protection of underlying wall assembly components from water infiltration.*

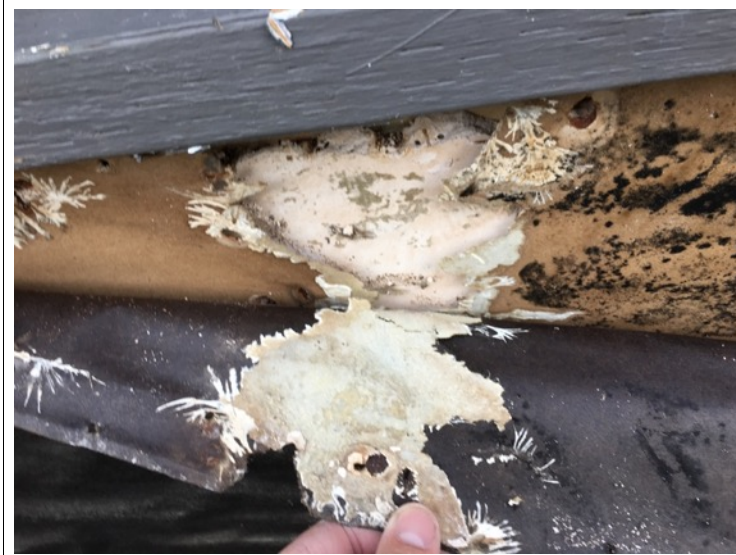
1.5.6

Microbial growth, fungal growth, deteriorated gypsum sheathing observed.

*Damage due to water infiltration and/or moisture accumulation within exterior wall assembly.*

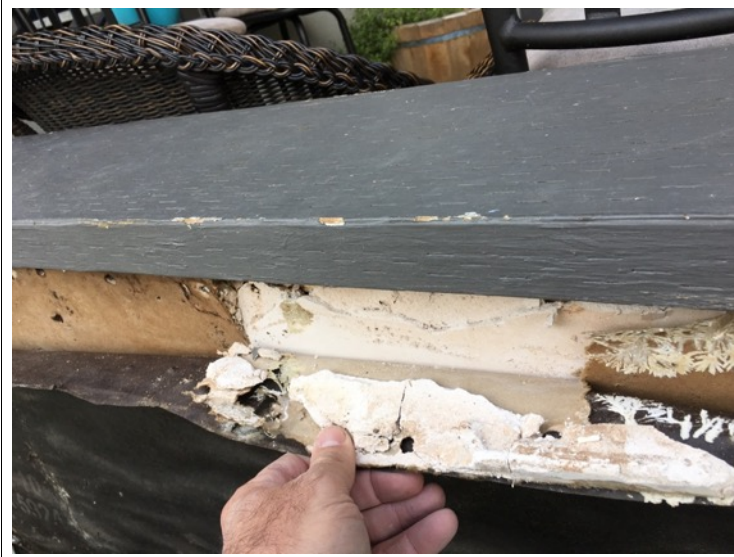
1.5.7

Deteriorated gypsum sheathing.

*Damage due to water infiltration and/or moisture accumulation within exterior wall assembly.*

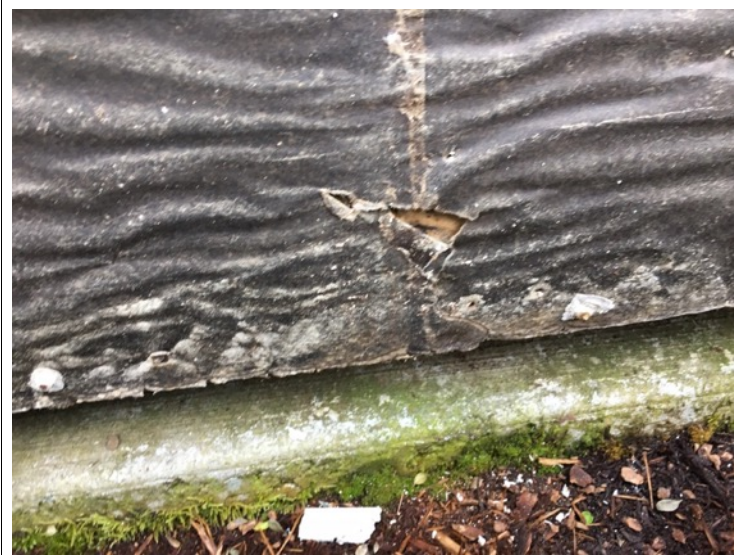
1.5.8

Microbial growth, fungal growth, water staining observed on WRB.

*Damage due to water infiltration and/or moisture accumulation within exterior wall assembly.*

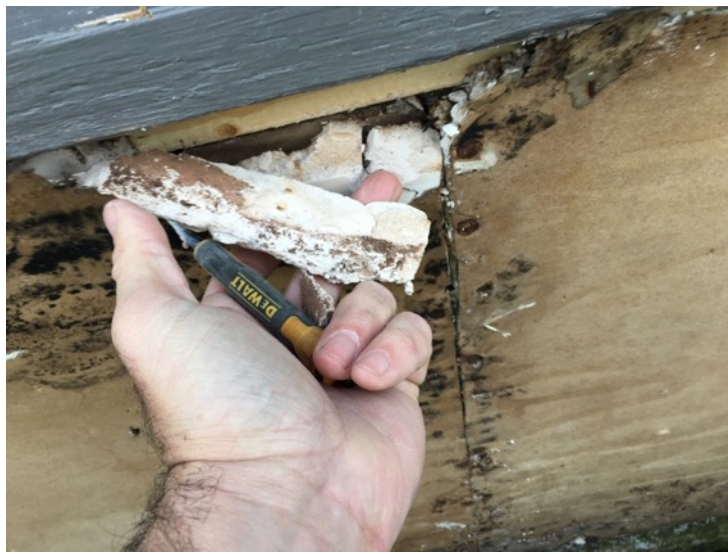
1.5.12

Deteriorated gypsum sheathing.

*Damage due to water infiltration and/or moisture accumulation within exterior wall assembly.*

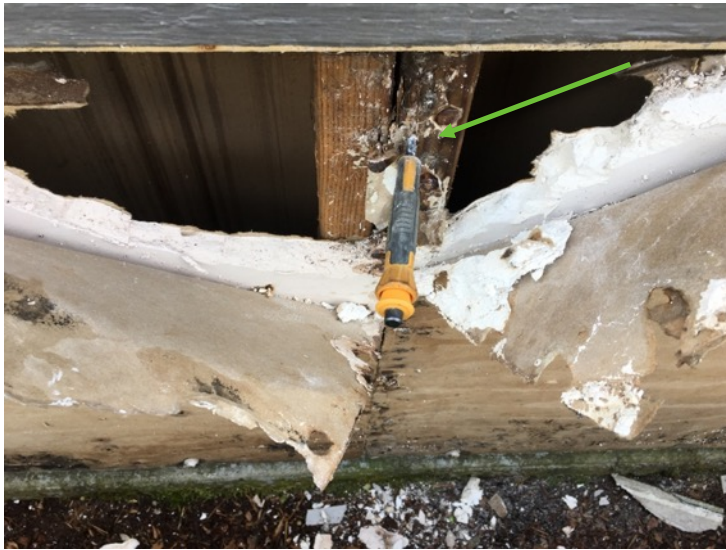
<p>1.5.15 Demonstration of deteriorated framing members</p> <p><i>Damage due to water infiltration and/or moisture accumulation within exterior wall assembly.</i></p>

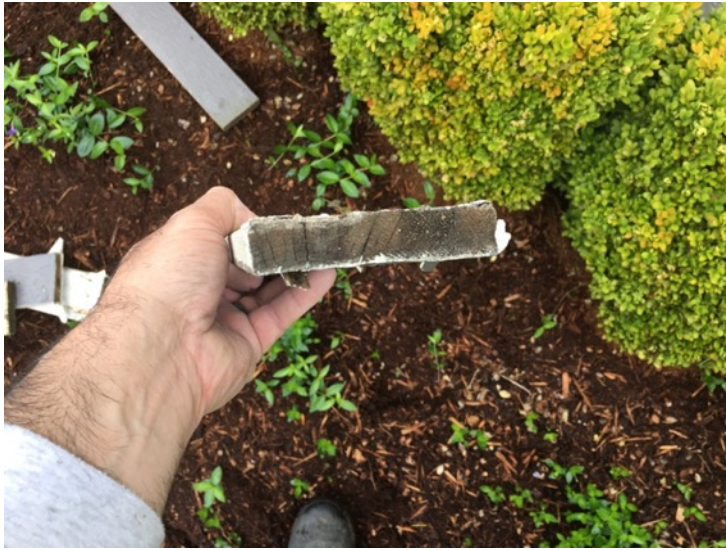
<p>1.5.16 Unprimed field cut edges of wood trim member.</p> <p><i>Condition facilitates moisture absorption and premature deterioration of trim members.</i></p>

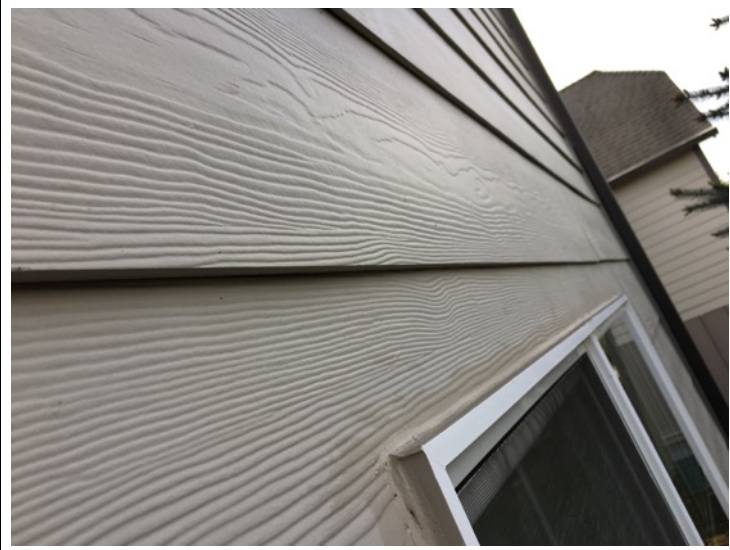
<p>1.6.3 Omitted egress at horizontal siding termination.</p> <p><i>Condition negates incidental water egress and facilitates moisture accumulation within the exterior wall assembly.</i></p>

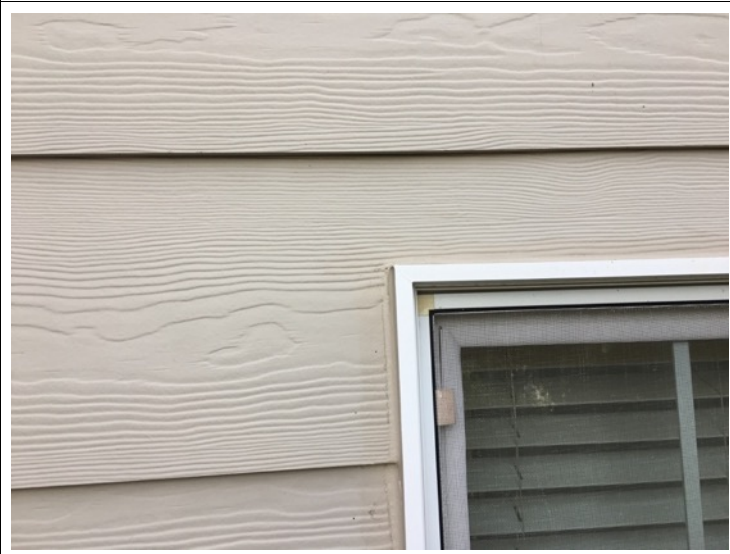
<p>1.6.4 Improper clearance between siding and window frame: Less than 3/8".</p> <p><i>Condition does not allow for the installation of properly dimensioned dynamic sealant joint application.</i></p>

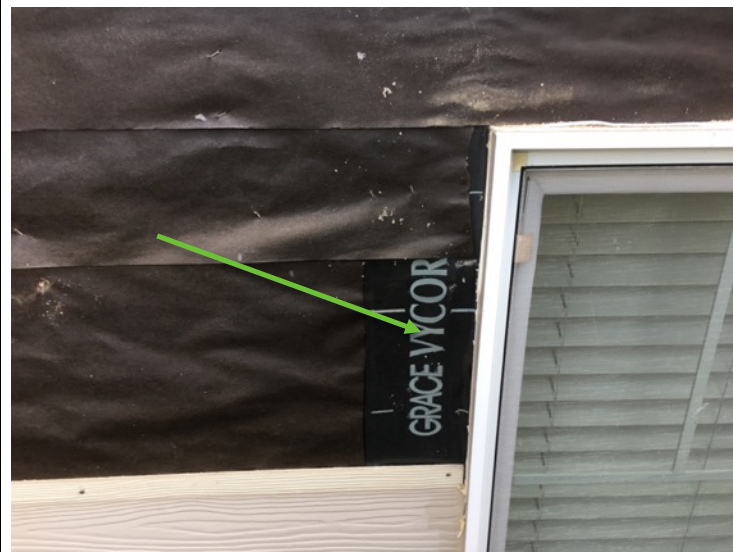
1.6.6

Improper installation of WRB. WRB does not adequately overlap flexible flashing at window jamb.

*Condition does not adequately shed water infiltration within exterior wall assembly.*

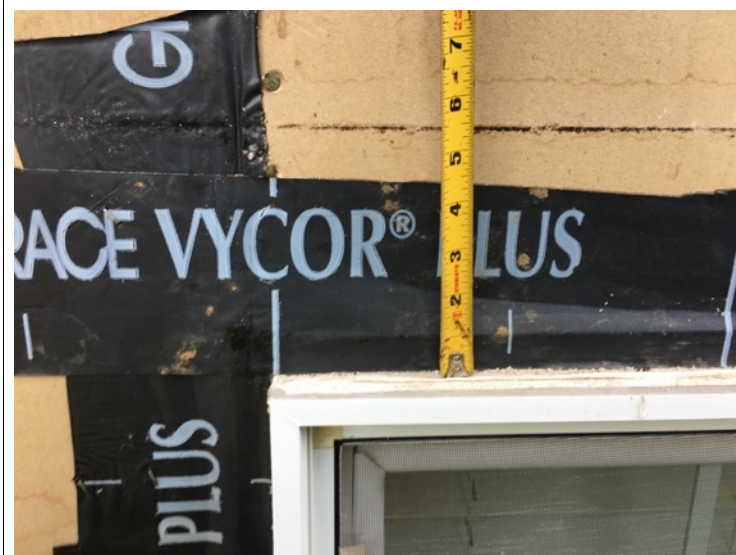
1.6.10

Improper installation of flexible flashing window head. Flexible flashing should be 9" in width.

*Condition does not adequately shed water infiltration within exterior wall assembly.*

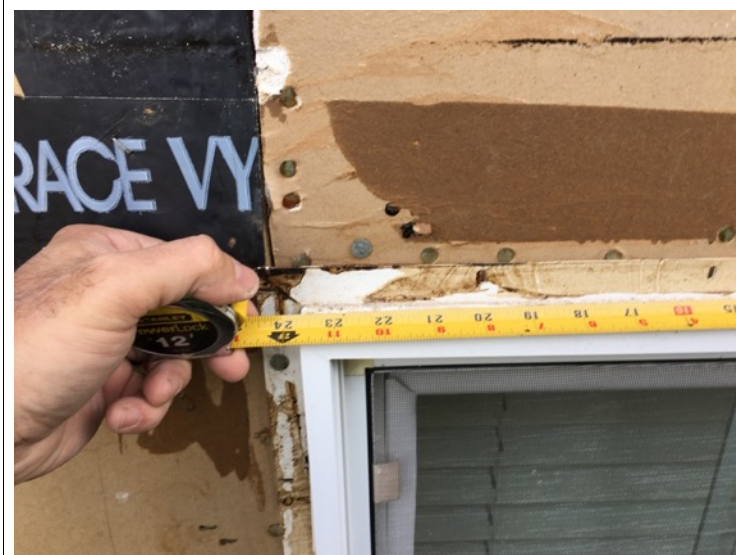
1.6.14

Omitted fasteners along entire span at window head.

*Condition does not adequately secure window to the underlying wall assembly.*

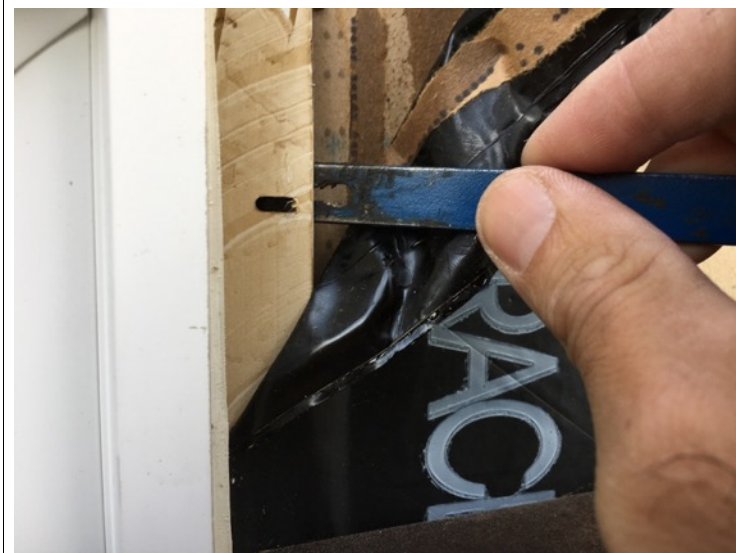
1.6.16

Omitted or discontinuous sealant bedding beneath fenestration mounting flange.

*Condition fails to provide adequate air leakage control and facilitates moisture transport through exterior wall assembly at fenestration rough opening.*

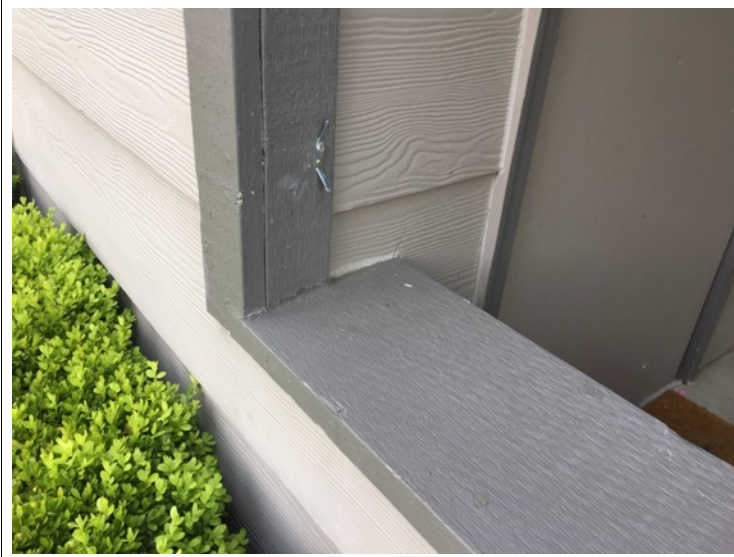
1.7.3

Omitted flashing provisions atop horizontal wood cap.

Omitted isometric flashing at horizontal to vertical interface.

*Condition facilitates water intrusion into exterior wall assembly.*

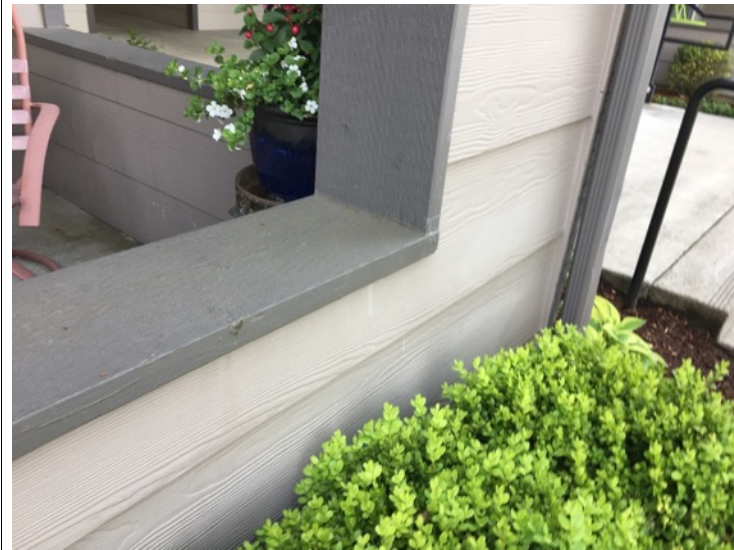
1.7.4

Omitted flashing provisions atop horizontal wood cap.

*Condition facilitates water intrusion into exterior wall assembly.*

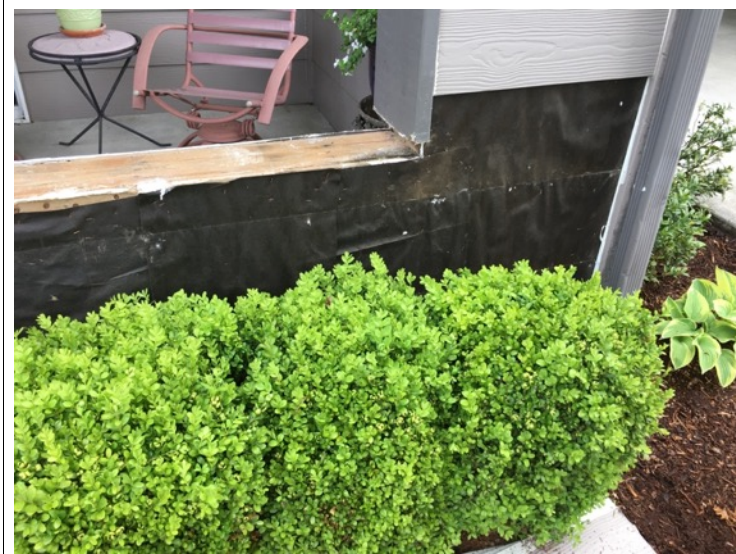
1.7.6

Omitted metal flashing and/or flexible flashing atop underlying wall assembly below wood trim.

*Condition fails to provide adequate protection of underlying wall assembly components from water infiltration.*

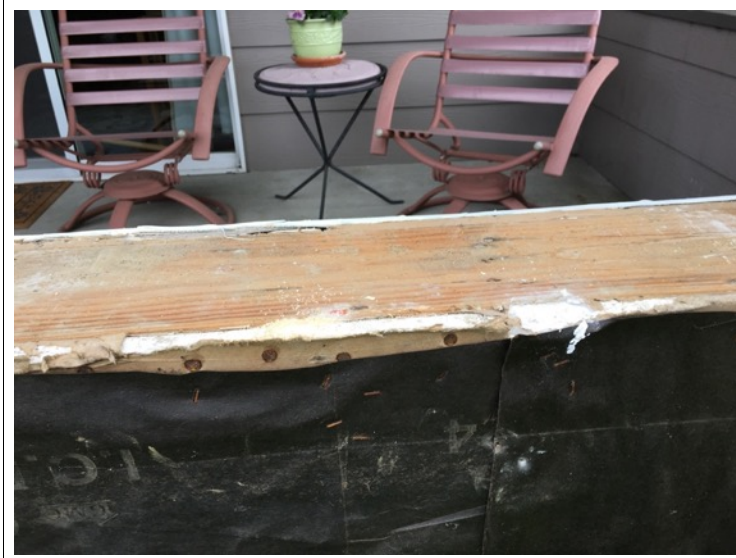
1.7.8

Discontinuous WRB.

*Condition fails to provide adequate protection of underlying wall assembly components from water infiltration.*

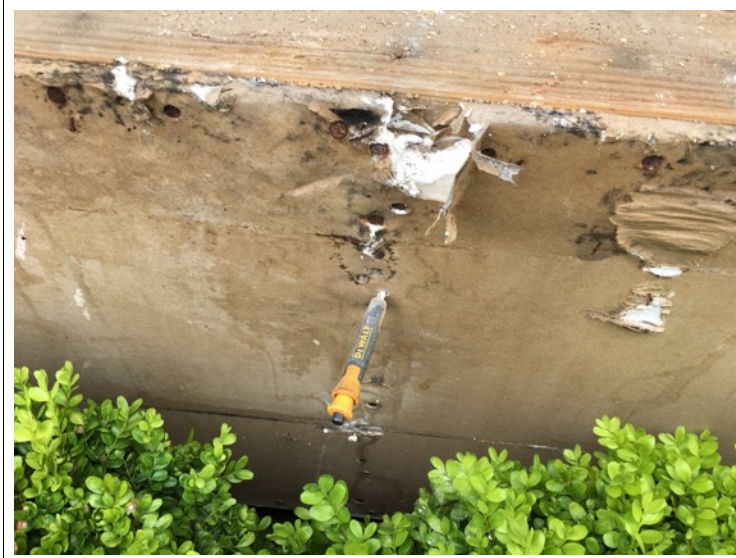
1.7.18

Demonstration of deteriorated gypsum sheathing.

*Damage results from sustained moisture absorption by exterior wall assembly components and/or moisture accumulation within exterior wall assembly.*

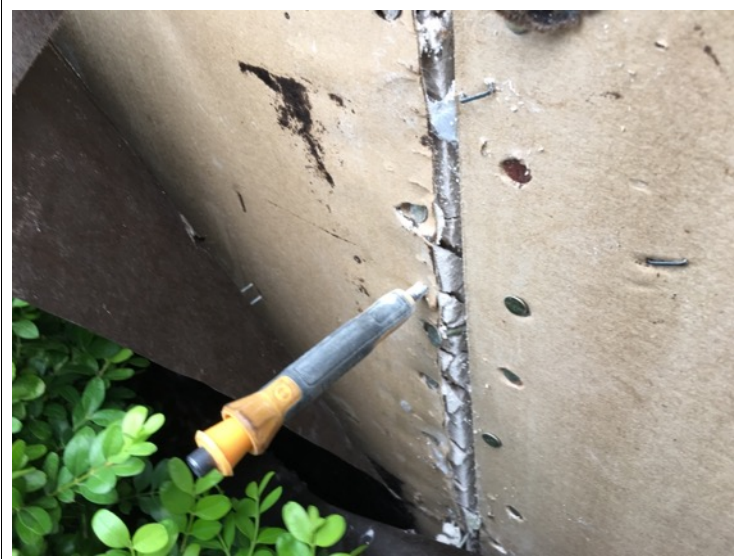
1.7.19

Demonstration of deteriorated gypsum sheathing.

*Damage results from sustained moisture absorption by exterior wall assembly components and/or moisture accumulation within exterior wall assembly.*

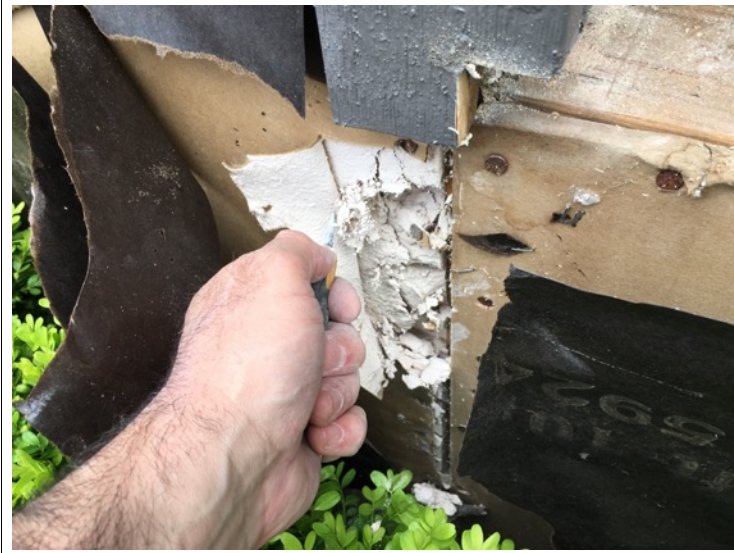
1.7.20

Demonstration of deteriorated gypsum sheathing.

*Damage results from sustained moisture absorption by exterior wall assembly components and/or moisture accumulation within exterior wall assembly.*

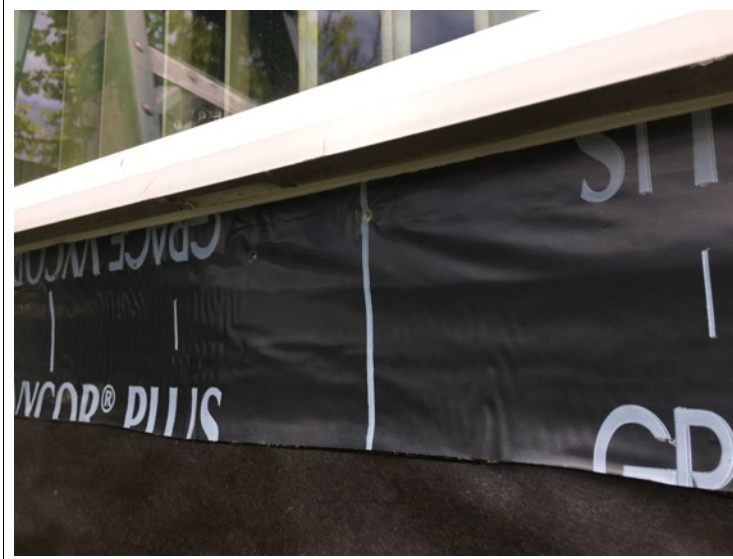
1.8.5

Reverse lap of flexible flashing at mounting flange sill.

*Condition negates incidental water egress and facilitates moisture accumulation within the exterior wall assembly.*

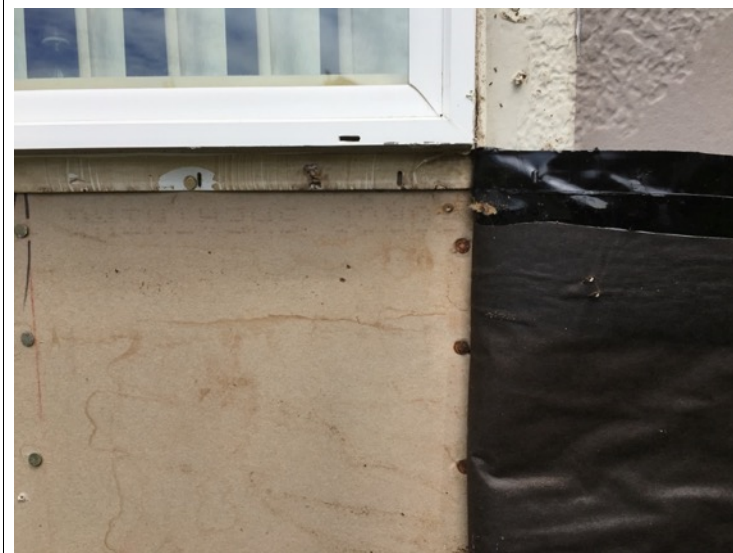
1.8.6

Reverse lap of flexible flashing at mounting flange sill.

*Condition negates incidental water egress and facilitates moisture accumulation within the exterior wall assembly.*
