# VINTAGE OAKS HOA

## BUILDING ENVELOPE INVESTIGATION

PREPARED FOR:  
VINTAGE OAKS HOA BOARD

REPORT DATE:  
5.25.2017

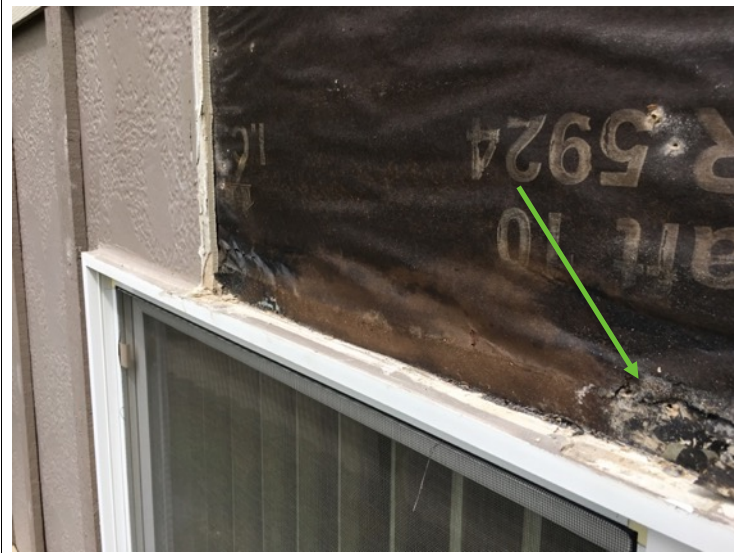
1.8.9

Deteriorated WRB. Fungal growth observed emanating from WRB.

*Damage results from sustained moisture absorption water leakage and/or moisture accumulation within the exterior wall assembly.*

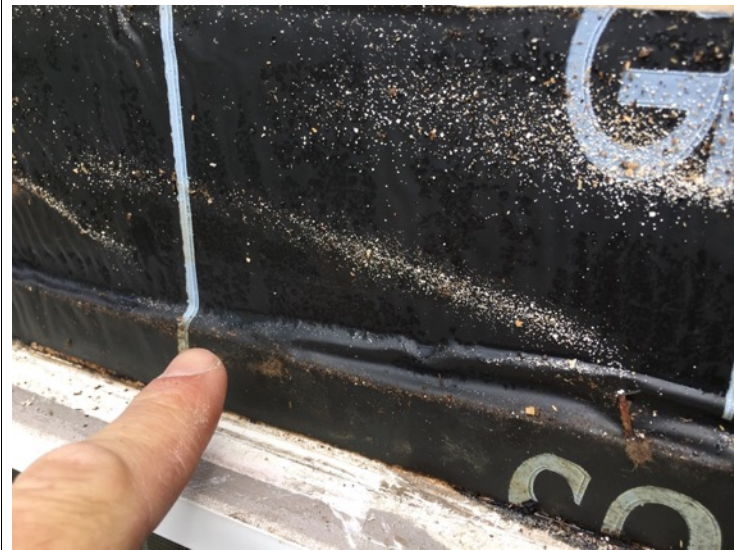
1.8.10

Moisture accumulation observed between WRB and flexible flashing.

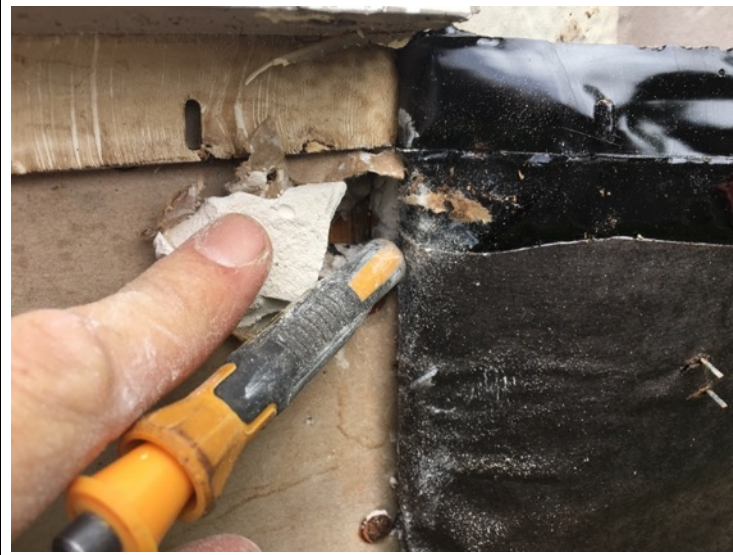
1.8.13

Demonstration of deteriorated gypsum sheathing. Corroded fasteners observed.

*Damage results from sustained moisture absorption by exterior wall assembly components and/or moisture accumulation within exterior wall assembly.*

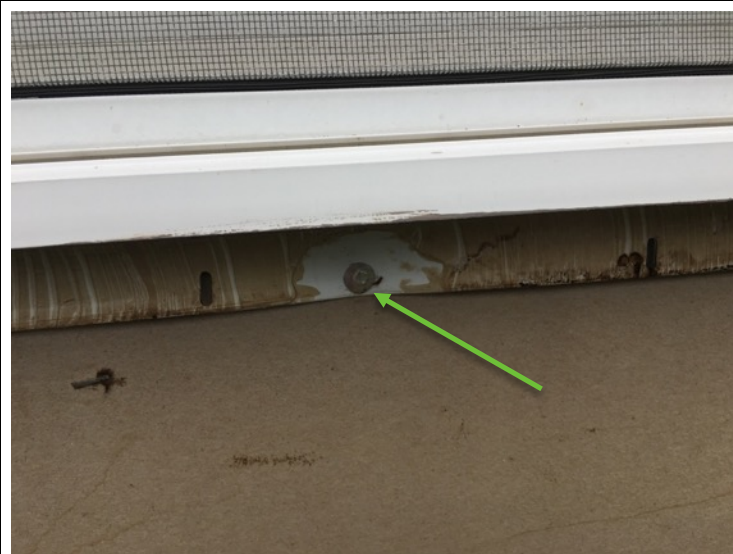
1.8.14

Improper installation of window assembly: fasteners not installed through pre-punched slots in mounting flange.

*Condition may distort window frame and not allow for accommodation of thermal movement of the window assembly.*

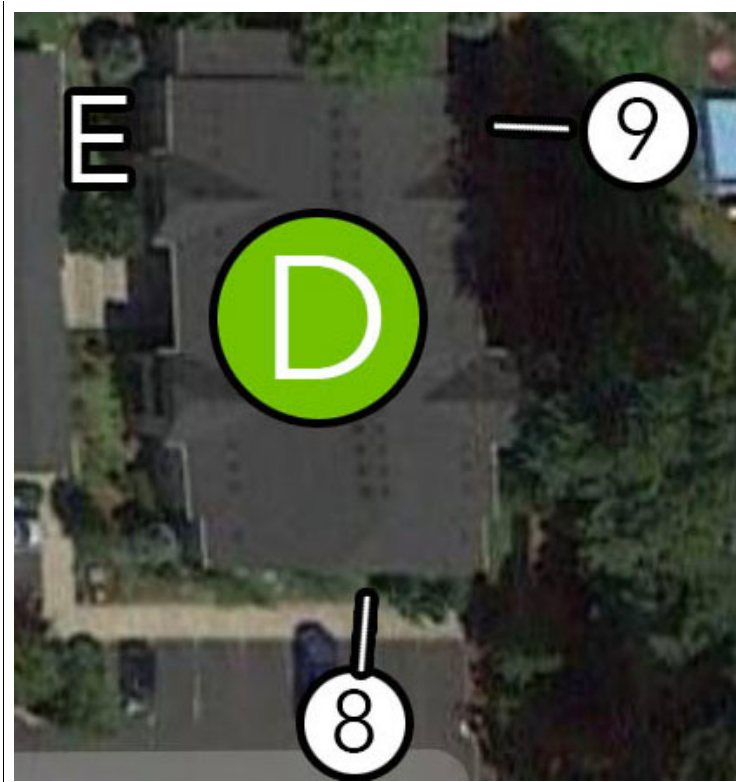
1.9.1

Exploratory Opening 9.  
Building D, East Elevation,  
2<sup>nd</sup> Story Deck Assembly.

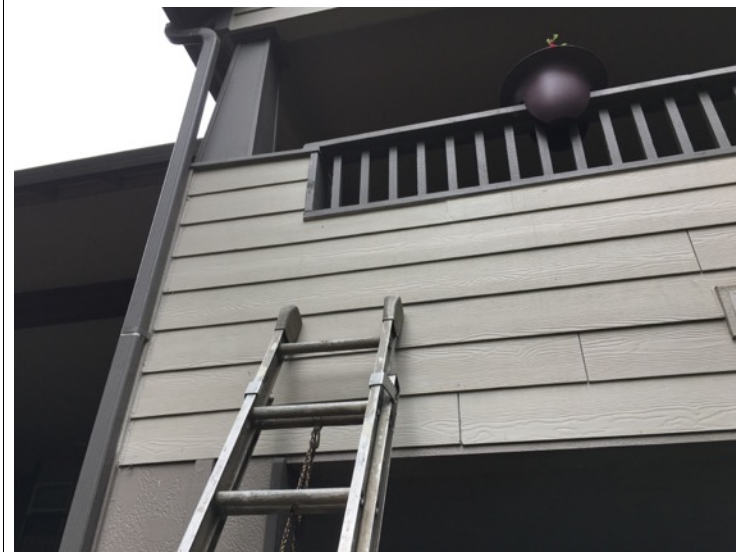
1.9.2

Exploratory Opening 9.  
Building D, East Elevation,  
2<sup>nd</sup> Story Deck Assembly.

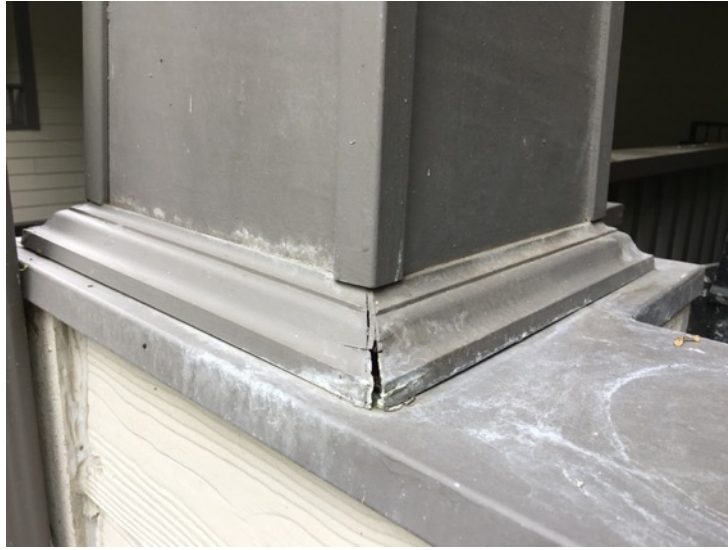
1.9.3

Trim and sealant failure at base of column assembly.

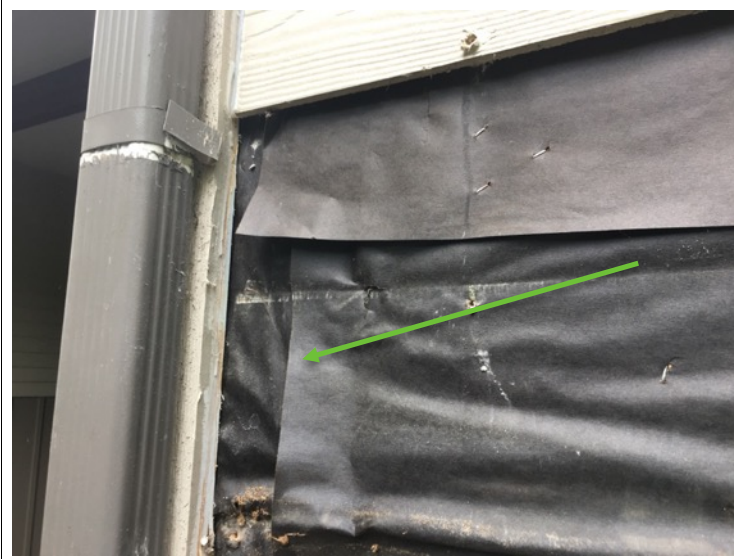
1.9.5

Improper installation of WRB. WRB should fully wrap corners of the underlying wall assembly.

*Condition fails to provide adequate incidental water protection for the underlying exterior wall assembly components.*

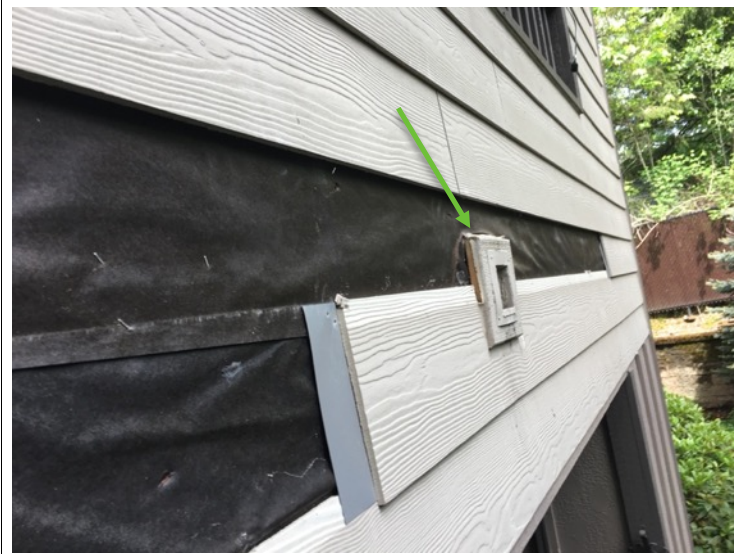
1.9.6

Omitted metal flashing atop projecting wood trim.

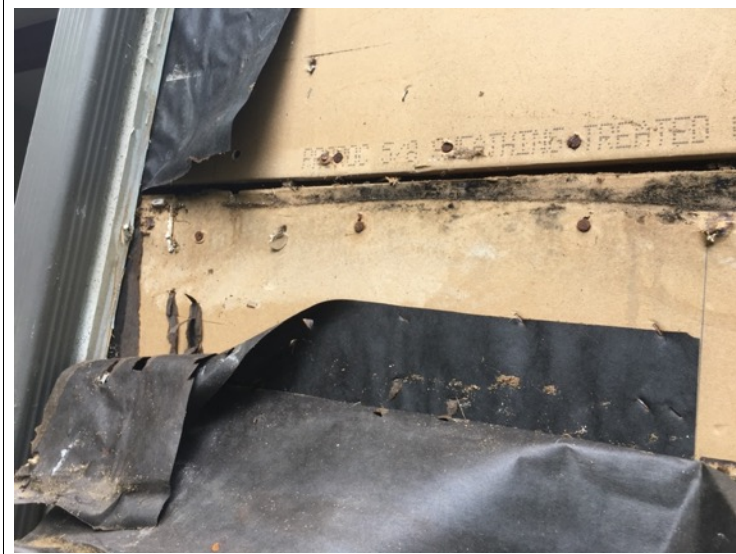
1.9.8

Moisture staining, microbial growth observed on gypsum sheathing. Corroded fasteners observed.

*Damage results from sustained moisture absorption by exterior wall assembly components and/or moisture accumulation within exterior wall assembly.*

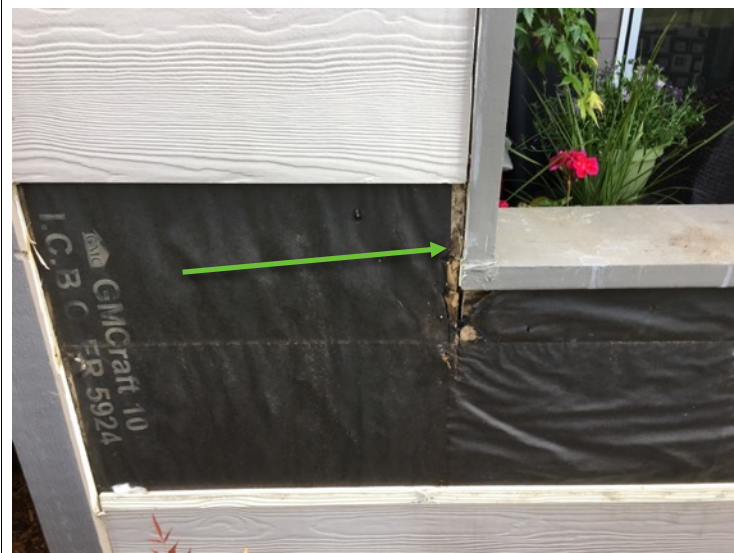
1.10.4

Discontinuous WRB. Omitted isometric saddle flashing. Omitted metal and/or flexible flashing.

*Condition fails to provide adequate incidental water protection for the underlying exterior wall assembly components.*

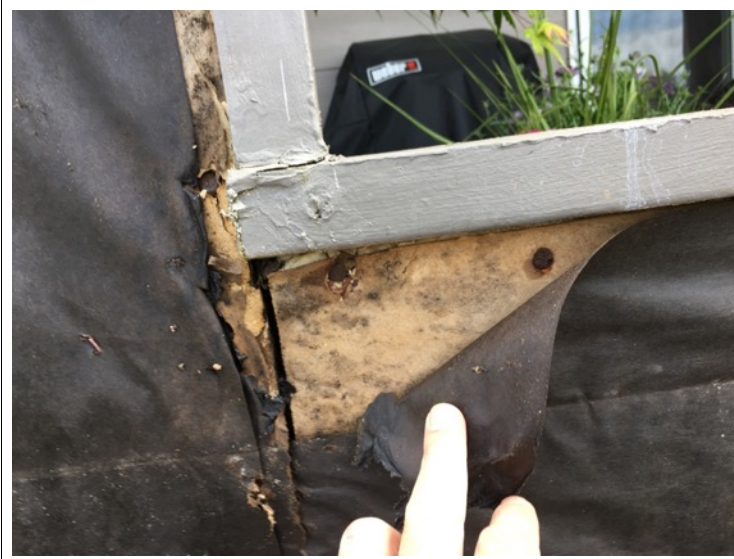
1.10.5

Deteriorated gypsum sheathing.

*Damage results from sustained moisture absorption by exterior wall assembly components and/or moisture accumulation within exterior wall assembly.*

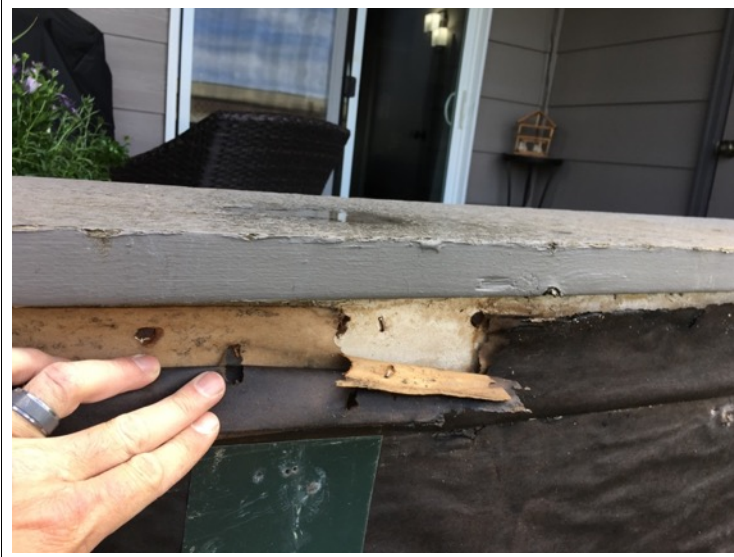
1.10.6

Deteriorated gypsum sheathing.

*Damage results from sustained moisture absorption by exterior wall assembly components and/or moisture accumulation within exterior wall assembly.*

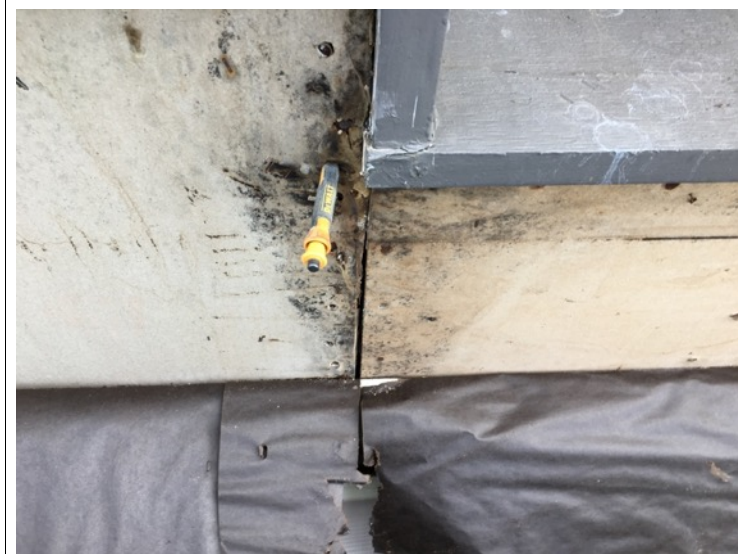
1.10.8

Demonstration of deteriorated gypsum sheathing.

*Damage results from sustained moisture absorption water leakage and/or moisture accumulation within the exterior wall assembly.*

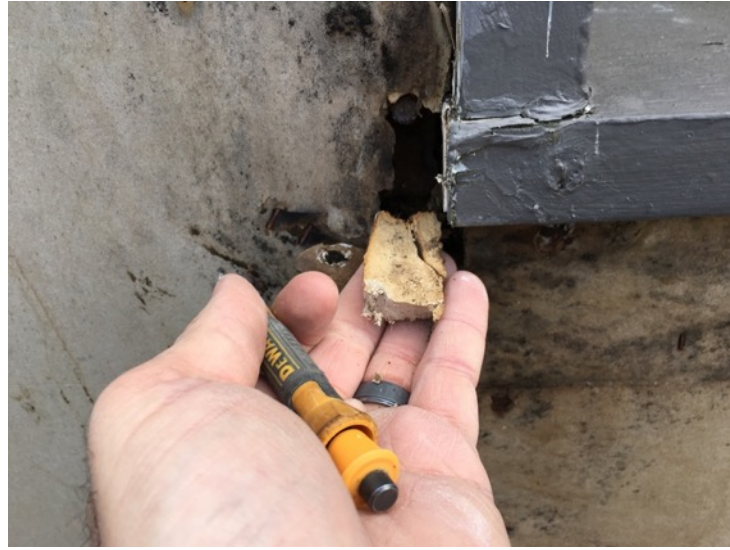
1.10.9

Demonstration of deteriorated gypsum sheathing.

*Damage results from sustained moisture absorption water leakage and/or moisture accumulation within the exterior wall assembly.*

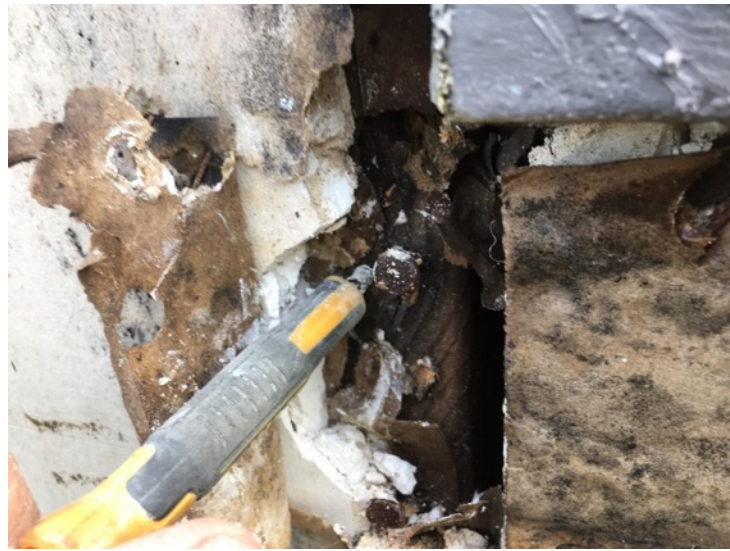
1.10.10

Demonstration of deteriorated framing member.

*Damage results from sustained moisture absorption water leakage and/or moisture accumulation within the exterior wall assembly.*

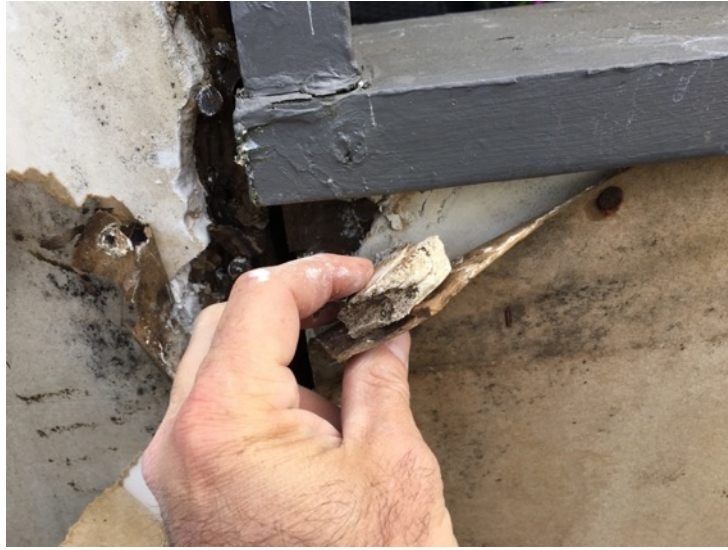
1.10.11 Demonstration of deteriorated gypsum sheathing.

*Damage results from sustained moisture absorption water leakage and/or moisture accumulation within the exterior wall assembly.*

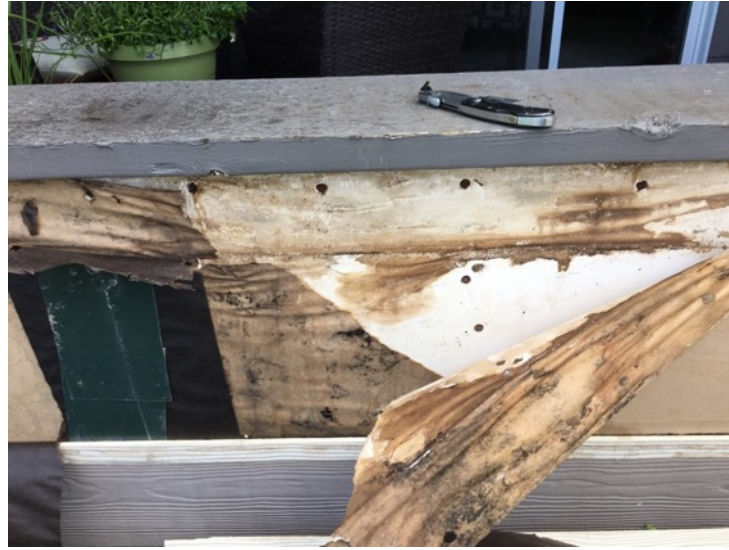
1.10.13 Deteriorated gypsum sheathing.

*Damage results from sustained moisture absorption water leakage and/or moisture accumulation within the exterior wall assembly.*

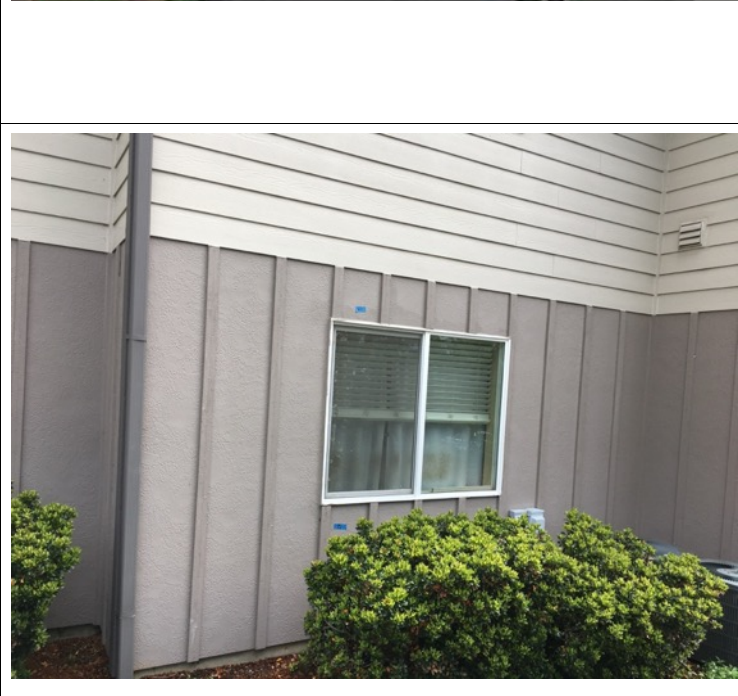
<p>1.11.2 Exploratory Opening 11. Building F, West Elevation, 1st Story Window.</p>

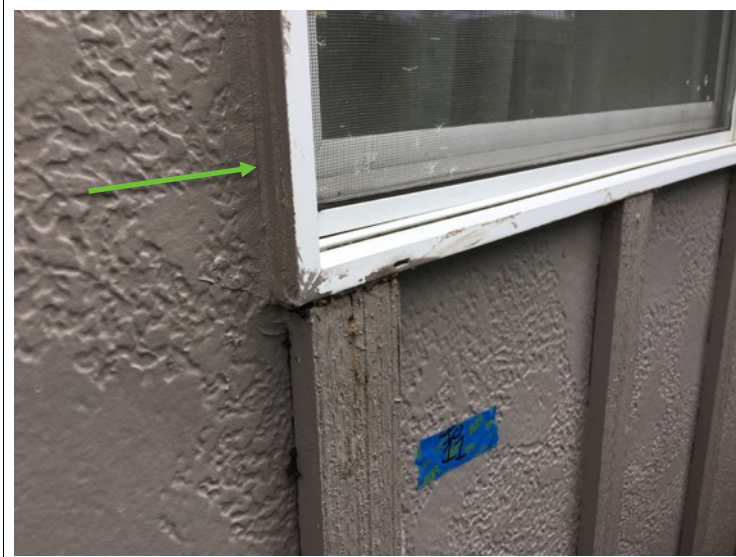
1.11.3

Omitted dynamic sealant joint between window frame and fiber cement panel.

*Condition fails to accommodate thermal movement of vinyl window assembly.*

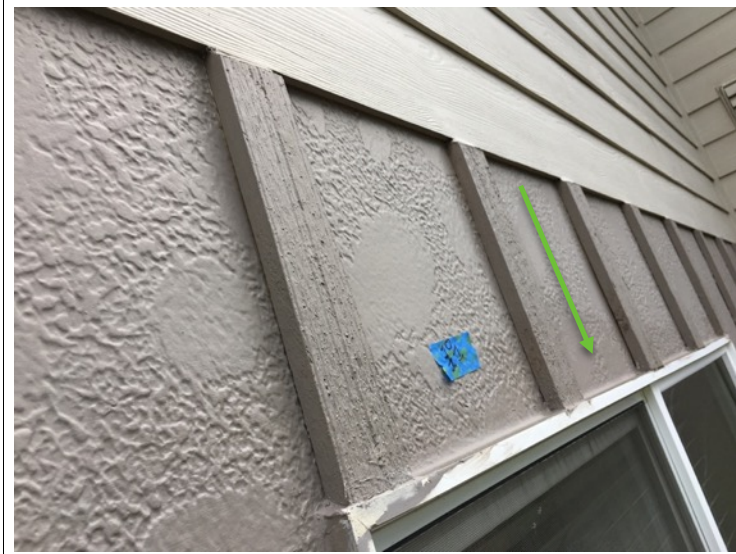
1.11.4

Omitted egress at horizontal siding termination.

*Condition negates incidental water egress and facilitates moisture accumulation within the exterior wall assembly.*

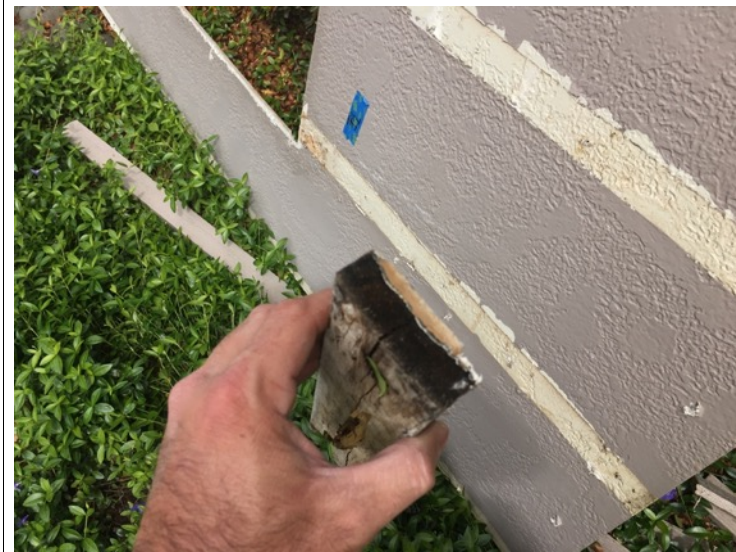
1.11.6

Unprimed field cut edges of wood trim member.

*Condition facilitates moisture absorption and premature deterioration of trim members.*

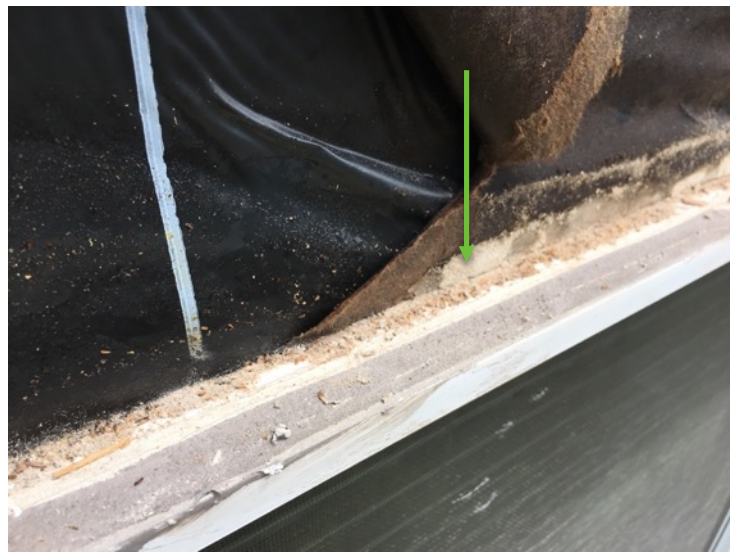
1.11.8

Improper installation of WRB. WRB is tucked inside window frame.

*Condition impedes incidental water egress and facilitates moisture accumulation within exterior wall assembly.*

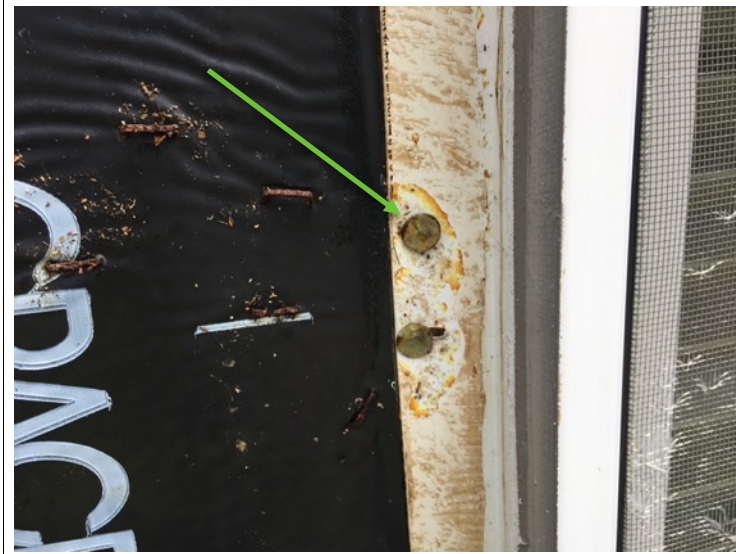
1.11.12 Improper installation of window assembly: fasteners not installed through pre-punched slots in mounting flange.

*Condition may distort window frame and not allow for accommodation of thermal movement of the window assembly.*

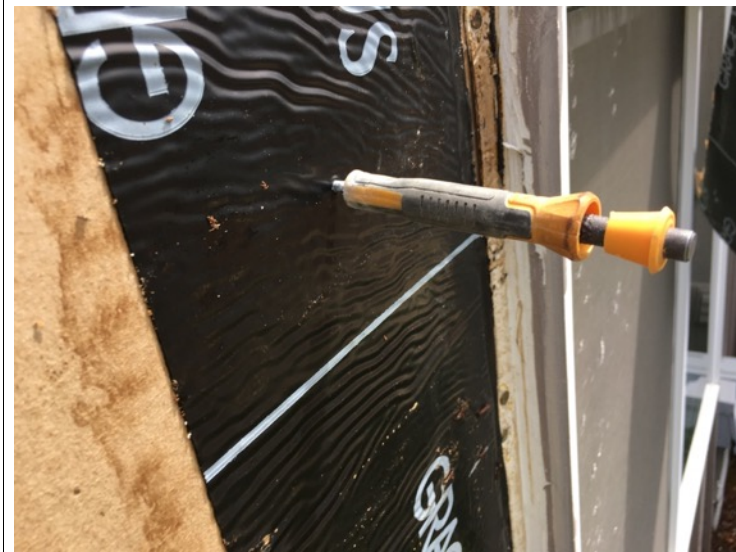
1.11.14 Demonstration of deteriorated gypsum sheathing.

*Damage results from sustained moisture absorption water leakage and/or moisture accumulation within the exterior wall assembly.*

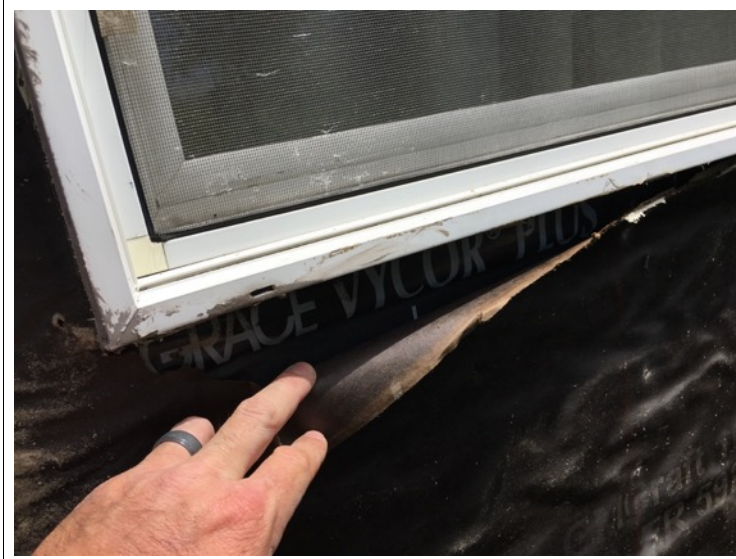
1.11.15

Reverse lap of WRB and flexible flashing at mounting flange sill.

*Condition negates incidental water egress and facilitates moisture accumulation within the exterior wall assembly.*

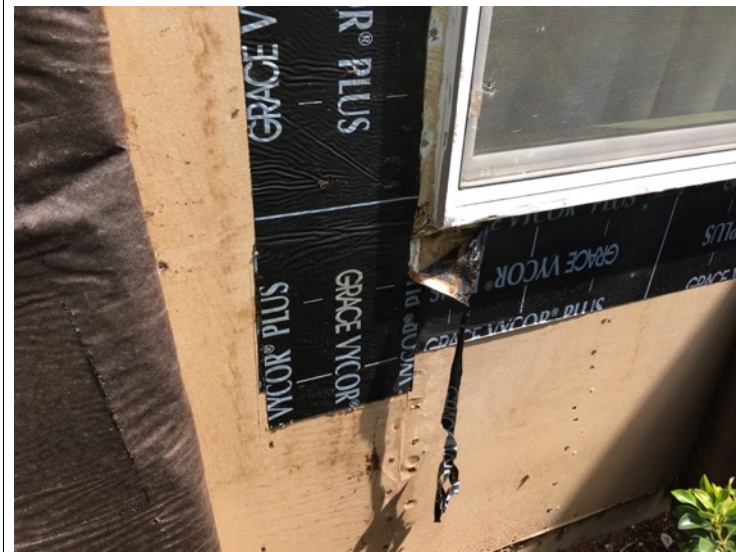
1.11.16

Reverse lap of WRB and flexible flashing at mounting flange sill.

*Condition negates incidental water egress and facilitates moisture accumulation within the exterior wall assembly.*

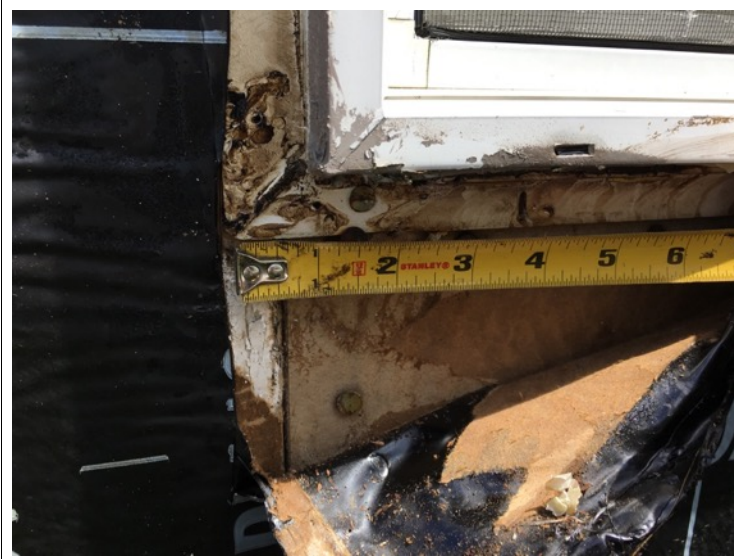
1.11.17 Improper installation of window assembly: fasteners not installed through pre-punched slots in mounting flange. Fastener installed within 3" of window corner.

*Condition may distort window frame and not allow for accommodation of thermal movement of the window assembly.*

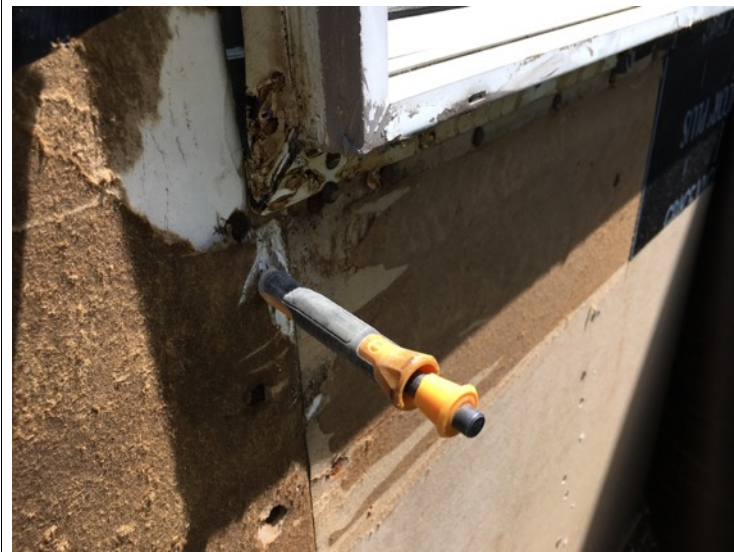
1.11.18 Demonstration of deteriorated gypsum sheathing.

*Damage results from sustained moisture absorption water leakage and/or moisture accumulation within the exterior wall assembly.*

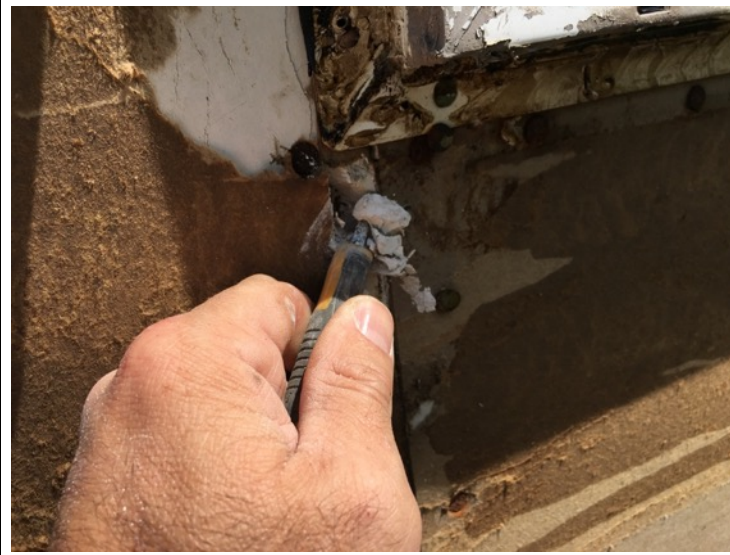
1.11.19

Demonstration of deteriorated gypsum sheathing.

*Damage results from sustained moisture absorption water leakage and/or moisture accumulation within the exterior wall assembly.*

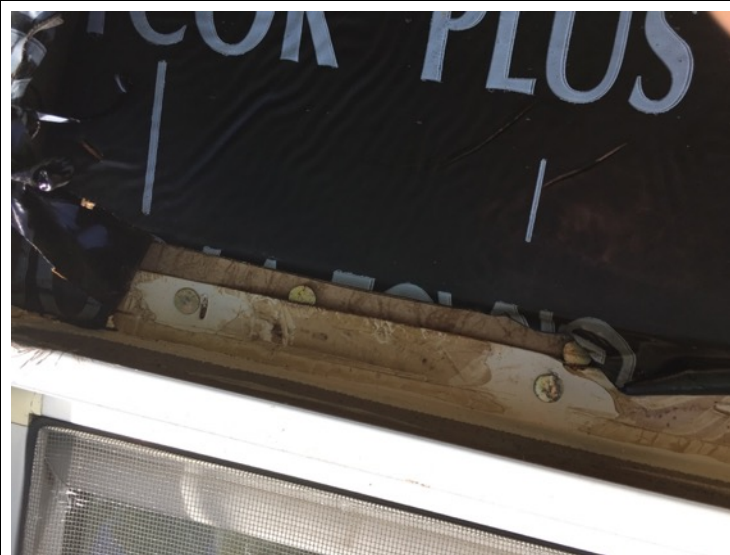
1.11.20

Improper installation of window assembly: fasteners not installed through pre-punched slots in mounting flange.

*Condition may distort window frame and not allow for accommodation of thermal movement of the window assembly.*

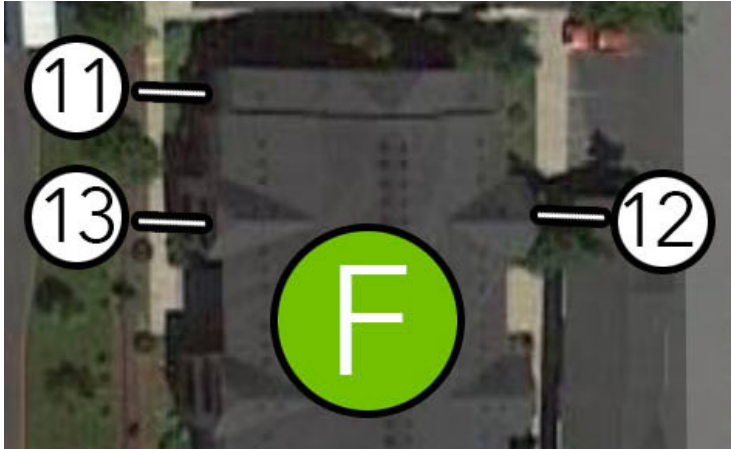
<p>1.12.1 Exploratory Opening 12. Building F, East Elevation, 2<sup>nd</sup> Story Deck.</p>

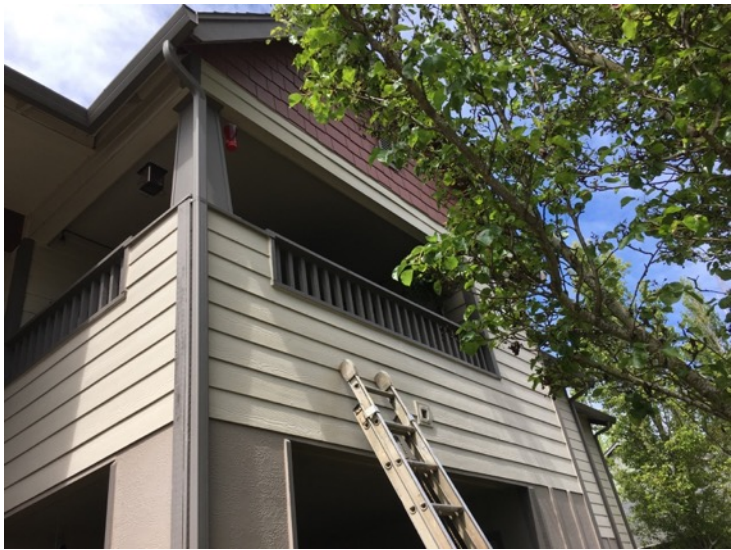
<p>1.12.2 Exploratory Opening 12. Building F, East Elevation, 2<sup>nd</sup> Story Deck.</p>

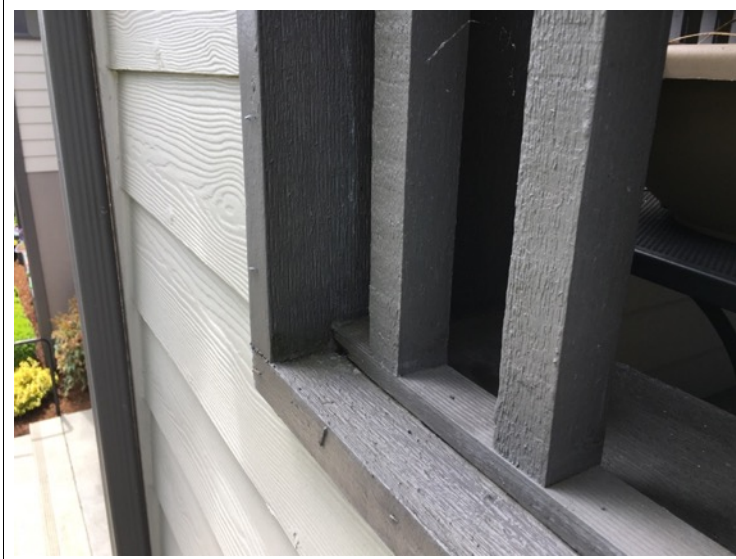
1.12.3

Omitted isometric saddle flashing.

*Condition does not adequately protect underlying wall assembly components from water infiltration.*

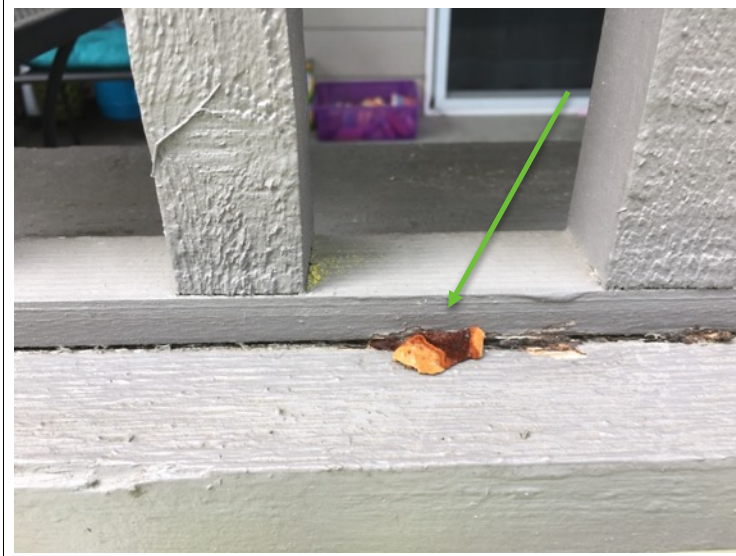
1.12.4

Fungal growth observed emanating from wall assembly components.

*Condition negates incidental water egress and facilitates moisture accumulation within the exterior wall assembly.*

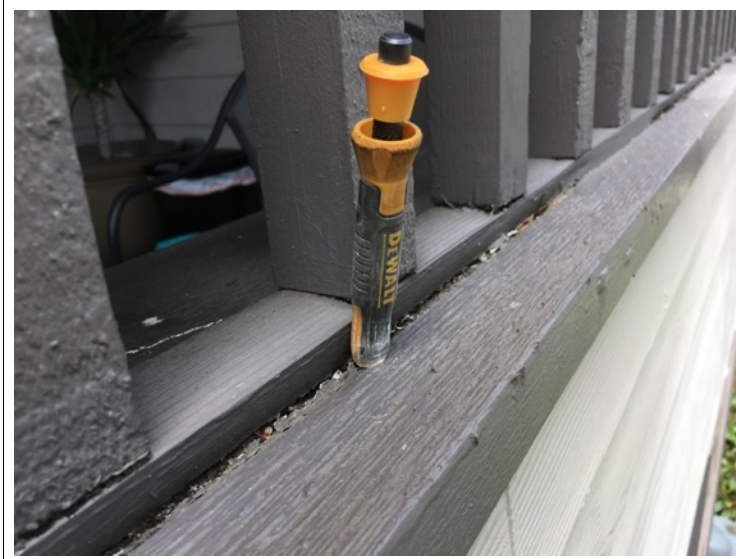
1.12.5

Demonstration of deteriorated wall assembly components.

*Damage results from sustained moisture absorption water leakage and/or moisture accumulation within the exterior wall assembly.*

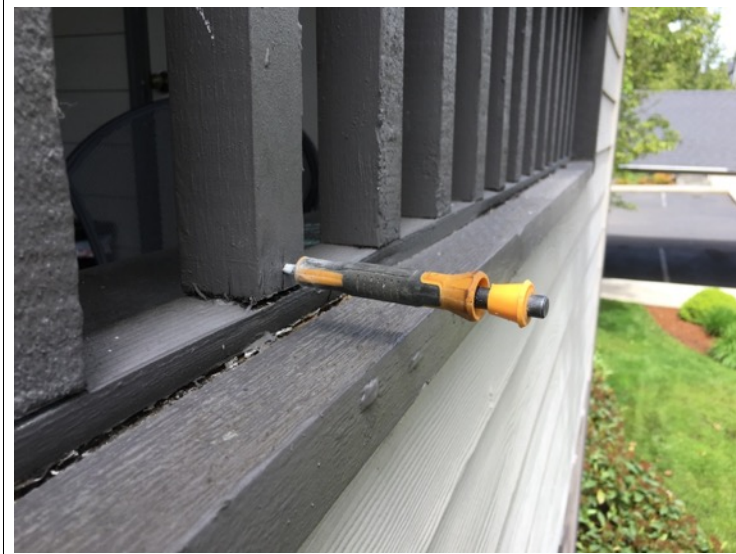
1.12.6

Demonstration of deteriorated wall assembly components.

*Damage results from sustained moisture absorption water leakage and/or moisture accumulation within the exterior wall assembly.*

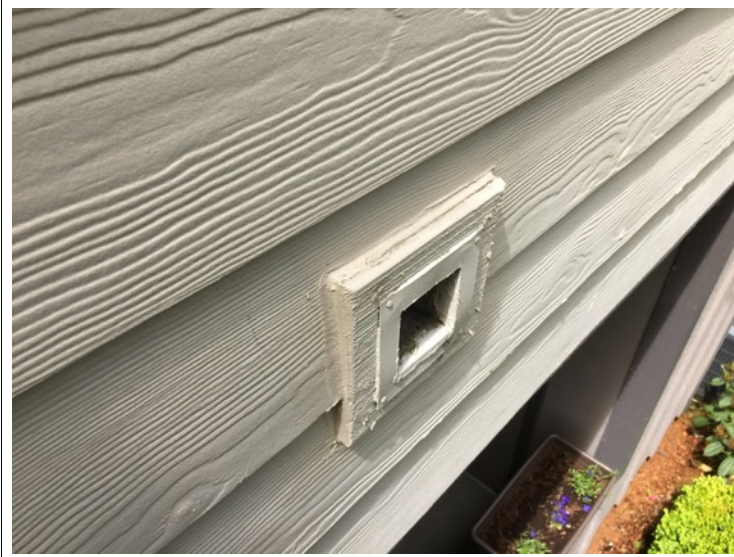
1.12.7

Omitted flashing atop projecting wood trim.

*Condition facilitates moisture absorption and premature deterioration of unprotected trim members.*

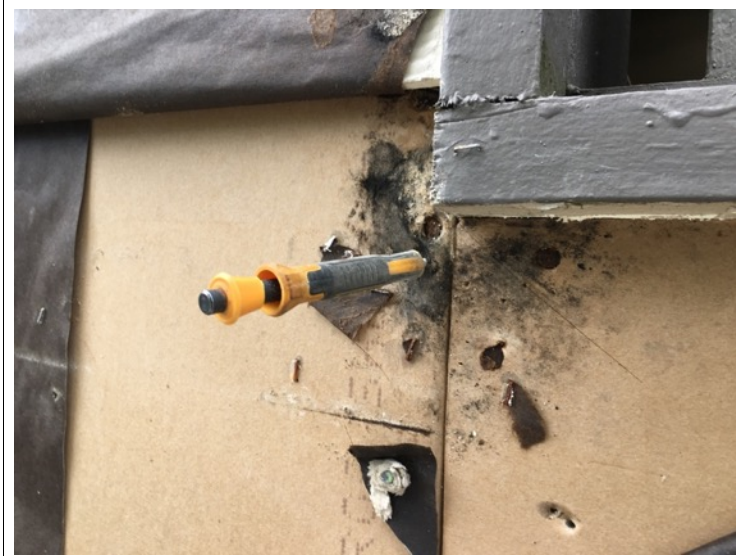
1.12.12 Demonstration of deteriorated wall assembly components.

*Damage results from sustained moisture absorption water leakage and/or moisture accumulation within the exterior wall assembly.*

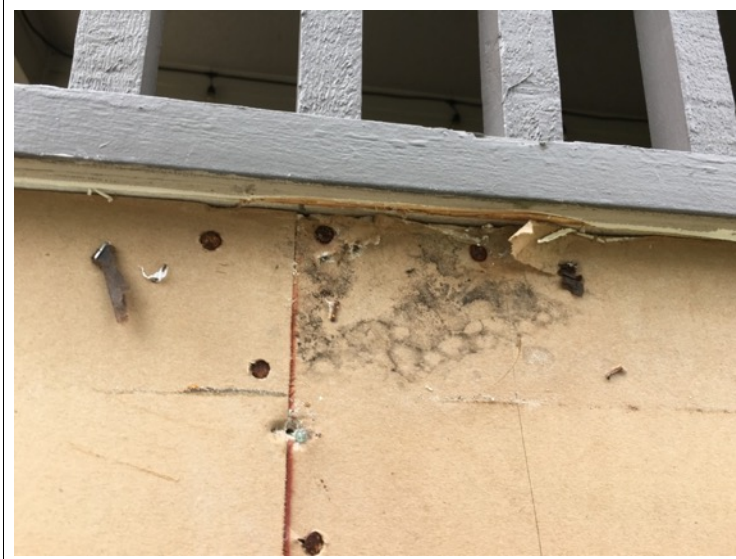
1.12.13

Deteriorated gypsum sheathing. Microbial growth, water staining and corroded fasteners observed.

*Damage results from sustained moisture absorption water leakage and/or moisture accumulation within the exterior wall assembly.*

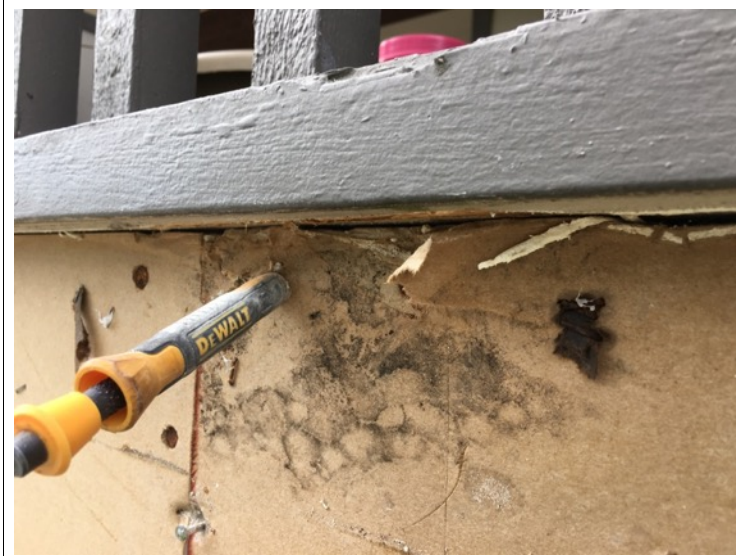
1.12.14

Demonstration of deteriorated wall assembly components.

*Damage results from sustained moisture absorption water leakage and/or moisture accumulation within the exterior wall assembly.*

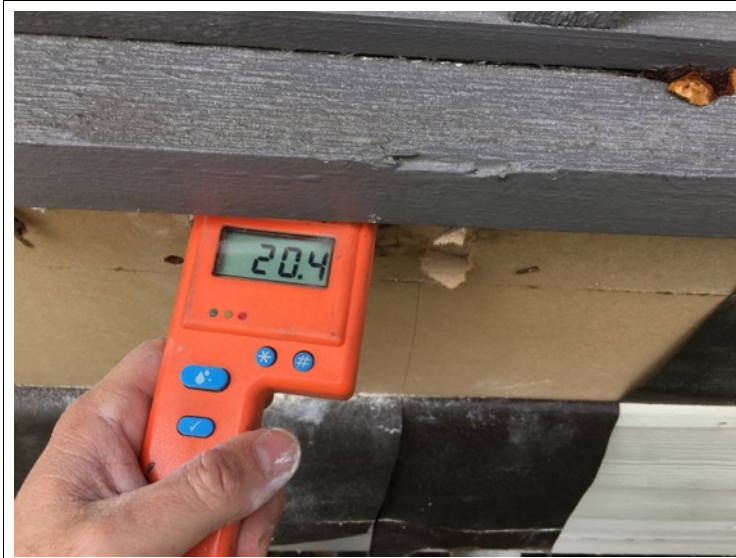
1.12.16 Elevated moisture content (40%) of framing member.

*Damage results from sustained moisture absorption by exterior wall assembly components and/or moisture accumulation within exterior wall assembly.*

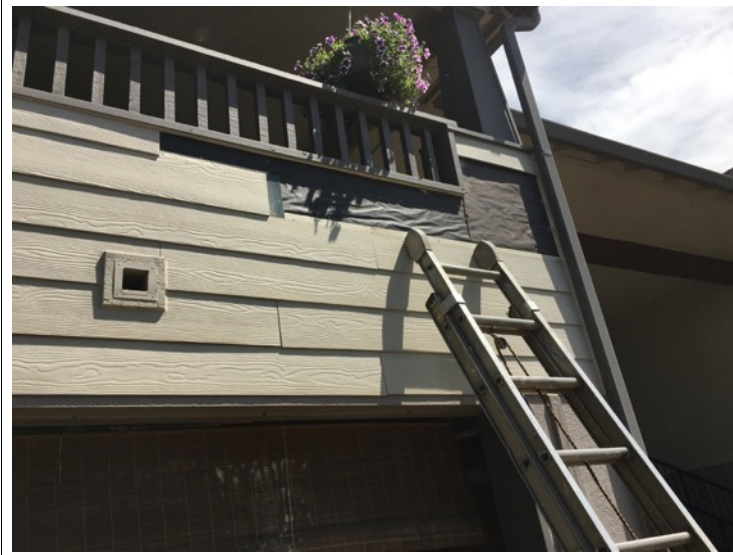
1.13.3

Picture of exploratory opening after cladding had ben removed.

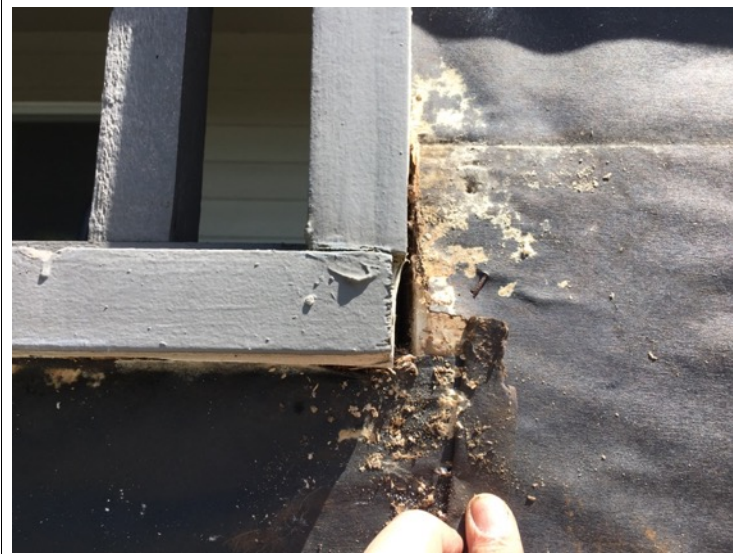
1.13.4

Omitted WRB and flexible flashing atop exterior wall assembly.

Fungal growth and deteriorated WRB observed.

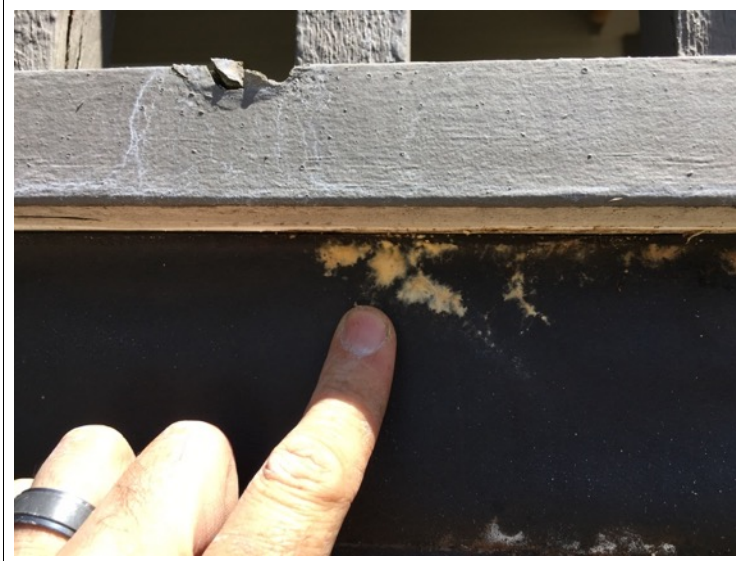
1.13.5

Fungal growth and deteriorated WRB observed.

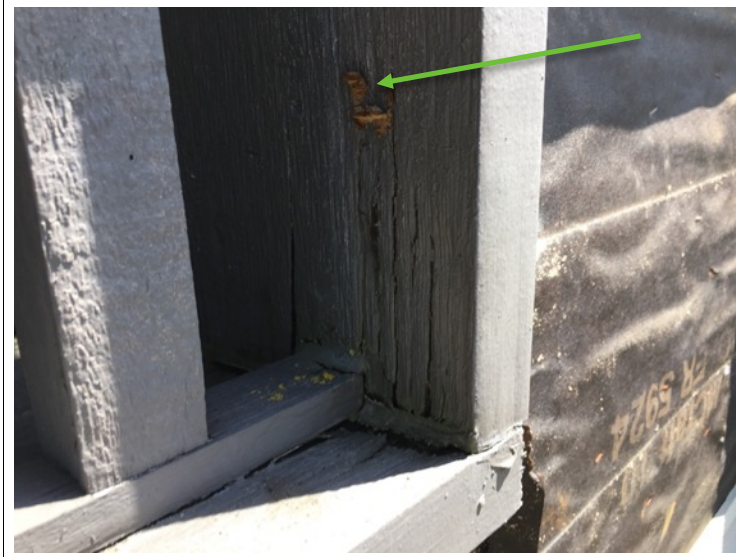
1.13.6

Fungal growth observed emanating from exterior wall assembly components.

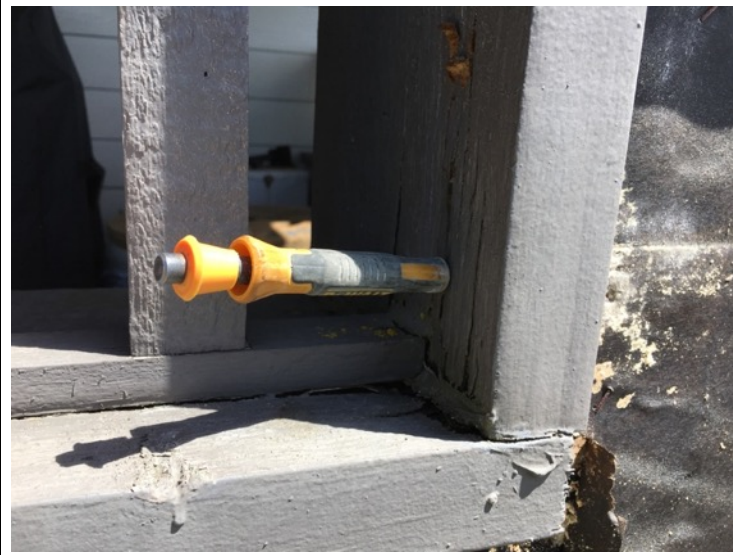
1.13.7

Demonstration of deteriorated wall assembly components.

*Damage results from sustained moisture absorption water leakage and/or moisture accumulation within the exterior wall assembly.*

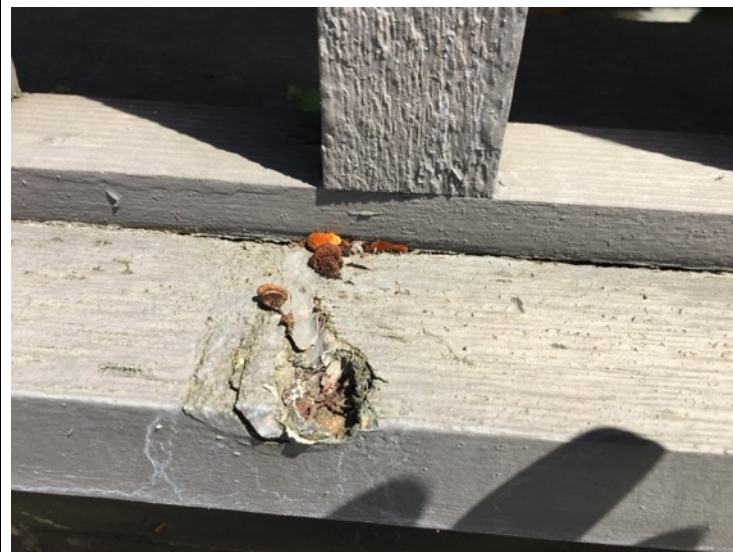
1.13.8

Fungal growth observed emanating from exterior wall assembly components.

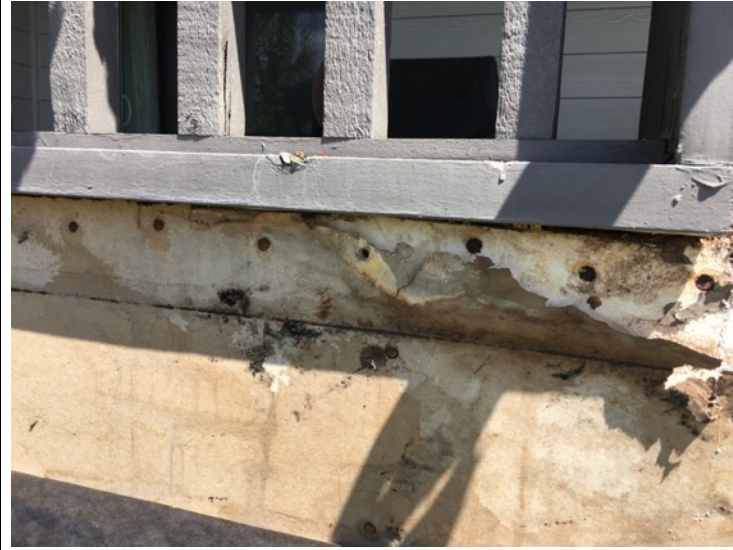
1.13.11 Deteriorated gypsum sheathing.

*Damage results from sustained moisture absorption water leakage and/or moisture accumulation within the exterior wall assembly.*

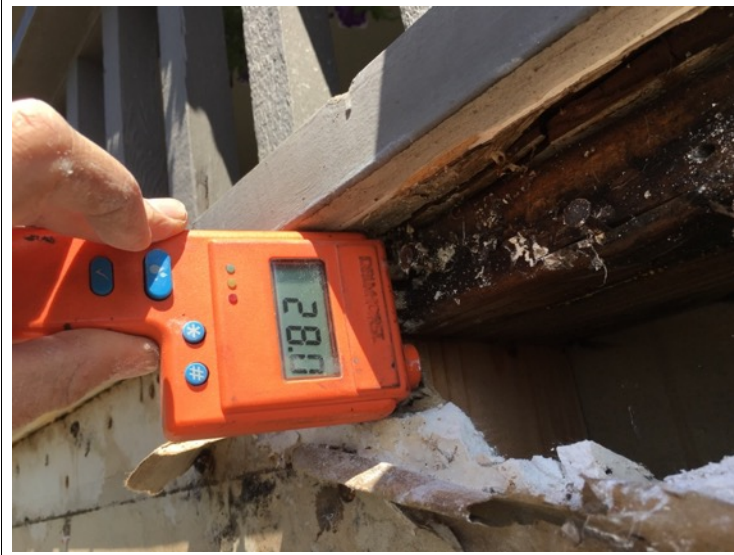
1.13.17 Elevated moisture content (28%) of framing member.

*Damage results from sustained moisture absorption by exterior wall assembly components and/or moisture accumulation within exterior wall assembly.*
