# VINTAGE OAKS HOA

## BUILDING ENVELOPE INVESTIGATION

PREPARED FOR:  
VINTAGE OAKS HOA BOARD

REPORT DATE:  
5.25.2017

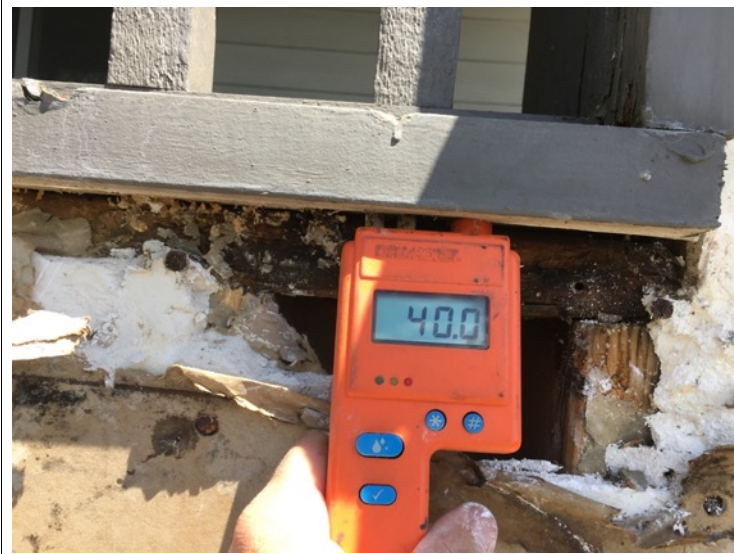
1.13.18 Elevated moisture content (40%) of wood trim.

*Damage results from sustained moisture absorption by exterior wall assembly components and/or moisture accumulation within exterior wall assembly.*

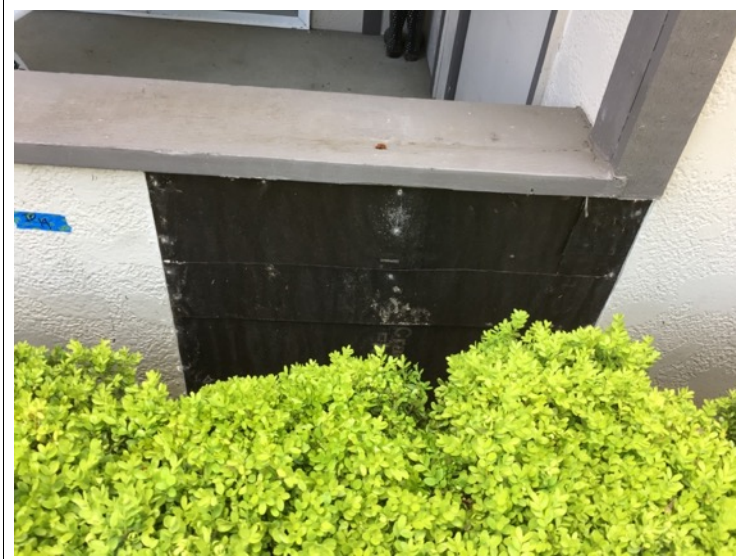
1.14.3

Picture of exploratory opening after cladding had been removed.

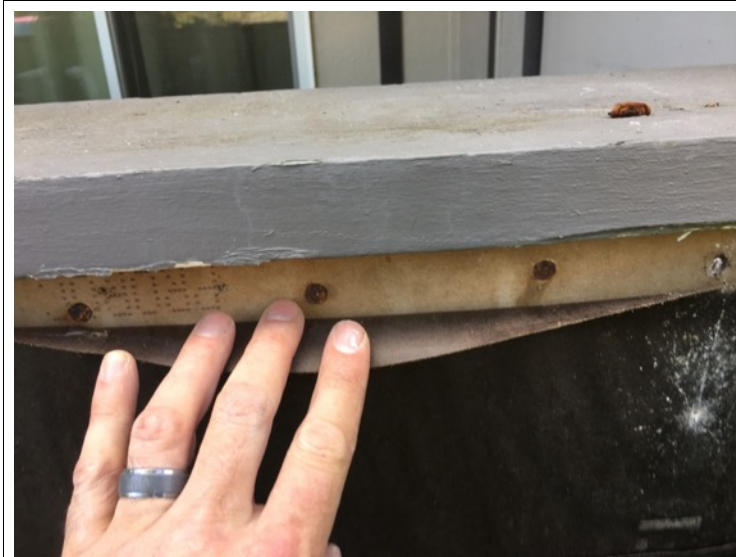
1.14.4

Discontinuous WRB and omitted flexible flashing atop exterior wall assembly.

Fungal growth and deteriorated WRB observed.

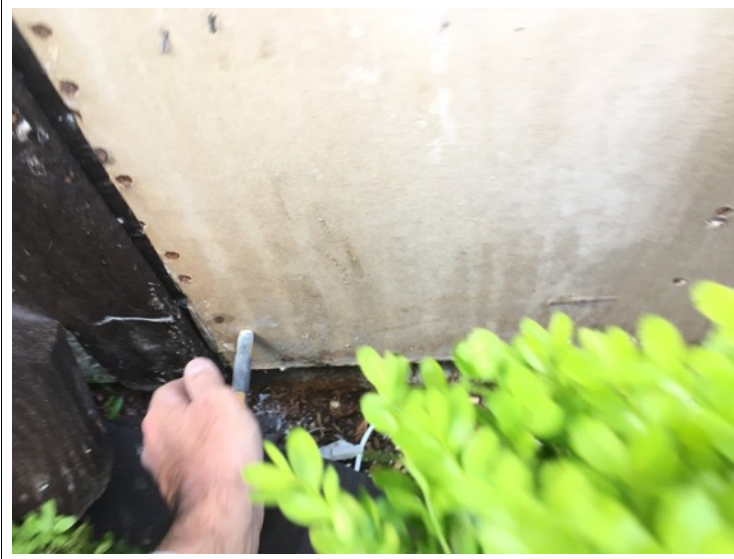
1.14.7

Demonstration of deteriorated gypsum sheathing.

*Damage results from sustained moisture absorption water leakage and/or moisture accumulation within the exterior wall assembly.*

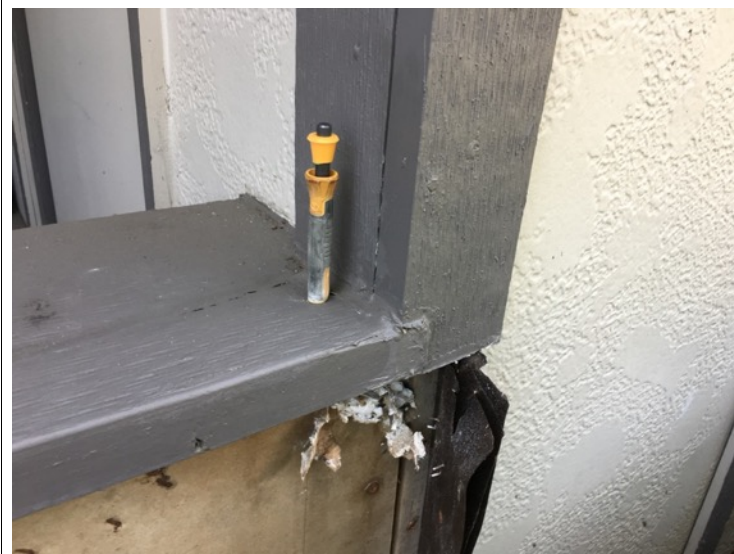
1.14.8

Demonstration of deteriorated wood trim.

*Damage results from sustained moisture absorption water leakage and/or moisture accumulation within the exterior wall assembly.*

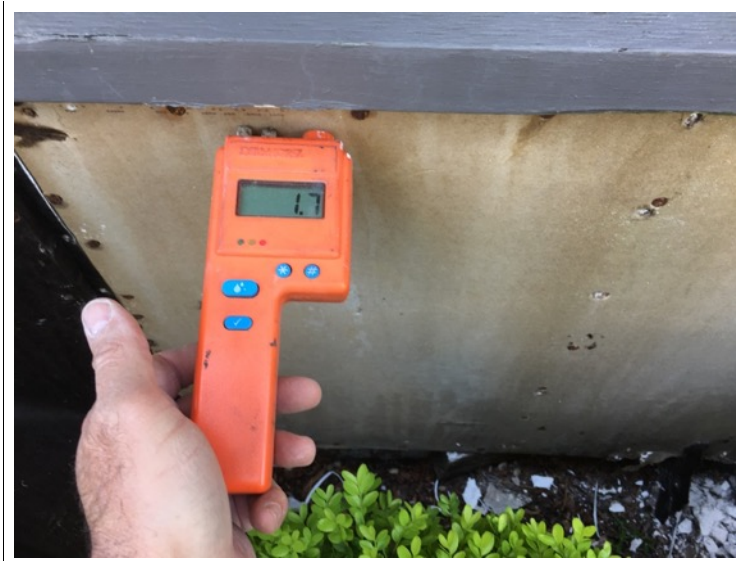
1.14.9

Elevated moisture content (1.7%) of gypsum sheathing.

*Damage results from sustained moisture absorption by exterior wall assembly components and/or moisture accumulation within exterior wall assembly.*

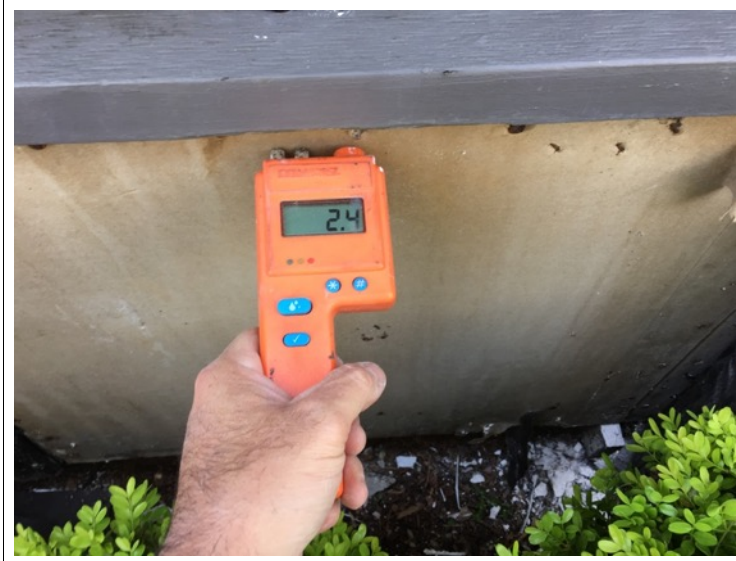
1.14.10

Elevated moisture content (2.4%) of gypsum sheathing.

*Damage results from sustained moisture absorption by exterior wall assembly components and/or moisture accumulation within exterior wall assembly.*

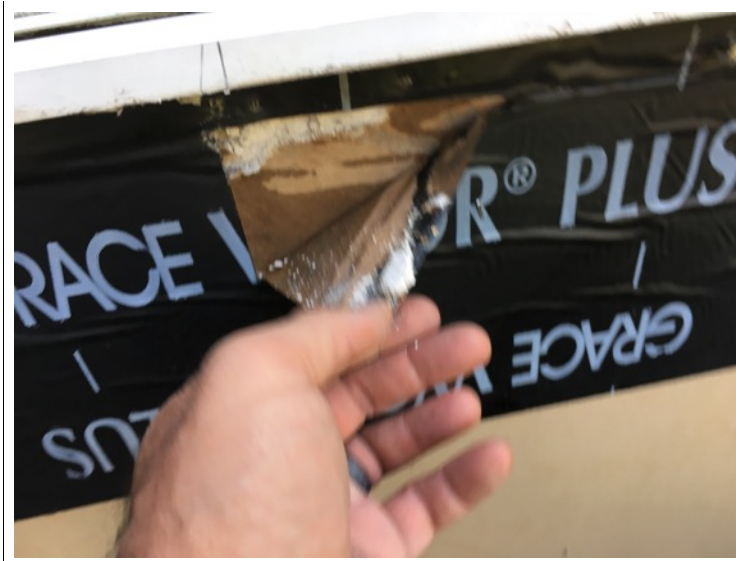
1.15.5

Deteriorated gypsum sheathing.

*Damage results from sustained moisture absorption water leakage and/or moisture accumulation within the exterior wall assembly.*

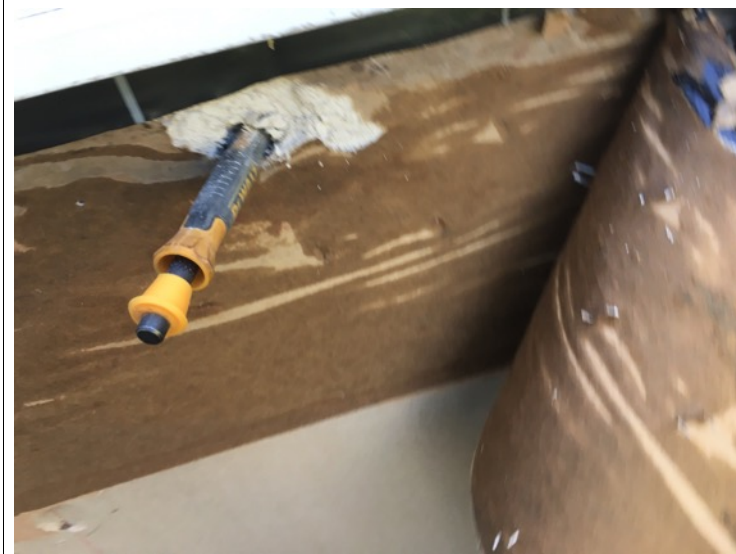
1.15.6

Demonstration of deteriorated gypsum sheathing.

*Damage results from sustained moisture absorption water leakage and/or moisture accumulation within the exterior wall assembly.*

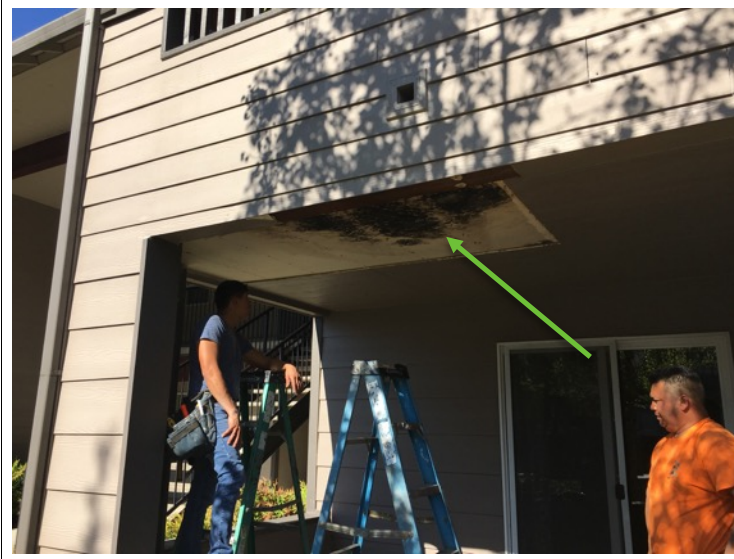
1.16.3

Picture of exploratory opening after plywood soffit had been removed.

Extensive microbial growth observed on underlying gypsum sheathing.

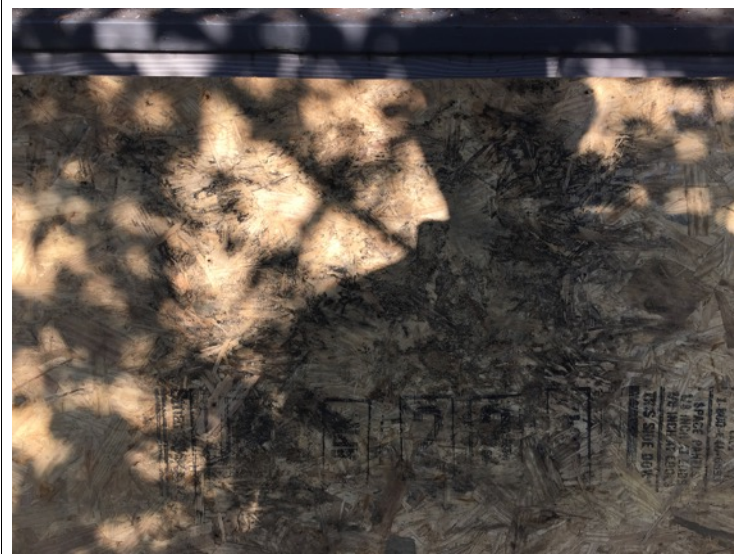
1.16.4

Extensive microbial growth observed on back side of soffit panel.

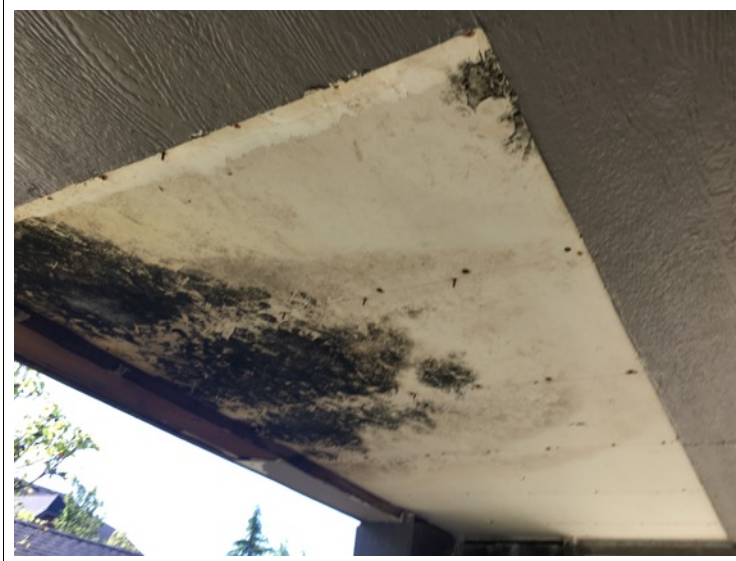
1.16.7

Heavy microbial growth observed on underlying gypsum sheathing in soffit.

*Damage results from sustained moisture to water leakage and/or moisture accumulation within the exterior wall assembly.*

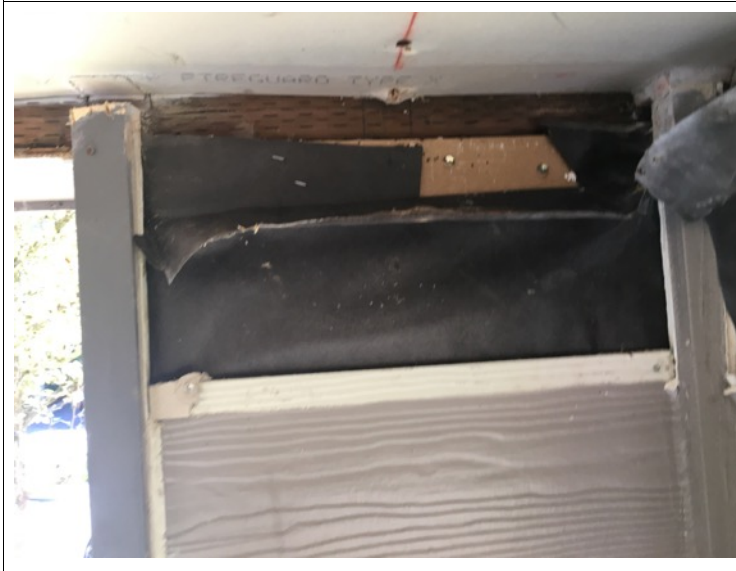
1.16.8

Discontinuous and/or omitted WRB.

*Condition does not allow for adequate protection of underlying wall assembly components from water infiltration and/or moisture accumulation.*

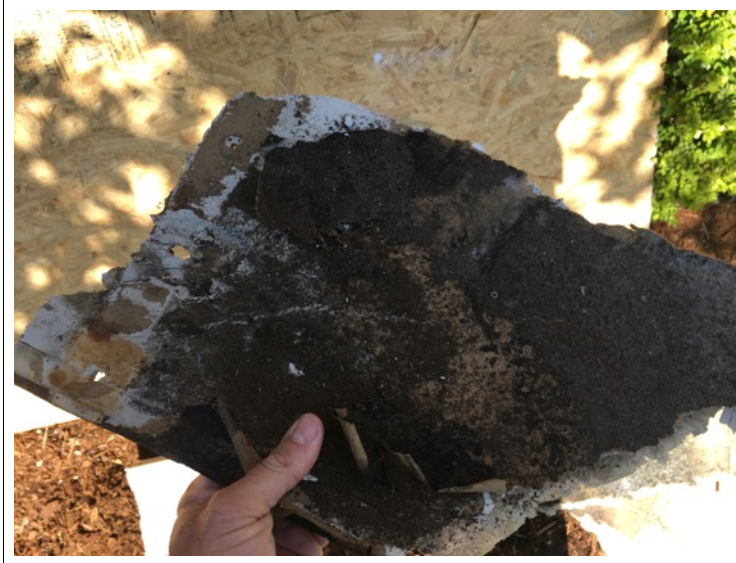
1.16.9

Heavy microbial growth observed on underlying gypsum sheathing in soffit.

*Damage results from sustained moisture to water leakage and/or moisture accumulation within the exterior wall assembly.*

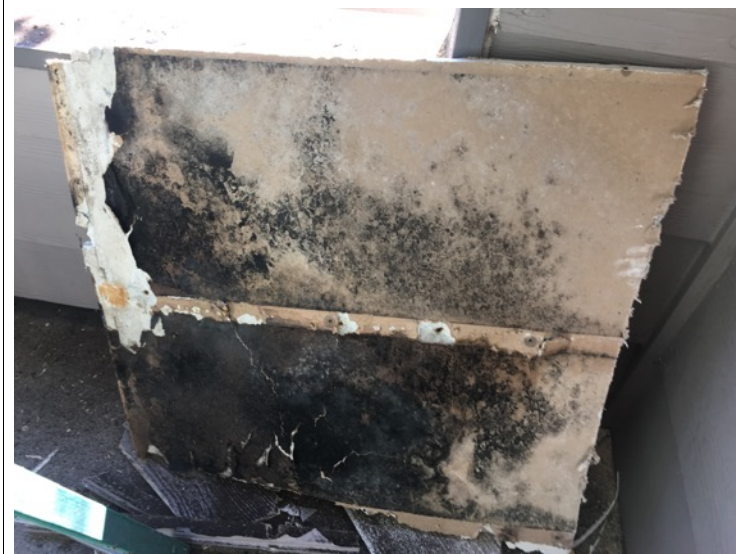
1.16.10

Heavy microbial growth observed on underlying gypsum sheathing in soffit.

*Damage results from sustained moisture to water leakage and/or moisture accumulation within the exterior wall assembly.*

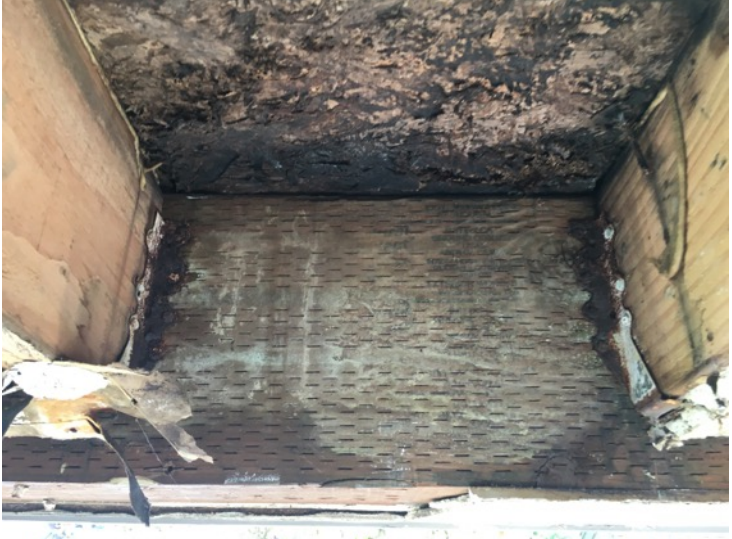
<p>1.16.13 Plywood sheathing which comprises the deck floor substrate is completely deteriorated at the face of the deck.</p> <p><i>Damage results from sustained moisture to water leakage and/or moisture accumulation within the exterior wall assembly.</i></p>

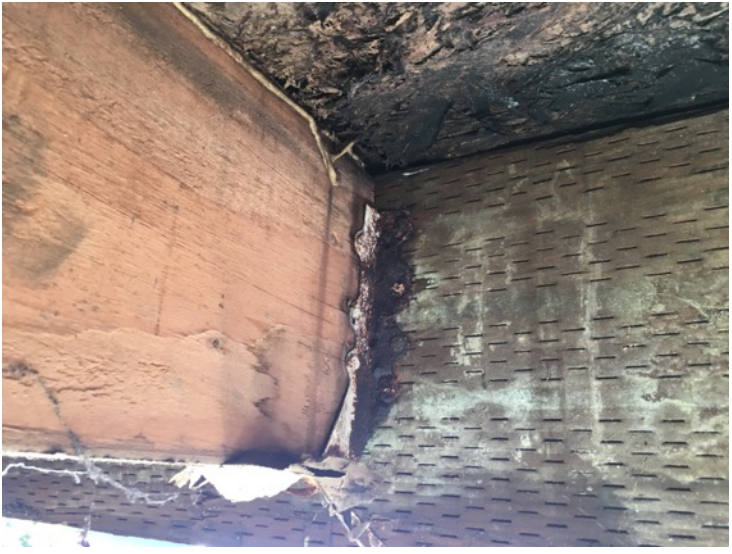
<p>1.16.14 Plywood sheathing which comprises the deck floor substrate is completely deteriorated at the face of the deck.</p> <p><i>Damage results from sustained moisture to water leakage and/or moisture accumulation within the exterior wall assembly.</i></p>

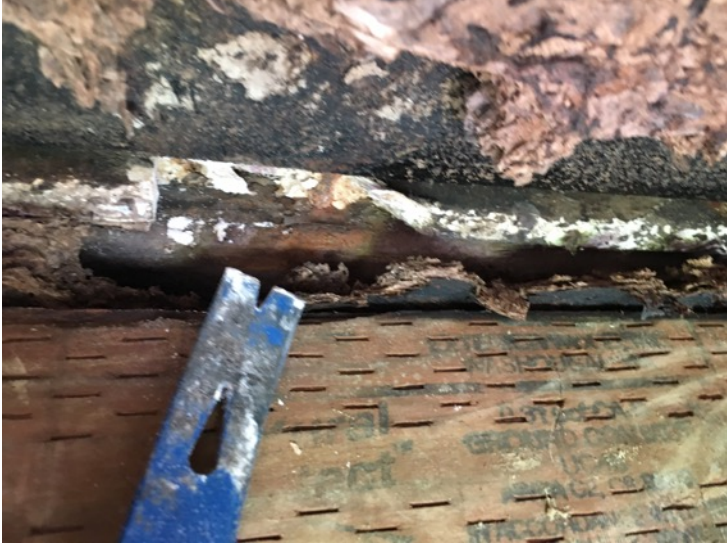
<p>1.16.15 Gypsum sheathing completely deteriorated.</p> <p><i>Damage results from sustained moisture to water leakage and/or moisture accumulation within the exterior wall assembly.</i></p>

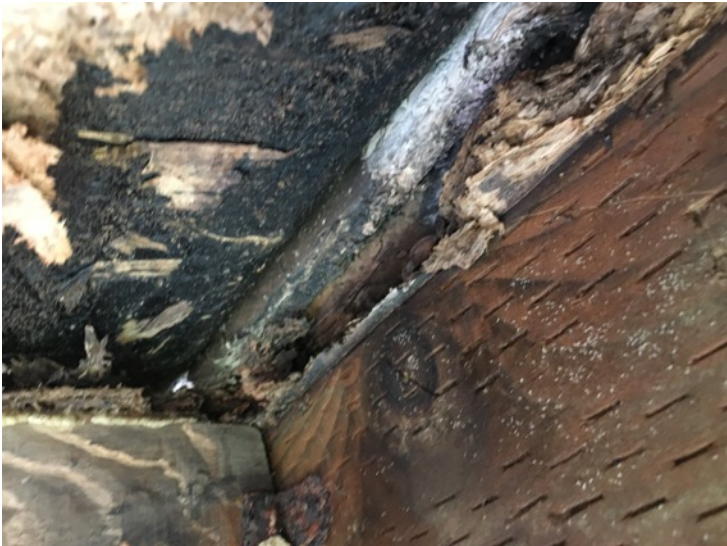
<p>1.16.16 Deck framing members deteriorated.</p> <p><i>Damage results from sustained moisture to water leakage and/or moisture accumulation within the exterior wall assembly.</i></p>

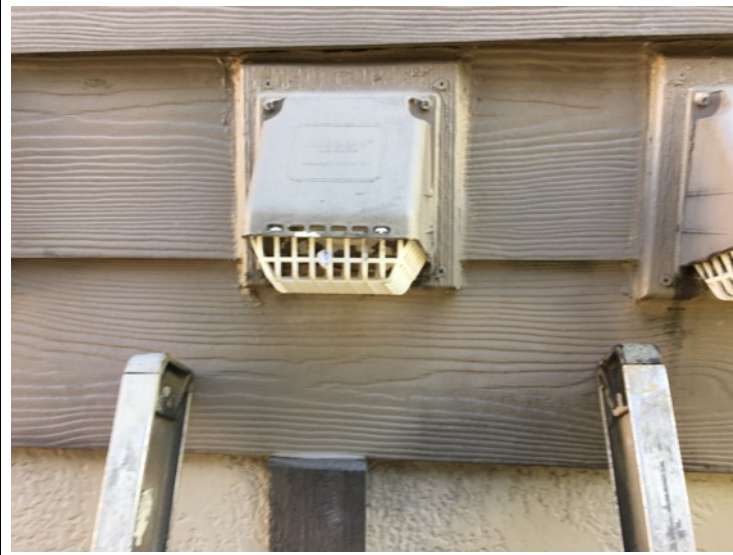
1.17.3

Omitted metal flashing atop projecting wood trim at vent blocks.

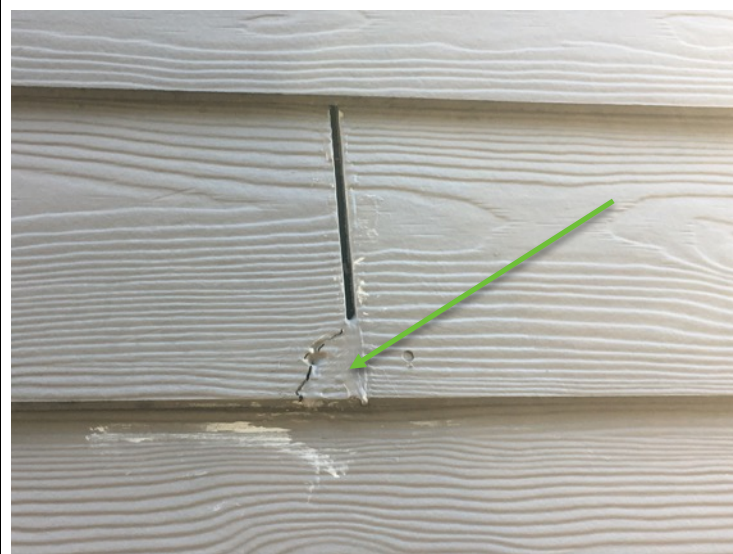
1.17.4

Cracked fiber cement lap siding.

*Damage due to the improper installation of siding material.*

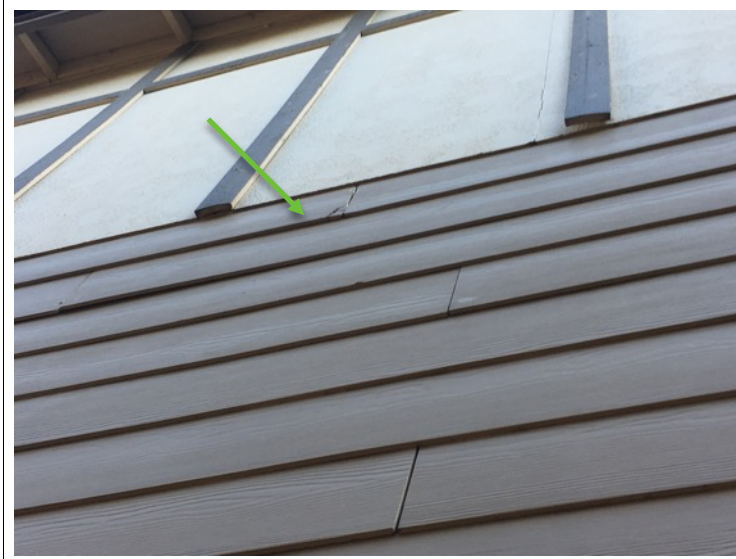
1.17.5

Cracked fiber cement lap siding.

*Damage due to the improper installation of siding material.*

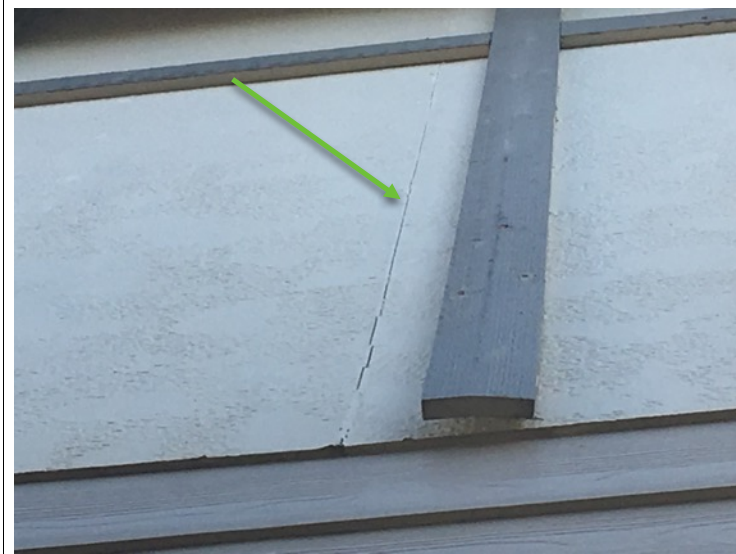
1.17.6

Improper installation of fiber cement panel siding and wood trim. Trim member should be installed to cover the seam between panels.

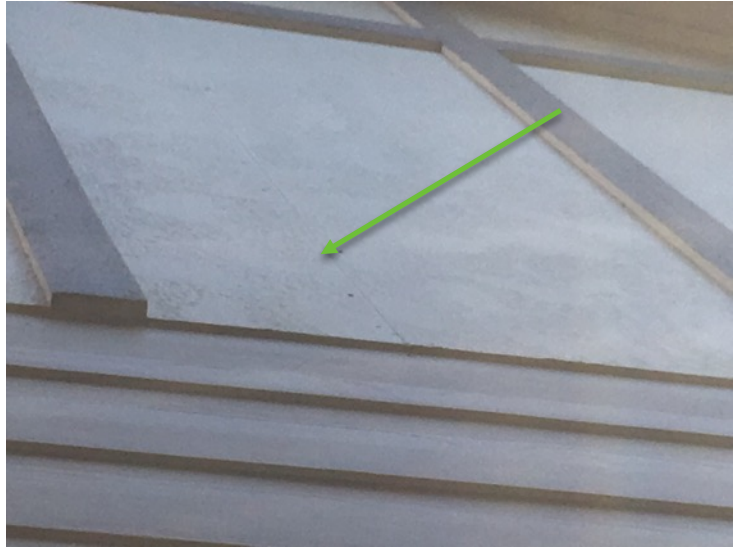
<p>1.17.7</p> <p>Improper installation of fiber cement panel siding and wood trim. Trim member should be installed to cover the seam between panels.</p>

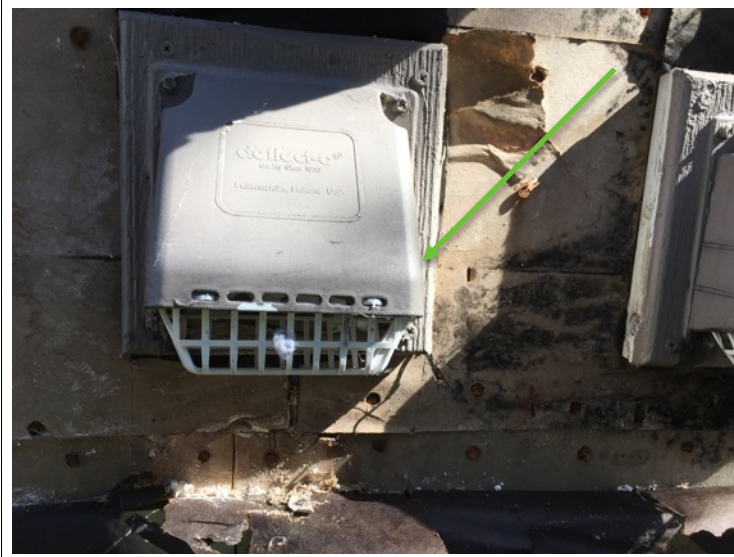
1.17.11

Omitted flexible flashing around the through wall vent penetration rough opening.

*Condition does not allow for adequate protection of underlying wall assembly components from water infiltration and/or moisture accumulation.*

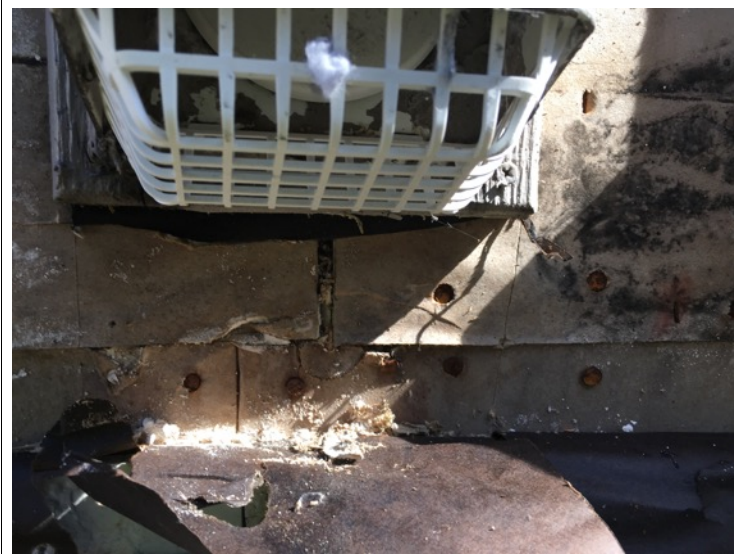
1.17.12

Deteriorated gypsum sheathing.

*Damage results from sustained moisture absorption water leakage and/or moisture accumulation within the exterior wall assembly.*

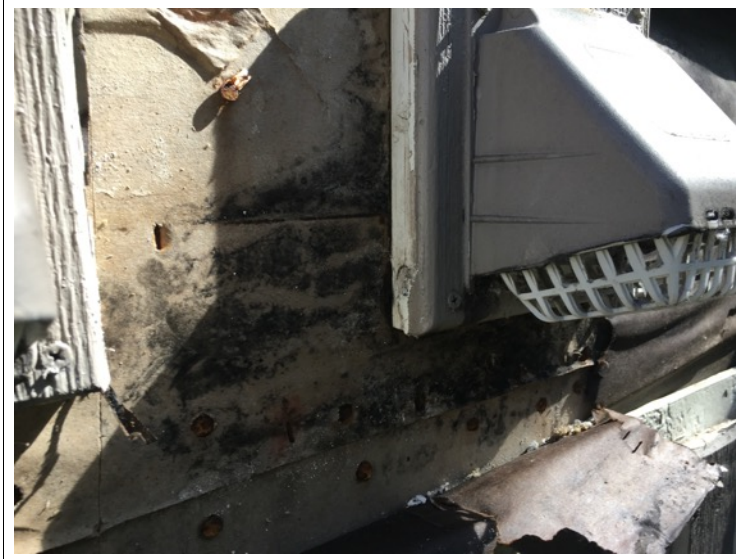
1.17.13

Deteriorated gypsum sheathing. Heavy microbial growth observed on gypsum sheathing.

*Damage results from sustained moisture absorption water leakage and/or moisture accumulation within the exterior wall assembly.*

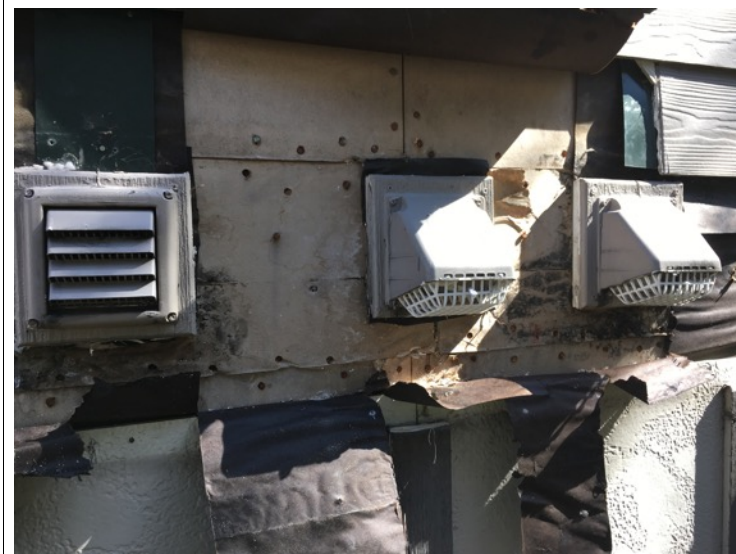
1.17.14

Deteriorated gypsum sheathing. Heavy microbial growth observed on gypsum sheathing.

*Damage results from sustained moisture absorption water leakage and/or moisture accumulation within the exterior wall assembly.*

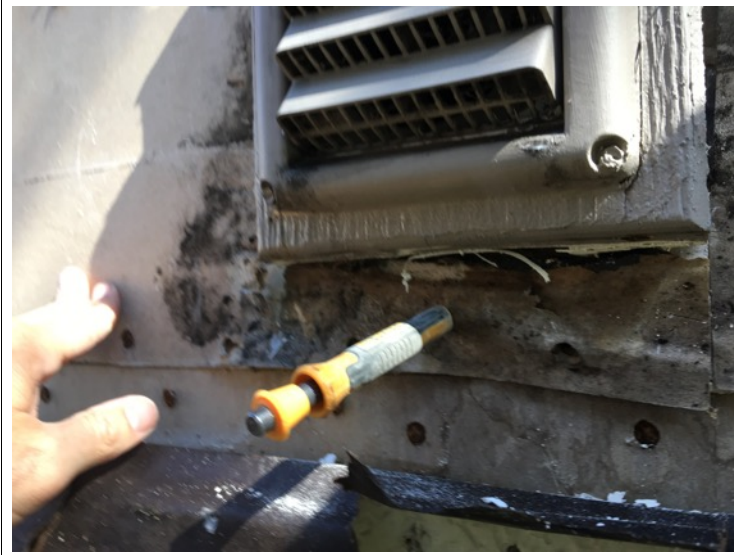
1.17.15 Demonstration of deteriorated gypsum sheathing.

*Damage results from sustained moisture absorption water leakage and/or moisture accumulation within the exterior wall assembly.*

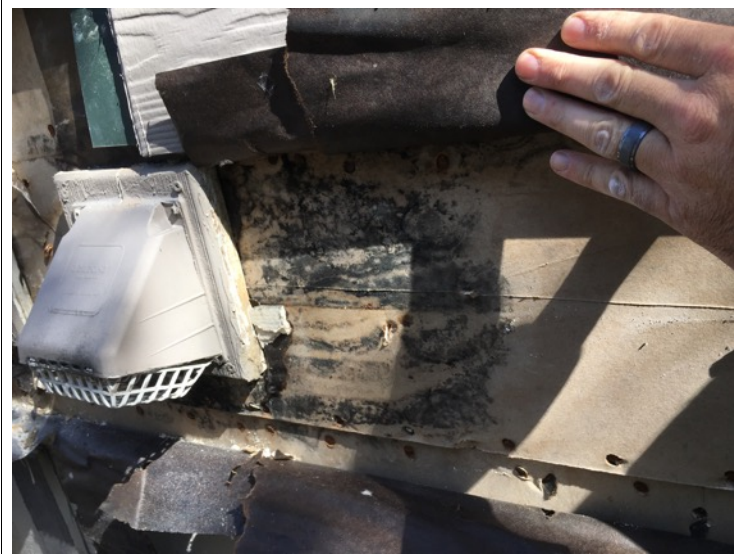
1.17.16 Deteriorated gypsum sheathing. Heavy microbial growth observed on gypsum sheathing.

*Damage results from sustained moisture absorption water leakage and/or moisture accumulation within the exterior wall assembly.*

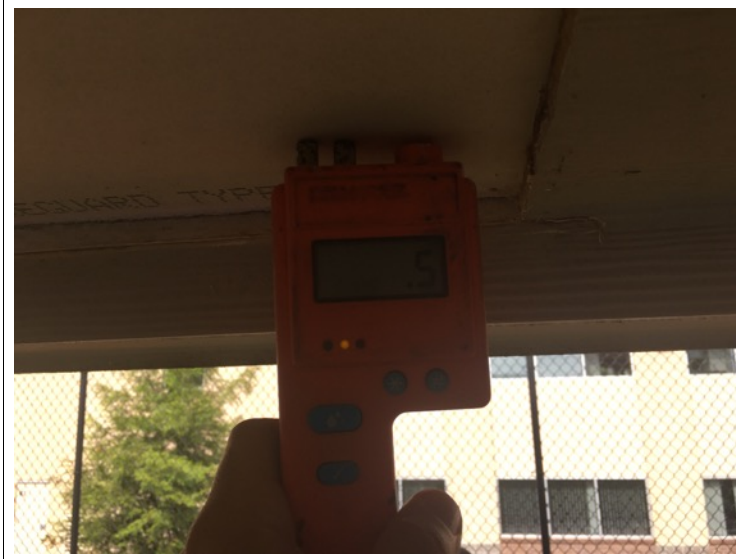
1.18.4

Elevated moisture content (.5%) of gypsum sheathing.

*Damage results from sustained moisture to water leakage and/or moisture accumulation within the exterior wall assembly.*

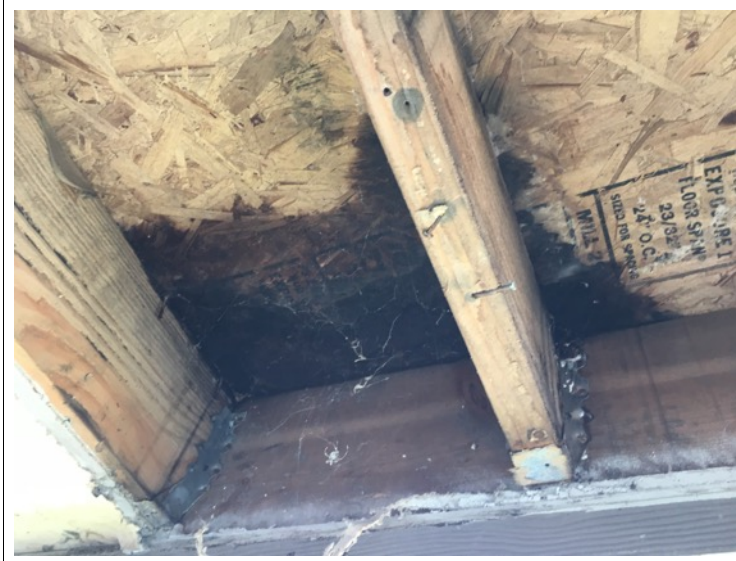
1.20.3

Moisture staining and deterioration observed on plywood sheathing which comprised deck flooring substrate.

*Damage results from sustained moisture absorption water leakage and/or moisture accumulation within the exterior wall assembly.*

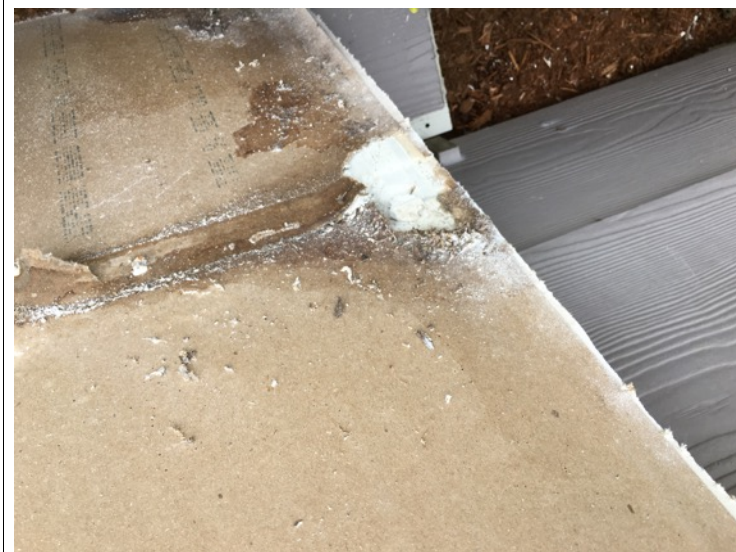
1.20.4

Moisture staining and deterioration observed on gypsum sheathing in deck soffit assembly.

*Damage results from sustained moisture absorption water leakage and/or moisture accumulation within the exterior wall assembly.*
